1 **Physical Modeling of Progressive Damage and Failure of Wood-Frame Coastal Residential**
2 **Structures Due to Surge and Wave Forces**

12 A physical model study was performed to examine the forces and response of 1:6 scale wood-frame
13 coastal residential structures subjected to storm surge and waves. An on-grade and an elevated specimen
14 were tested and exposed to regular waves with varying water depths and wave heights to simulate typical
15 wave/surge conditions resulting from landfall hurricanes on low-lying barrier islands such as Hurricane
16 Sandy that impacted the US East Coast in 2012 and Hurricane Ike that affected the US Gulf Coast in 2008.
17 Results show that through careful design, wood-frame model specimens can be constructed to have similar
18 strength and stiffness compared to full-scale structures. The two specimens were subjected to increasing
19 surge and wave conditions, and the progressive damage was monitored using LiDAR. The on-grade
20 specimen failed at a lower water level than the elevated specimen as expected. Both specimens showed

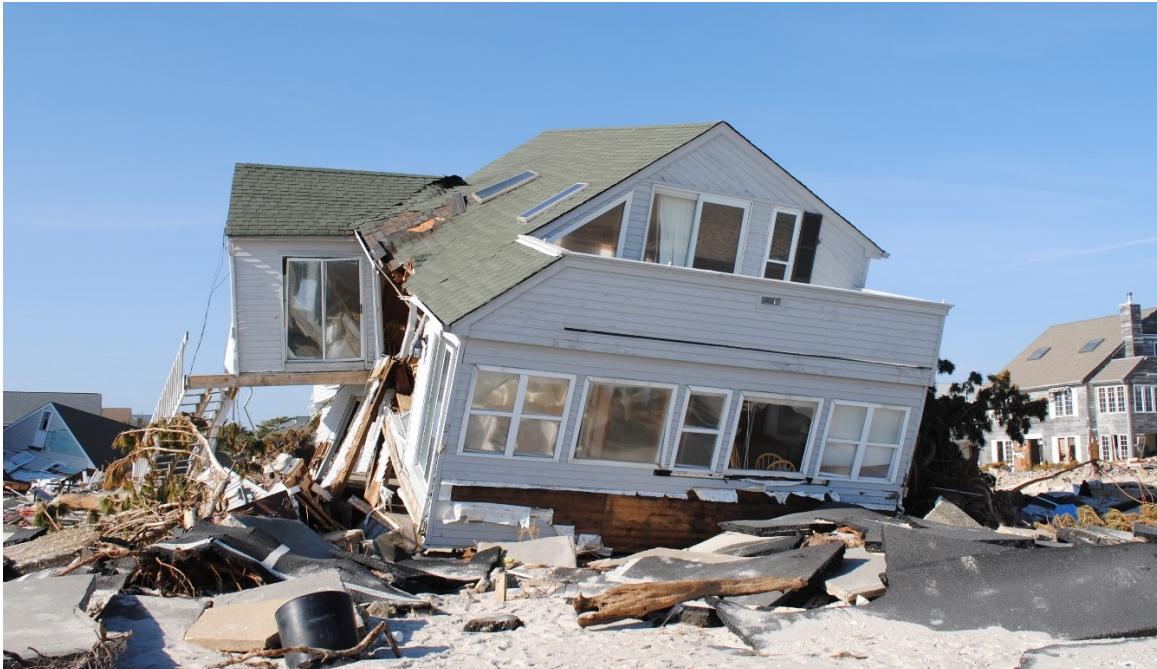
211
212 Figure 1. Damaged residential structures in Ortley Beach, New Jersey, after Hurricane Sandy in 2012. Photo
213 courtesy: T. Tomiczek.

209 (2017) recorded the failure modes of the structures and the severity of damage. Figure 1 shows example
210 damages to these structures by the combination of surge and waves (Tomiczek et al., 2017).

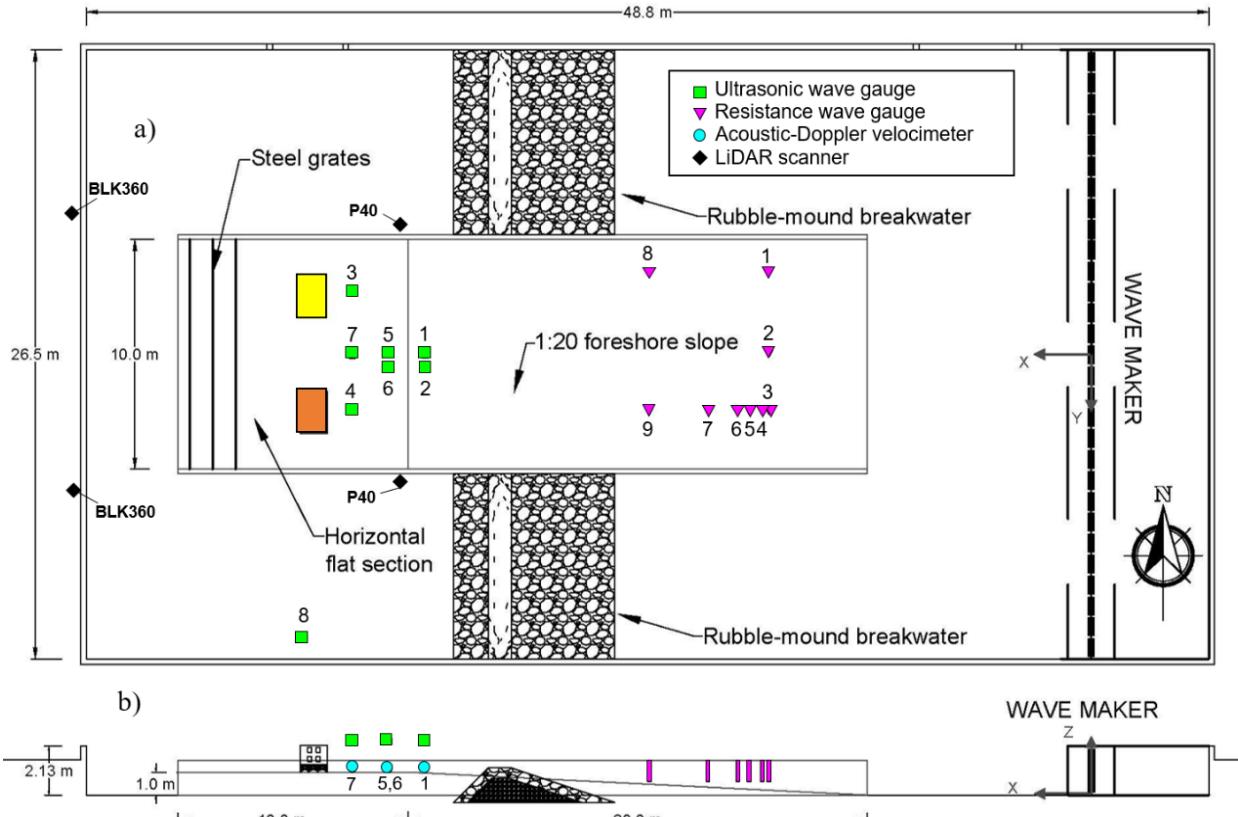
227 Figure 2. Sketch of directional wave basin. Plan view (a) and profile view (b).

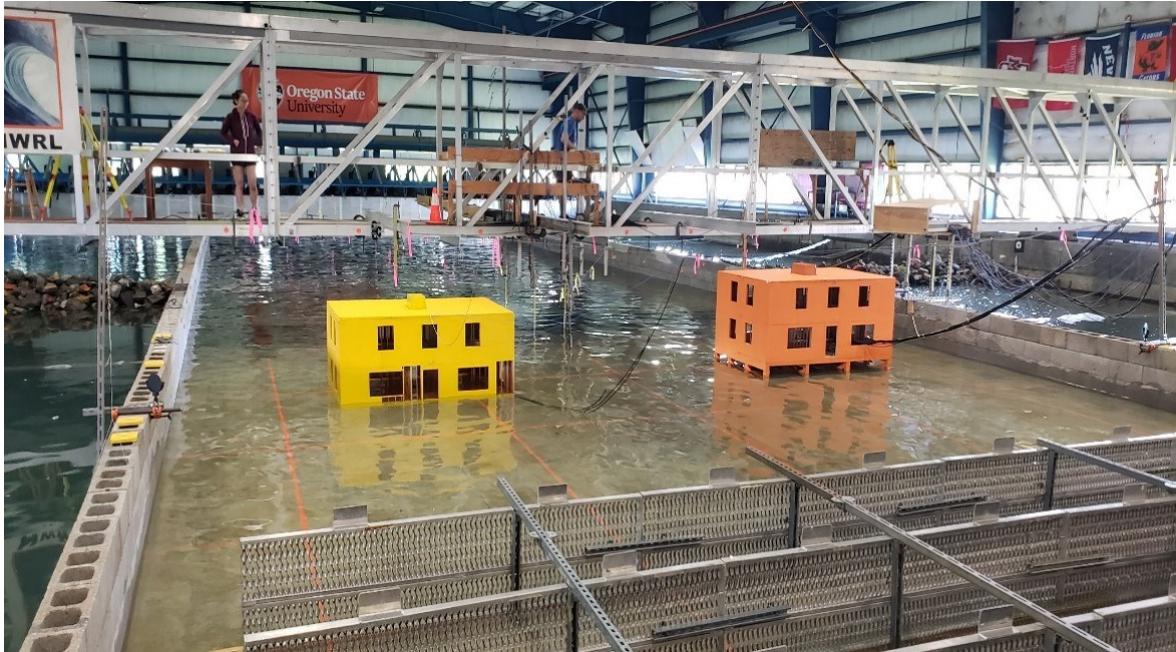
248 Figure 3. Photo of the directional wave basin after Trial 3. On-grade specimen (left) shows damage from
249 previous trials.

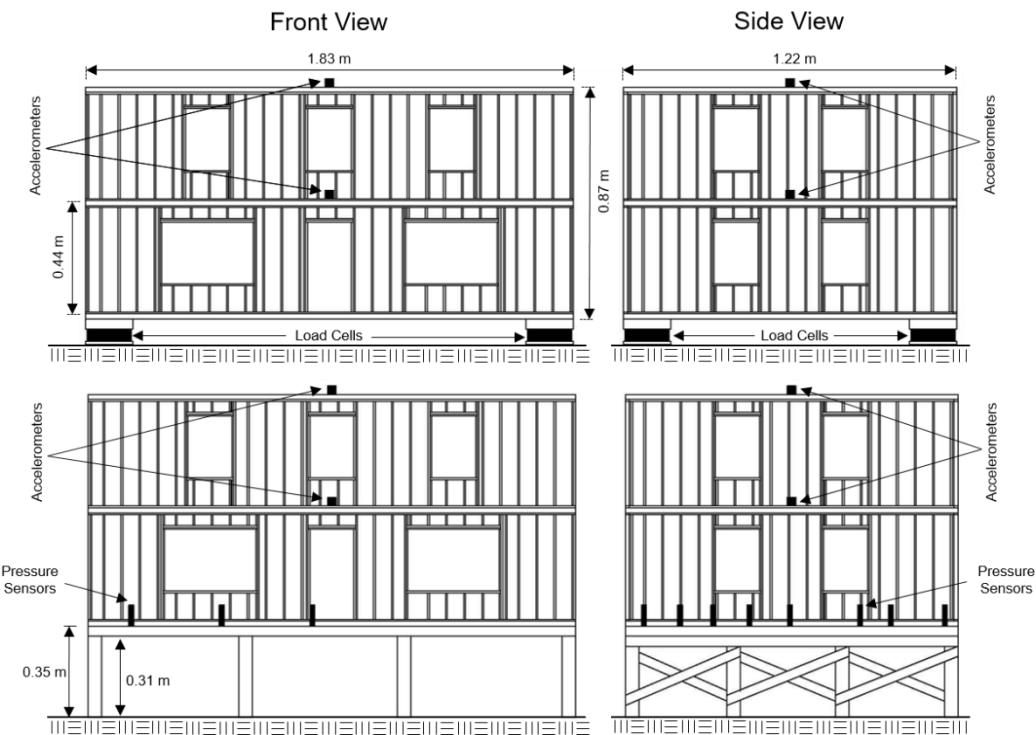
326
 327 Figure 4. Front view and side view of the on-grade specimen (top) and elevated specimen (bottom).
 328

321 The second modification was the construction of the cross-bracing on the piles in the x -direction as
 322 prescribed in the CCM. A drawing of each specimen can be seen in Figure 4 with the modifications that
 323 were done. The on-grade specimen had to be raised 9.7 cm for the load cells to be correctly installed
 324 underneath it but is still considered to be “on-grade” for this study. Additional specimen information, such
 325 as window and door dimensions, can be found in Duncan et al. (2020).

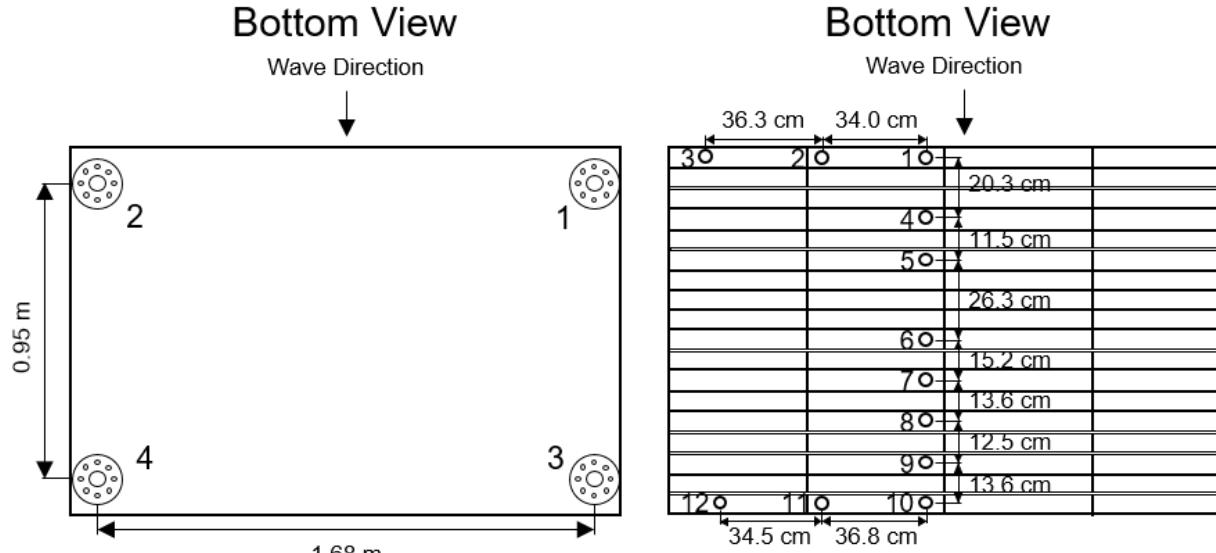
352 Figure 5. Drawing of the load cell configuration underneath the on-grade specimen (left)
 353 and the pressure sensor configuration on the bottom of the elevated specimen (right).

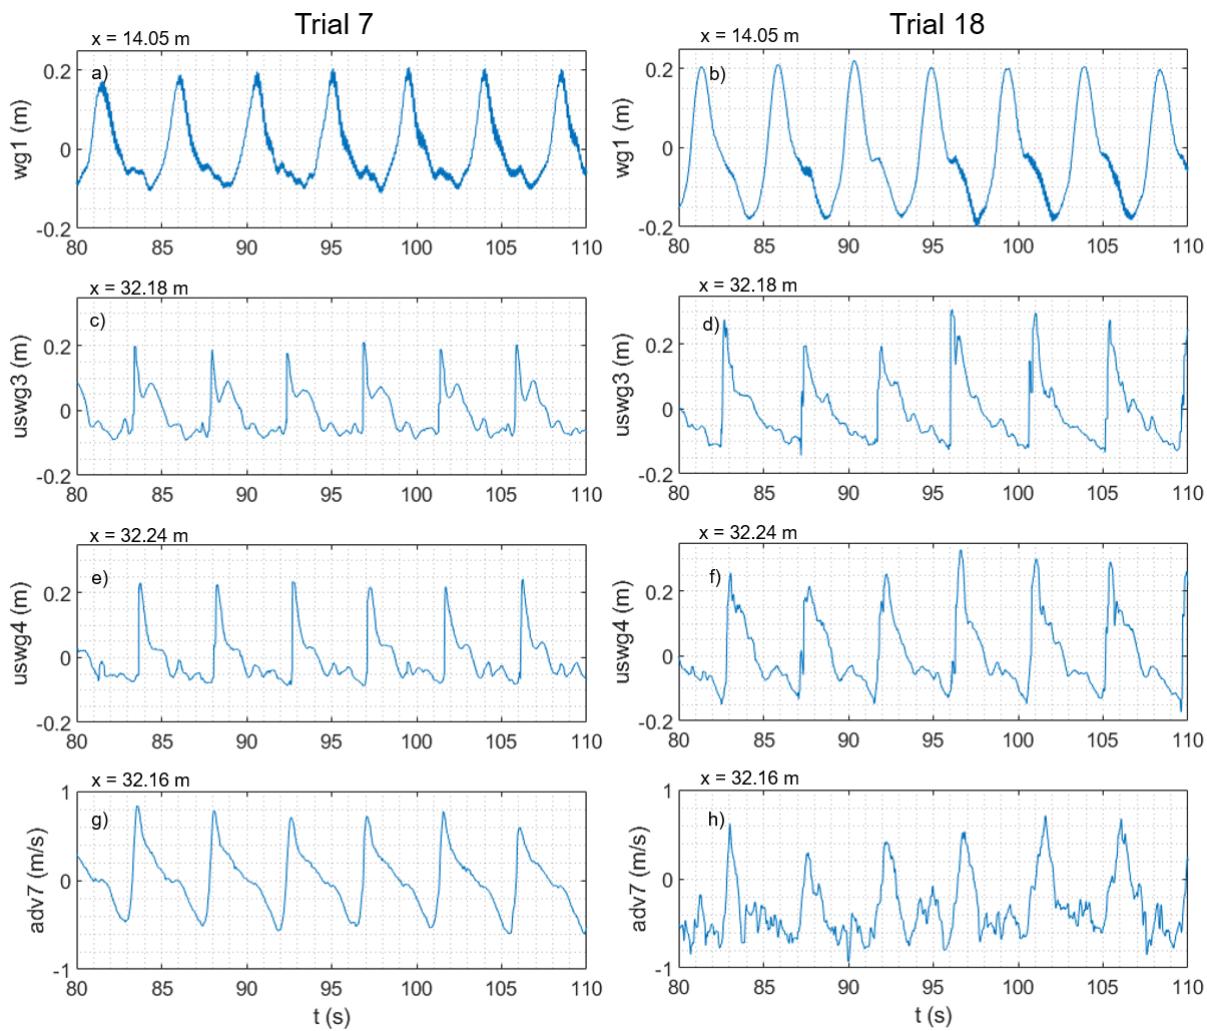
470 Figure 6. Time series of the hydrodynamic conditions from Trial 7 (left, $h_0 = 1.30$ m) and Trial 18 (right,
 471 $h_0 = 1.40$ m). Panels a-f show free surface elevations and g-h show wave-induced water velocities in the x -
 472 direction. The x -position of each sensor is also indicated above each panel.

474 Trial 7 had a water depth of 1.30 m at the wavemaker, which relates to a 0.30 m water depth at the
475 specimens and an air gap of 0.05 m relative to the elevated specimen. Trial 18 had a water depth of 1.40 m
476 at the wavemaker, which relates to a 0.45 m water depth at the specimens and an air gap of -0.05 m relative
477 to the elevated specimen. The waves breaking directly on the specimens during Trial 7 and the negative air
478 gap during Trial 18 led to relatively large forces measured by the load cells underneath the on-grade
479 specimen and large uplift pressures on the elevated specimen. Figure 7 shows the overturning force
480 measured by the load cells underneath the on-grade specimen (Figure 7a, c, e, and g), uplift pressures on
481 the bottom of the elevated specimen (Figure 7b, d, f, h), and accelerations on the top level of both specimens
482 (Figure 7i, j). Figure 7a, c and Figure 7e, g show that the front and back pairs of load cells are uniform as

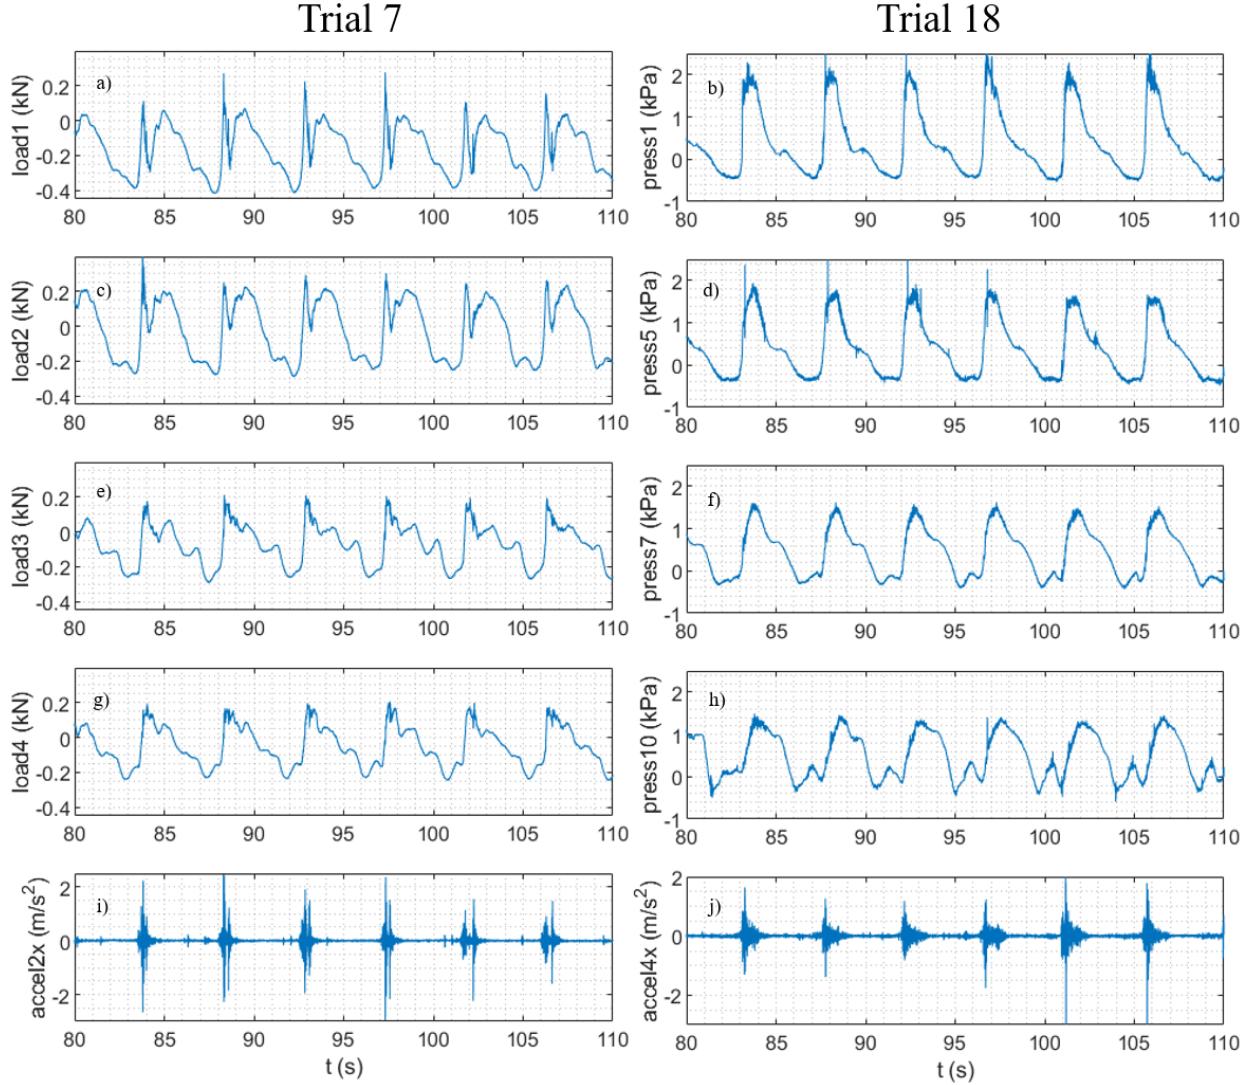
489 Figure 7. Time series of load cells 1-4 and accelerometer 2 on the on-grade specimen from Trial 7 (left, h_0
490 = 1.30 m). Time series of pressure sensors 1, 5, 7, and 10 and accelerometer 4 on the elevated specimen
491 from Trial 18 (right, h_0 = 1.40 m). Both accelerometer time series (i and j) are in the x-direction.

483 would be expected for the normally incident waves. The loads shown here are consistent with Wilson et al.
484 (2008), Garcia et al. (2008), and van de Lindt et al. (2009). In Figure 7b, d, f, and h, an apparent decrease
485 in uplift pressure can be seen as waves propagate from the front of the specimen to the back. Figure 7i, j
486 show that there are large accelerations that occur with the initial impact by the wave on the structure and
487 that these accelerations dampen before the arrival of the subsequent wave.

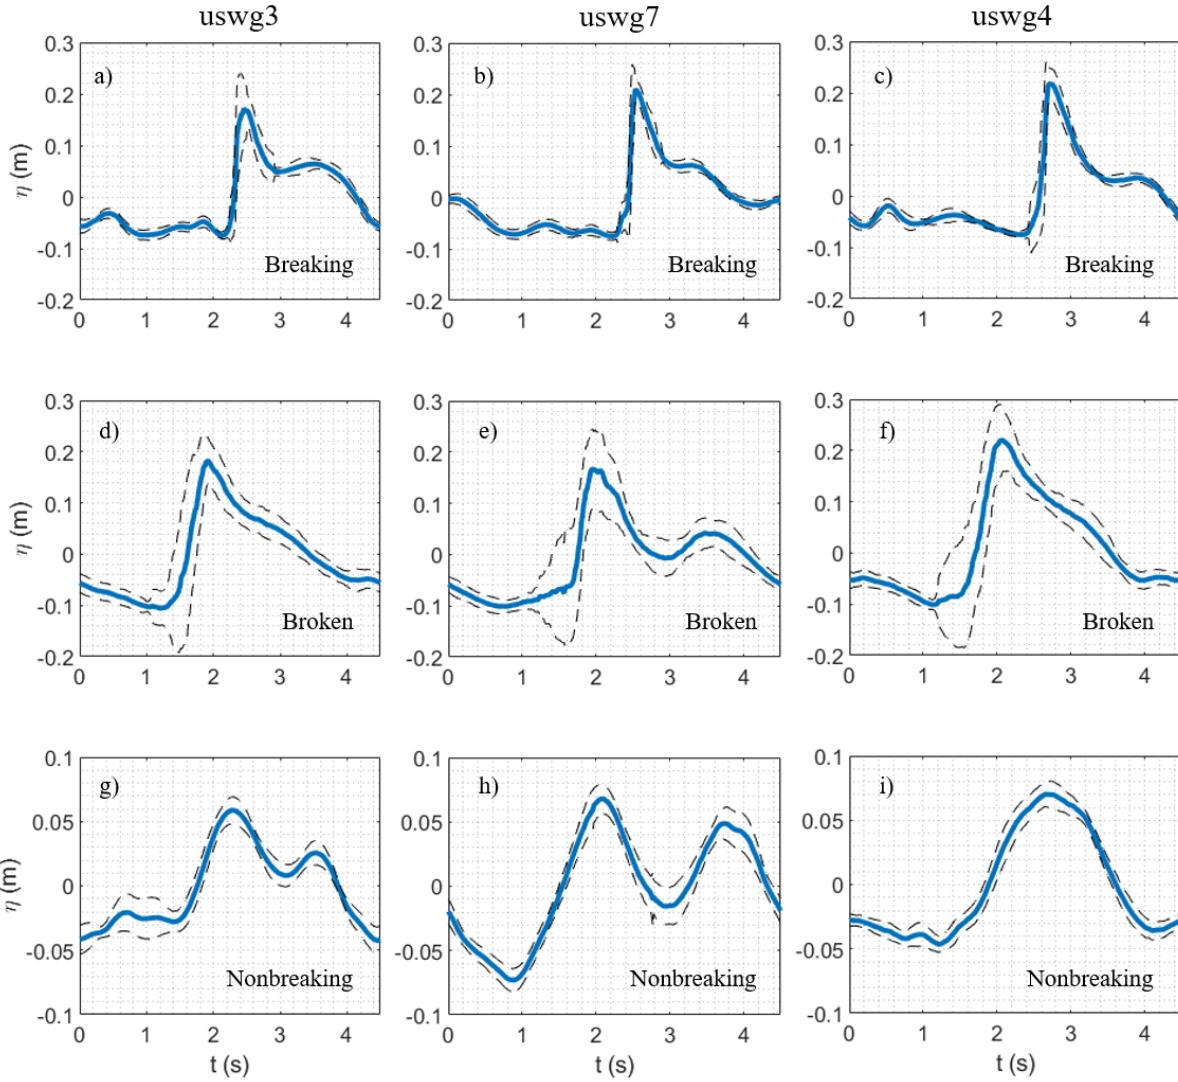
523 Figure 8. Examples of ensemble-averaged free surface elevations (blue solid line) from Trial 7 (a, b, and c,
524 $h_0 = 1.30$ m), Trial 18 (d, e, and f, $h_0 = 1.40$ m), and Trial 19 (g, h, and i, $h_0 = 1.45$ m) and their standard
525 deviations (black dashed line). Plots on the left (a, d, and g) were taken from uswg3; plots in the middle (b,
526 e, and h) were taken from uswg7; plots on the right (c, f, and i) were taken from uswg4.

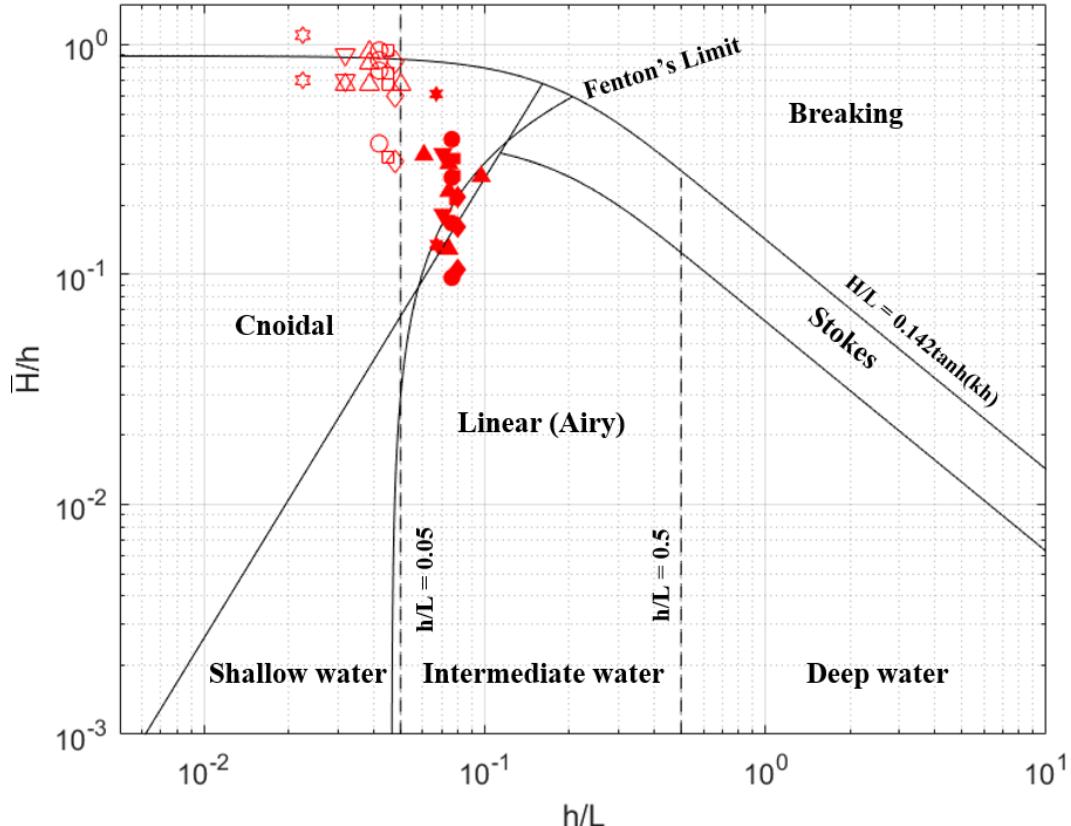
542 Figure 9. Wave classification from wg1 (solid) and uswg7 (hollow) for each trial. For $h_0 = 1.10$ m (star); h_0
 543 = 1.20 m (downward triangle); $h_0 = 1.30$ m (upward triangle); $h_0 = 1.35$ m (circle); $h_0 = 1.40$ m (square); h_0
 544 = 1.45 m (diamond).

530 It is important to classify the types of waves that were run during the experiment and to know when
 531 it is acceptable to apply specific wave theories. Figure 9 shows the classification of the types of waves run
 532 for each trial of the experiment at wg1 and uswg7 except for Trial 3, where H is the ensemble averaged
 533 wave height, h is the still water depth, and L is the calculated wavelength. Filled circles are for wg1, which
 534 was offshore, and hollow circles are for uswg7 in front of the on-grade specimen. The marker types
 535 correspond to the still water depth at the wavemaker at the start of each trial. For this experiment, second
 536 order nonlinear waves were generated and can be classified as Cnoidal waves. At wg1, most waves are
 537 within the Cnoidal Theory limits and are in shallow water based on Fenton's limit. Waves from
 538 approximately four trials can be classified by linear wave theory in intermediate water depth. At uswg7, all

539 waves are defined by Cnoidal waves and are in shallow water. These waves are all either approaching the
 540 theoretical breaking limit given by Miche's equation or have crossed the theoretical breaking limit.

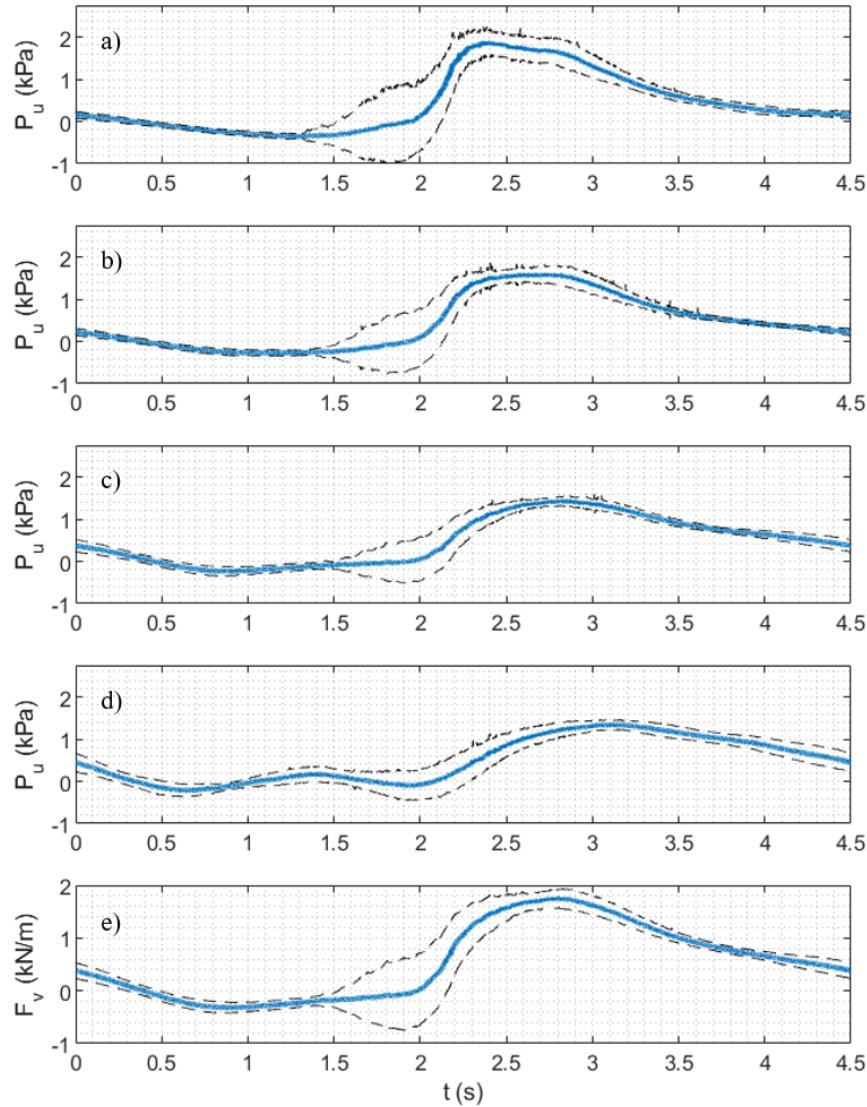
553 Figure 10. Ensemble averaged uplift pressures and total vertical force measured on the elevated specimen
 554 from press1 (a), press5 (b), press7 (c), press10 (d), and total vertical force (e) from Trial 18 ($h_0 = 1.40$ m).

546 Figure 10 shows the ensemble-averaged uplift pressures, P_u , from four of the twelve total pressure
 547 sensors and the total vertical force per unit width, F_v , taken from the eight pressure sensors along the middle
 548 of the elevated specimen from Trial 18. The magnitude of the uplift pressures is consistent with Park et al.
 549 (2017). The peak pressure decreases and becomes more elongated as the wave moves through the structure,
 550 which was present for a majority of trials. F_v was calculated by integrating the pressure distribution over
 551 the length of the specimen in the x -direction.

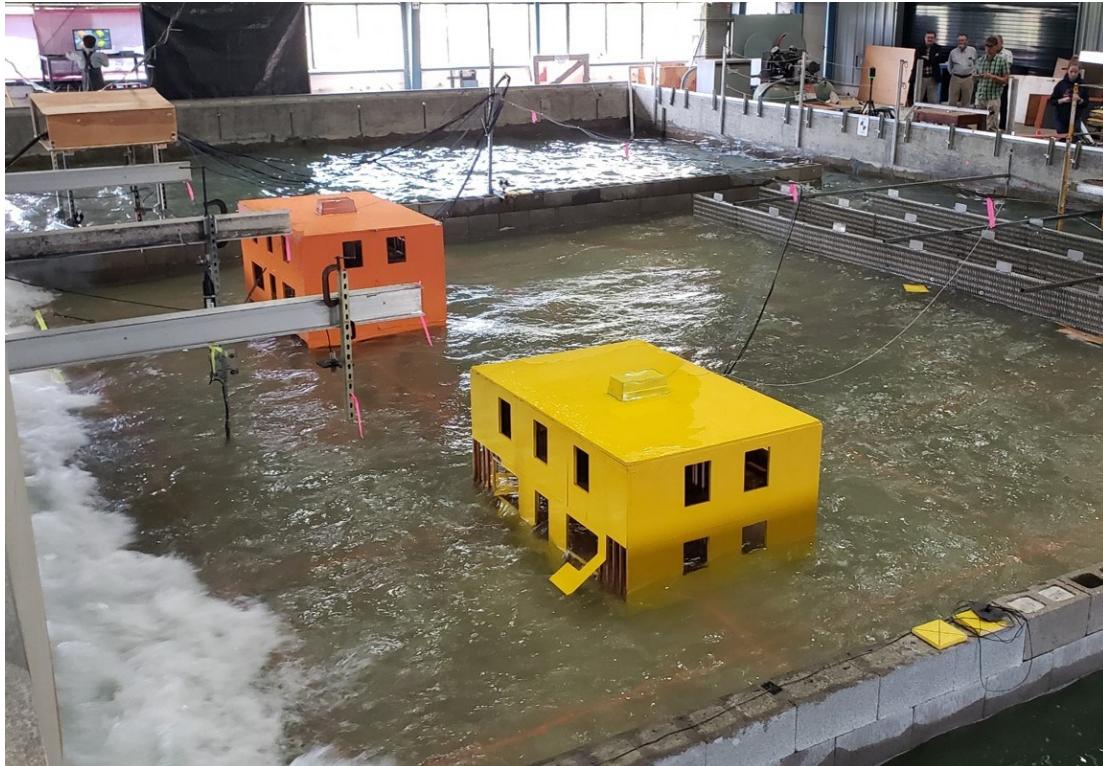
577 Figure 11. Photo taken during trial 10 ($h_0 = 1.30$ m) that shows the damages the specimens experienced
578 during testing.

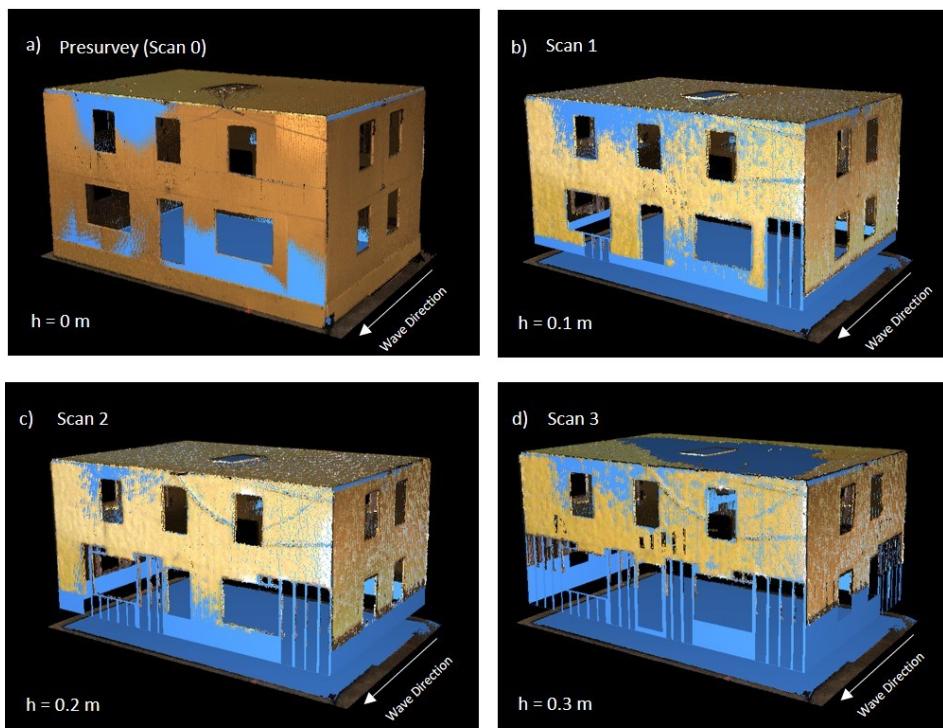
603 Figure 12. Models of the on-grade specimen created after each scan (Yu et al., 2019).

595 LiDAR scans were taken of the wave basin before Trial 1 (presurvey scan) and before each increase
 596 in water level. Point clouds generated from the scans were used to quantitatively and qualitatively track the
 597 progressive damages of each specimen. Yu et al. (2019) used Leica Cyclone to model the structural
 598 members of each specimen, including each wall panel and wall stud. Figure 12 and Figure 13 show the
 599 models that were created of both specimens from each scan. These figures show the progressive damages
 600 to the walls that were discussed in Section 6.1. Points below the water level and areas of the specimen that
 601 were covered in water were not visualized because the scanners used do not scan through the water.

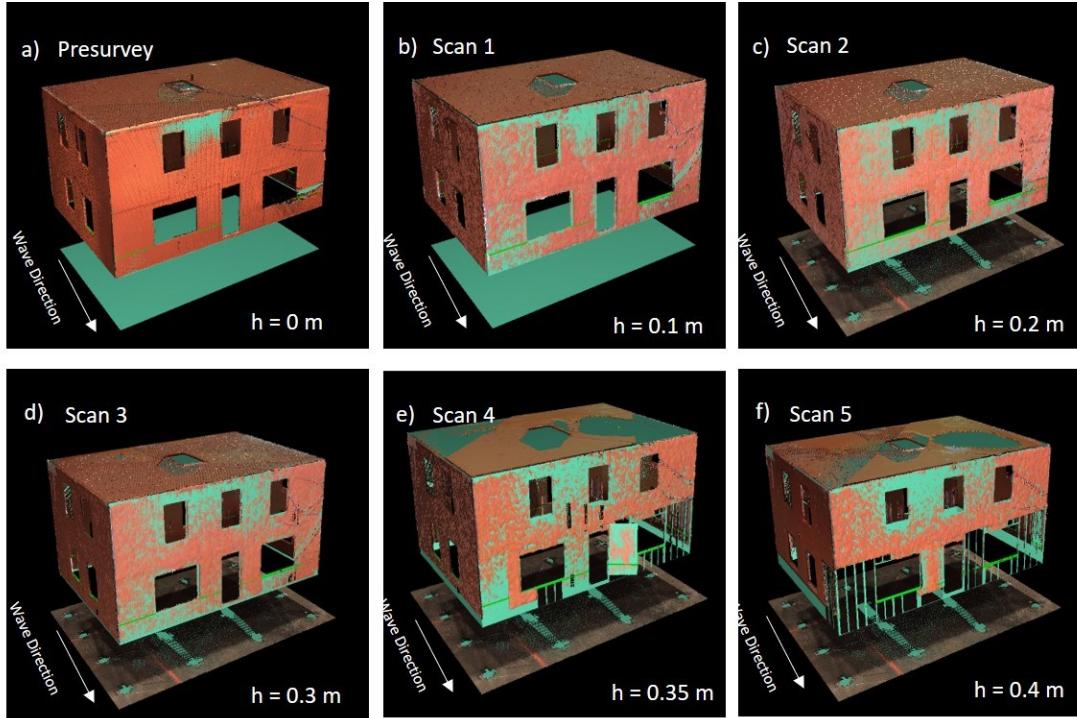
605 Figure 13. Models of the elevated specimen created after each scan (Yu et al., 2019).

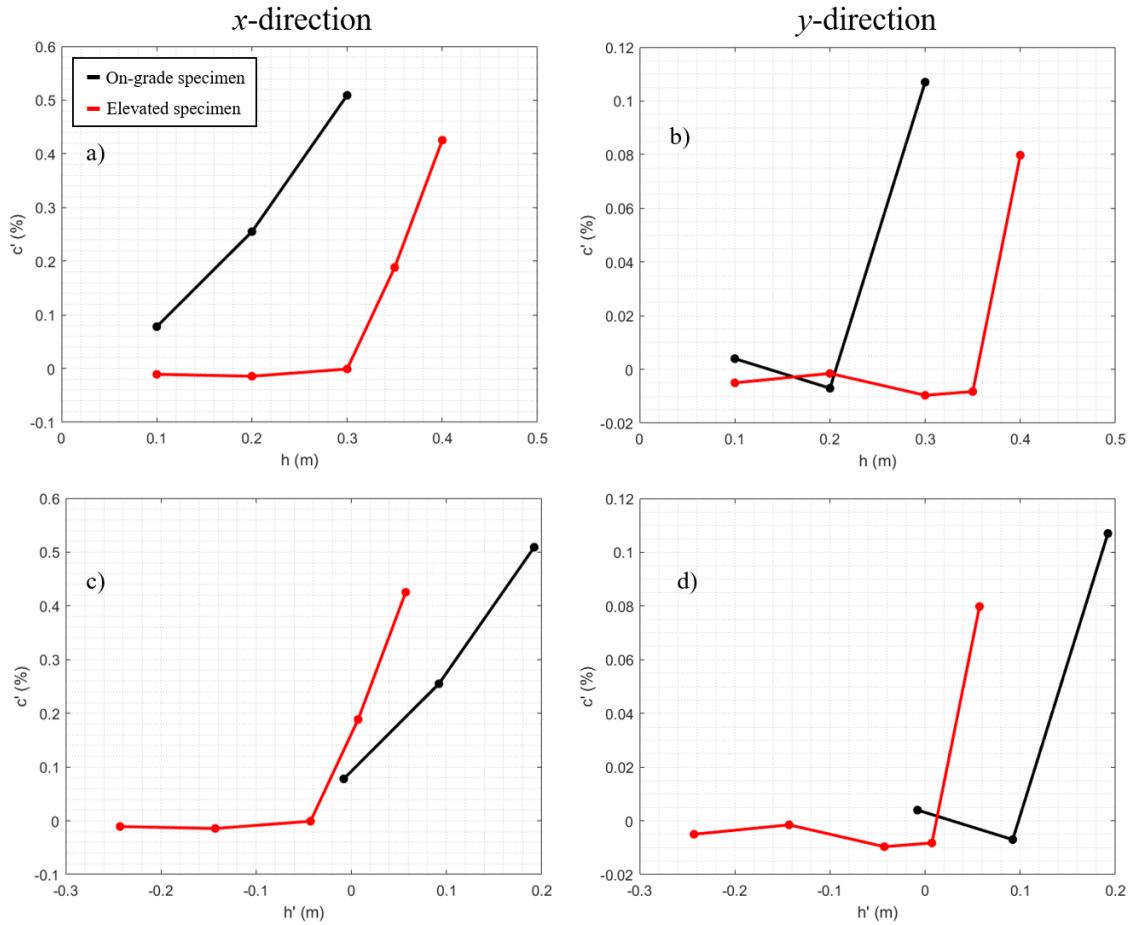
626 Figure 14. Cumulative damage fraction, c' , of the on-grade specimen (red) and elevated specimen (black)
 627 as a function of h (a, b) and h' (c, d). Panels a and c are of walls oriented in the x -direction and panels b
 628 and d are of walls oriented in the y -direction (Yu et al., 2019).

620 for the elevated specimen. Figure 14c and Figure 14d show c' as a function of h' in the x -direction and y -
 621 direction. These plots also indicate that the elevated specimen failed at a slightly quicker rate than the on-
 622 grade specimen. The difference in damage rates may be because the elevated specimen became waterlogged
 623 and structurally weaker the longer it was in the water and experienced more waves relative to the on-grade
 624 specimen.

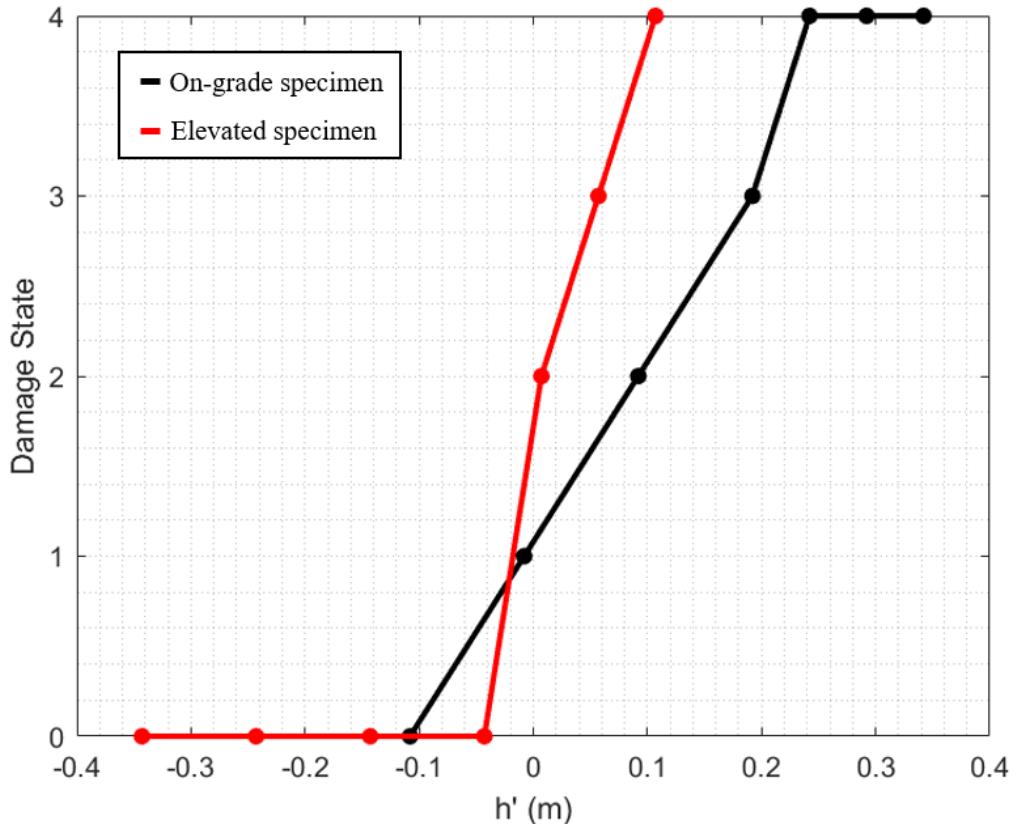
642 Figure 15. Damage state of the on-grade specimen (black) and the elevated specimen (red) as a function of
 643 h' (Yu et al., 2019).

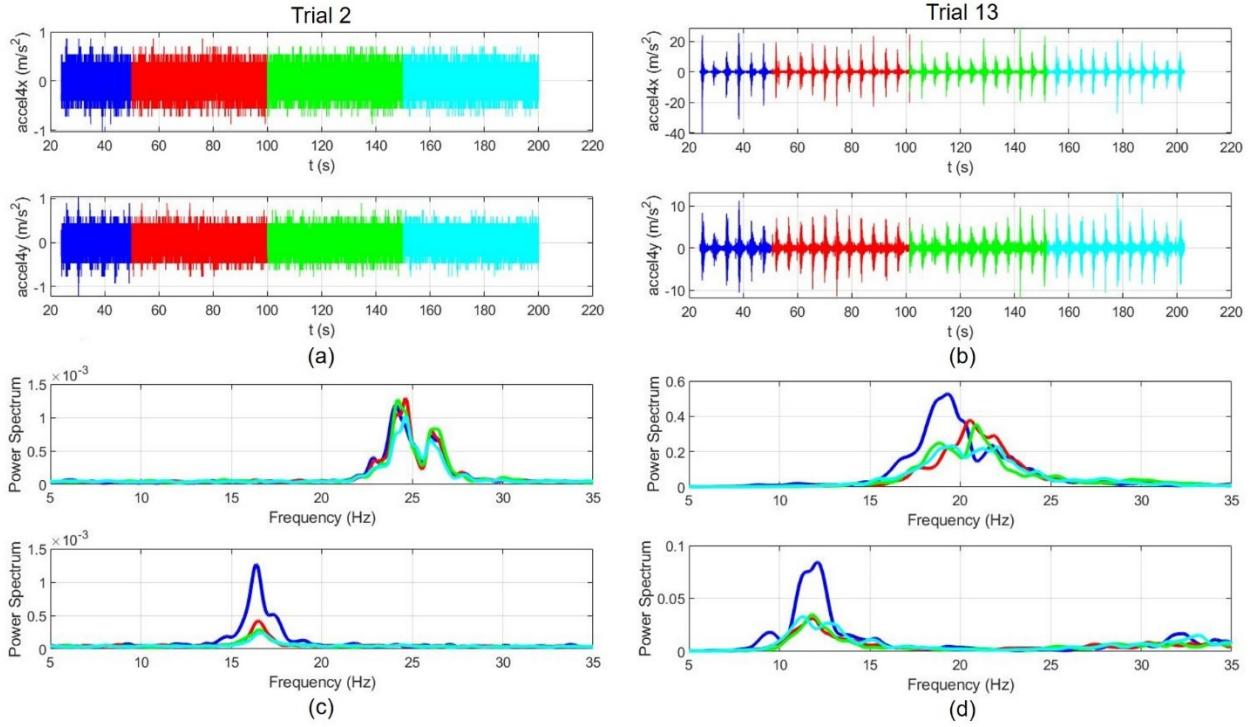
678 Figure 16. Elevated specimen hydrodynamic testing response in terms of x - and y -direction. Acceleration
 679 measurements for (a) Trial 2 ($h_0 = 1.10$ m) and (b) Trial 13 ($h_0 = 1.35$ m). Corresponding power spectrum
 680 for (c) Trial 2 and (c) Trial 13. Note that approximately the first 20 seconds were not considered in the
 681 data analysis reported here and that colors of the curves for the power spectral density functions shown
 682 have direct relation to the colors selected in plotting of the acceleration time series.

661 Figure 16c and d show the power spectrum functions for trials 2 and 13, respectively, for both the
662 x- and y-directions. Note that the colors of the PSD functions shown have direct relation to the colors
663 selected in plotting of the acceleration time series for the same trials and for the x- and y-directions. The
664 frequencies at which the peak values of the PSD functions are observed correspond to the natural
665 frequencies. Comparison of the natural frequencies obtained from Figure 16c (Trial 2) and d (Trial 13)
666 indicate that the natural frequencies in both the x- and y-direction tend to decrease with increase trial
667 number.

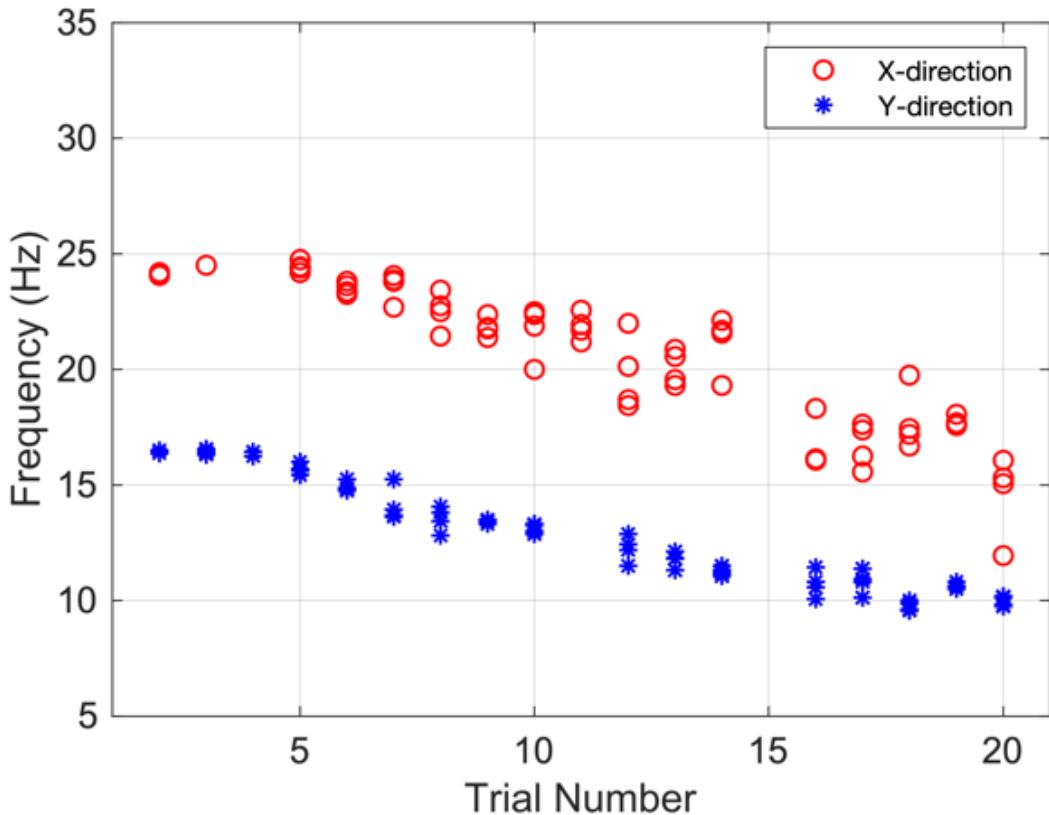
684
685 Figure 17. Elevated specimen identified natural frequency as a function of the trial number.
686

668 The reduction in natural frequencies as a function of the trial number can be further observed in
669 Figure 17, which shows the identified natural frequencies as a function of the trial number for the elevated
670 specimen. For each trial, four points are shown in this figure for both the x-direction and y-direction
671 markers, which correspond to the four groups of waves mentioned in results shown in Figure 16. The
672 reduction of the natural frequency with trial number can in part be explained with the accumulated loss of
673 shear walls that was observed during testing that was also illustrated in Section 6.2. The natural frequency
674 reduction can also be attributed to the loosening of nails and other connections and other load duration
675 effects on wood members and connections (e.g., Rosowsky and Bulleit, 2002). However, this was not
676 explored further in this study.

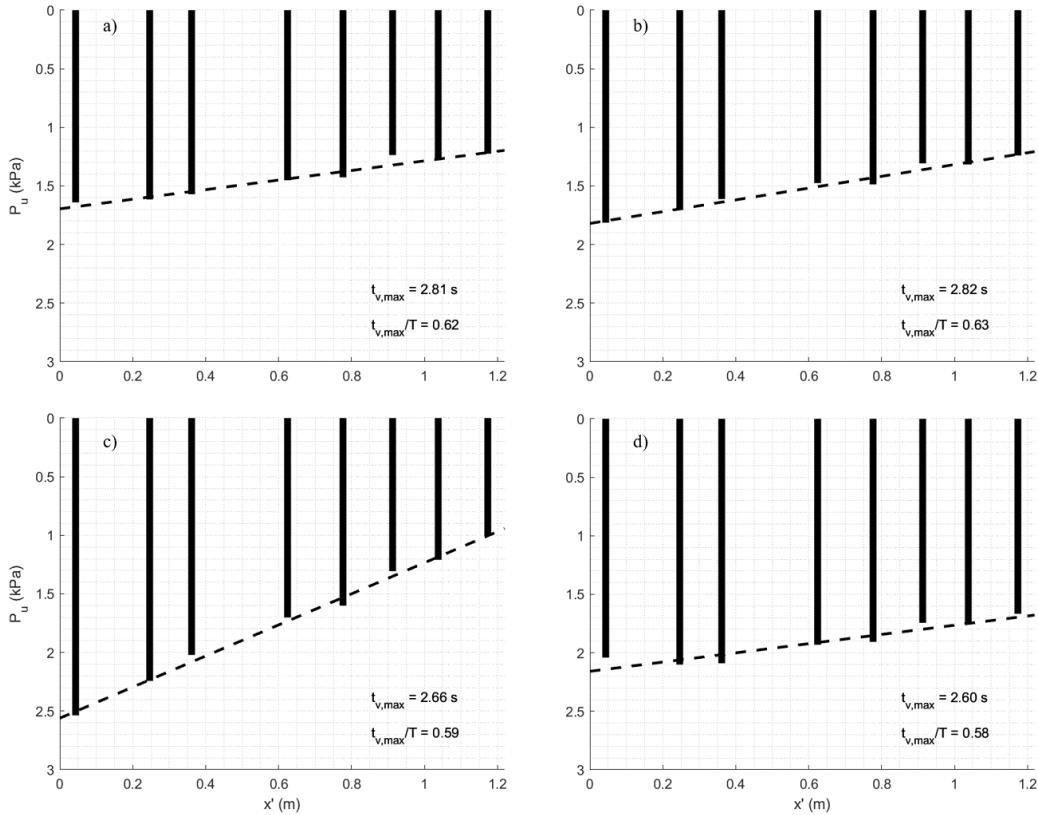
714 Figure 18. Uplift pressure distribution along the bottom of the elevated specimen at the time of maximum
 715 vertical force during trials 18 (a, $h_0 = 1.40$ m), 19, (b, $h_0 = 1.45$ m), 20 (c, $h_0 = 1.45$ m), and 21 (d, $h_0 =$
 716 1.45 m). x' indicates the location of the pressure sensor measurement relative to the length of the
 717 specimen in the wave direction (x -direction).

708 front to the back of the specimen, which was observed for most trials with a negative air gap. While the
 709 maximum uplift pressure is not always at the very front of the specimen, it is likely that it will occur near

710 the front. This indicates that the uplift pressures will be greatest at the front of the structure and will decrease
 711 as a wave travels from the front to the back of a structure for waves that produce relatively large vertical
 712 forces.

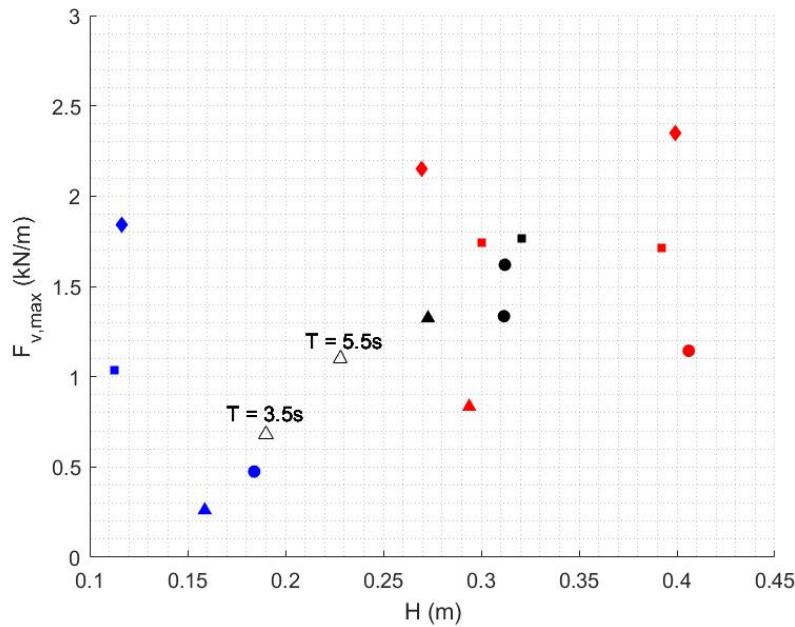
734
 735 Figure 19. Maximum ensemble-averaged vertical force against ensemble-averaged wave height. Colors
 736 indicate nonbreaking (blue), broken (black), and breaking (red) waves. Marker types indicate trials where
 737 $h = 0.30\text{ m}$ (triangles), $h = 0.35\text{ m}$ (circles), $h = 0.40\text{ m}$ (squares), and $h = 0.45\text{ m}$ (diamonds).

725 obtain a total vertical force time series. Finally, the time series was ensemble-averaged and the maximum
 726 force, $F_{v,max}$, was identified. Figure 19 shows $F_{v,max}$ for each trial plotted as a function of the ensemble-
 727 averaged wave height, \bar{H} , at uswg4 in front of the elevated specimen. The different colors indicate
 728 nonbreaking (blue), broken (black), and breaking (red) waves. The various marker types indicate a water
 729 depth of 0.30 m (triangles), 0.35 m (circles), 0.40 m (squares), and 0.45 m (diamonds). Figure 19 shows a
 730 correlation between increasing wave height and increasing vertical force, which is consistent with past
 731 literature such as Bradner et al. (2011). There are two outlier trials where the wave heights were relatively
 732 small (approximately $\bar{H} = 0.11\text{m}$) yet yielded relatively large forces. The air gap is negative in these two

733 outlier trials, which could explain why the measured force is larger than expected with small wave heights.

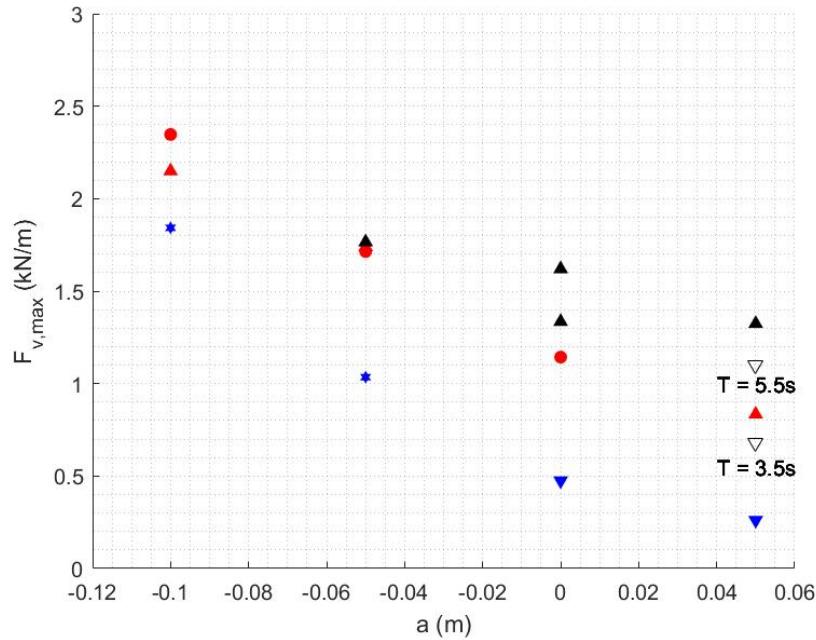
763 Figure 20. Maximum ensemble averaged vertical force against air gap. Nonbreaking (blue),
 764 broken (black), and breaking (red). $\bar{H} < 0.15$ m (stars), $0.15 \leq \bar{H} < 0.25$ m (down triangle),
 765 $0.25 \leq \bar{H} < 0.35$ m (triangles), and $\bar{H} \geq 0.35$ m (circles).

738
 739 Figure 20 shows $F_{v,max}$ plotted as a function of the air gap, a . The different marker types indicate a
 740 value of \bar{H} less than 0.15 m (stars), between 0.15 m and 0.25 m (downward triangle), between 0.25 m and
 741 0.35 m (upward triangles), and greater than 0.35 m (circles). Figure 20 shows the maximum vertical force

751 vertical forces will begin to decrease as the air gap becomes more negative because the bottom of the
752 structure is less affected by the dynamic pressures (Park et al., 2017; Tomiczek et al., 2019). However, the
753 elevated specimen failed before more trials could be run, so this effect is not present in this study.
754 Nonbreaking waves had the smallest force at each of the different air gaps due to relatively small wave
755 heights, but at the most negative air gap, a nonbreaking wave produced a relatively large force compared
756 to all other trials even with a small wave height. The peak forces occurring at an air gap of -0.1 m were due
757 to relatively large waves breaking on the specimen directly. All trials had a period of $T = 4.5$ s except for
758 Trial 9 and Trial 10, which are labeled in both plots and indicated by hollow markers. Bradner et al. (2011)
759 found that the maximum uplift force was dependent on the wave period. Not enough data was collected to

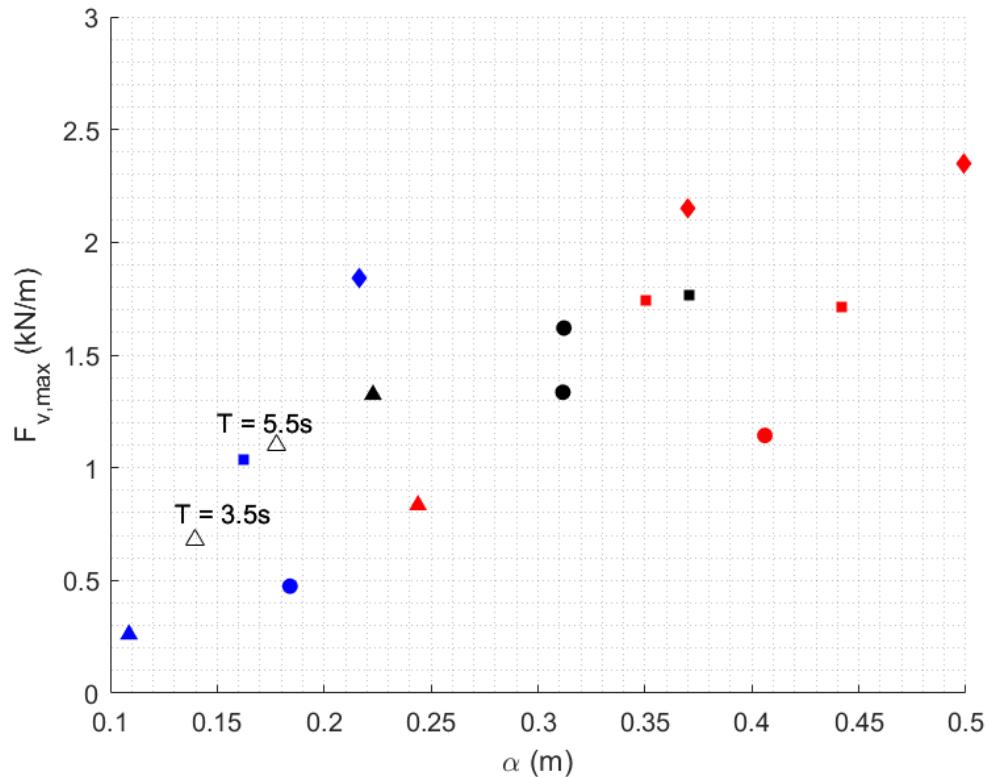
814 Figure 21. Maximum vertical force as a function of α . Colors indicate nonbreaking (blue), broken (black),
815 and breaking (red) waves. Marker types indicate trials where $h = 0.30$ m (triangles), $h = 0.35$ m (circles), h
816 = 0.40 m (squares), and $h = 0.45$ m (diamonds).

Equation 8 must be integrated over the length of the structure in the x -direction to obtain the total vertical force. Figure 21 shows the maximum vertical force, $F_{v,max}$, as a function of α . This figure shows the positive correlation between maximum vertical force and α . A conservative uplift pressure distribution equation was also created:
