1 **Physical Modeling of Progressive Damage and Failure of Wood-Frame Coastal Residential**
2 **Structures Due to Surge and Wave Forces**

12 A physical model study was performed to examine the forces and response of 1:6 scale wood-frame
13 coastal residential structures subjected to storm surge and waves. An on-grade and an elevated specimen
14 were tested and exposed to regular waves with varying water depths and wave heights to simulate typical
15 wave/surge conditions resulting from landfall hurricanes on low-lying barrier islands such as Hurricane
16 Sandy that impacted the US East Coast in 2012 and Hurricane Ike that affected the US Gulf Coast in 2008.
17 Results show that through careful design, wood-frame model specimens can be constructed to have similar
18 strength and stiffness compared to full-scale structures. The two specimens were subjected to increasing
19 surge and wave conditions, and the progressive damage was monitored using LiDAR. The on-grade
20 specimen failed at a lower water level than the elevated specimen as expected. Both specimens showed

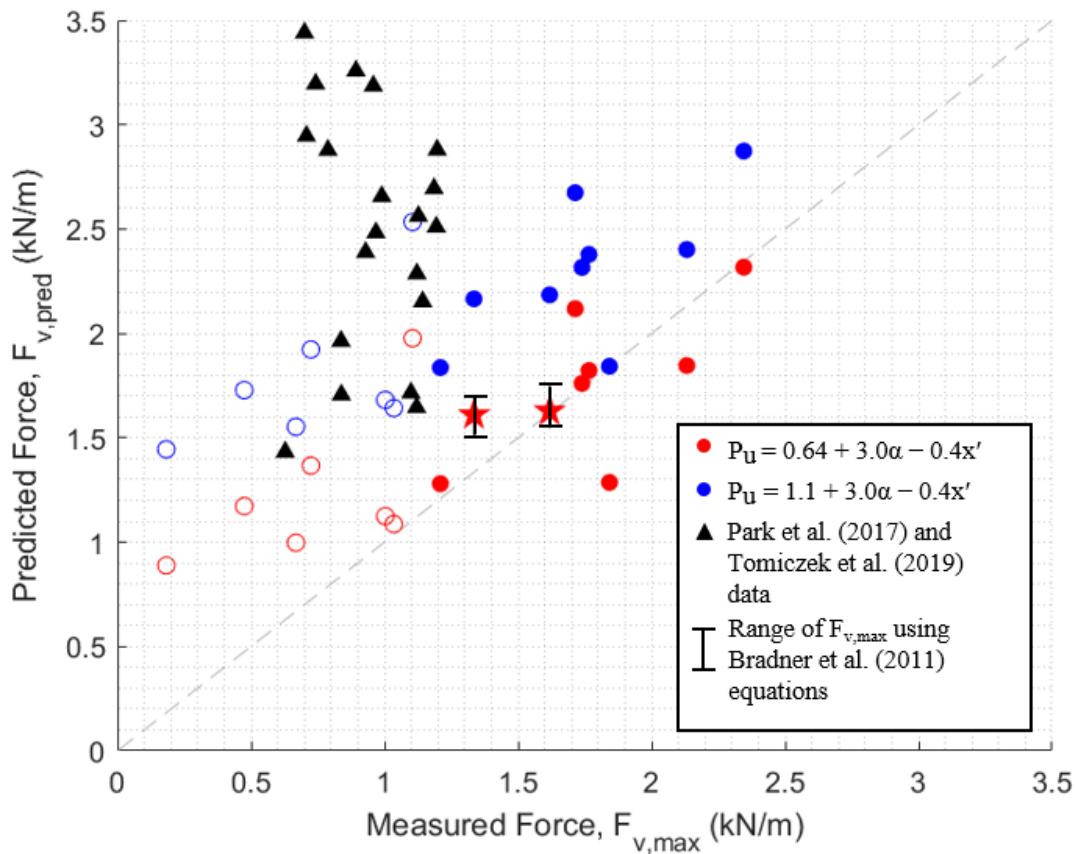
826
 827 Figure 22. Measured vertical force compared to the predicted vertical force. Force predicted using Equation
 828 8 in red and force predicted using Equation 9 in blue. A marker that is not filled indicates that the trial did
 829 not use values of \bar{H} , a , h , and w to L within the valid ranges described above.

821 Figure 22 compares the measured vertical forces and predicted vertical forces using both Equation
 822 8 and Equation 9. Solid circles indicate the trials where the maximum vertical force exceed 50% of the
 823 highest $F_{v,max}$ value recorded and hollow circles indicate trials where the maximum vertical force did not
 824 exceed 50% of the highest $F_{v,max}$ value recorded and therefore did not have ranges of \bar{H} , a , h , and w to L in
 825 the valid ranges described above.

830
 831 Data from Park et al. (2017) and Tomiczek et al. (2019) was used in conjunction with the data
 832 collected from this study to validate Equation 8 and Equation 9. Figure 22 also shows the comparison of
