# **Experimental Studies of Rock Socketed Piles with Different Transverse Reinforcement Ratios**

Rabie Farrag<sup>1</sup>; Benjamin Turner, Ph.D., G.E., P.E.<sup>2</sup>; Carter Cox, P.E.<sup>3</sup>; and Anne Lemnitzer, Ph.D.<sup>4</sup>

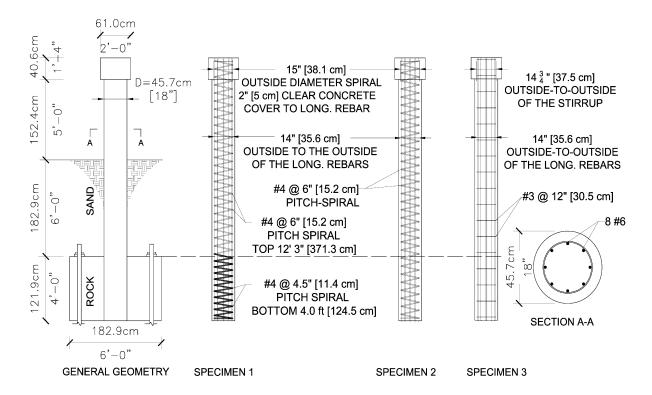
Figure 1. Schematic specimen configuration and variation of transverse reinforcement for all specimens

All pile specimens had identical longitudinal reinforcement (8 #6 bars, with a ratio of 1.41%), and varied only in transverse reinforcement (Table 1). The transverse reinforcement for Specimen 1 was designed to satisfy the maximum rock socket shear predicted using LPile. Specimen 2 was reinforced with the code-minimum volumetric transverse reinforcement ratio (to satisfy AASHTO LRFD Bridge Design Specs., 8<sup>th</sup> Ed.). And the transverse reinforcement for Specimen 3 was designed so that the nominal shear resistance is equal to the maximum applied shear at the pile head, which results in hoop spacing that exceeds the maximum permissible spacing allowed by codes. The latter configuration is not permitted in any structural design and served for experimental demonstration purposes only. The pile configuration and reinforcement are illustrated in Figure 1.

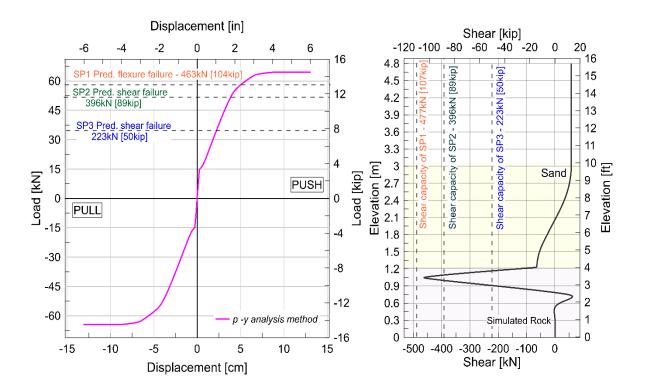
Figure 2. Prediction of pile load-displacement (left) and pile shear forces due to lateral loads 58 kN (13 kips) at the pile head (right).

For an applied lateral pile head load of 58 kN [13 kips], the LPile analysis predicted an amplified pile shear force of 463 kN [104 kips] in the rock socket. This predicted amplified shear corresponds to 8 times the applied lateral head load and more than double the nominal shear resistance provided in Specimen 3 (Figure 2). The stratigraphy and test geometry were chosen to

The loading protocol was developed based on the predictive analyses shown in Figure 2 and followed the general guidelines of ASCE 41-06, in which applied displacement levels are selected as fractions or multipliers of the anticipated yield displacement. Quasi-static, reverse-cyclic loading was applied at the pile head using three cycles per displacement level up to ultimate capacity. Hereafter two cycles per displacement level were performed until substantial degradation of the load-displacement relationship was noticeable. Loading was applied under displacement control at the center of the pile cap using a 76.2 cm [30 in] stroke, 667 kN [150 kips] capacity hydraulic actuator (see Figures 4 and 6). The pile head displacement history is shown in Figure 7.

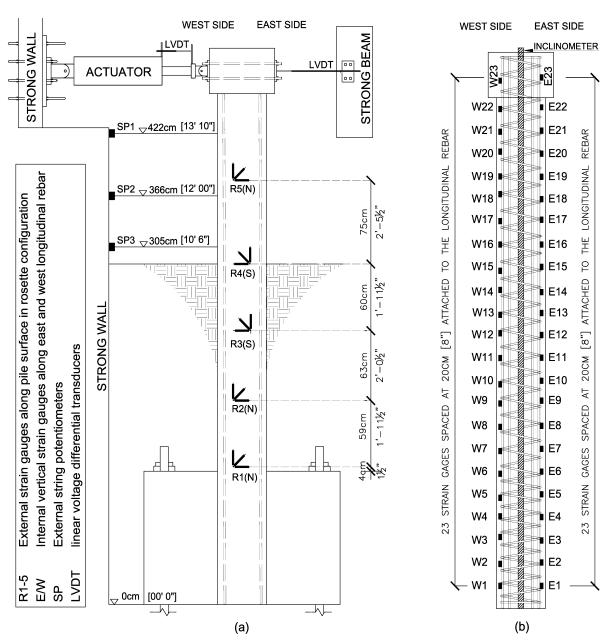
Figure 3. Instrumentation layout for Specimen 1, external sensors (a), and internal sensors (b) (tetrahedral sensors not shown)

The specimen instrumentation consisted of internal and external sensors, such as inclinometers, linear voltage differential transducers (LVDTs), strain gauges in longitudinal, rosette, tetrahedral configurations, and string potentiometers. A schematic instrumentation plan for Specimen 1 is exemplarily shown in Figure 3.

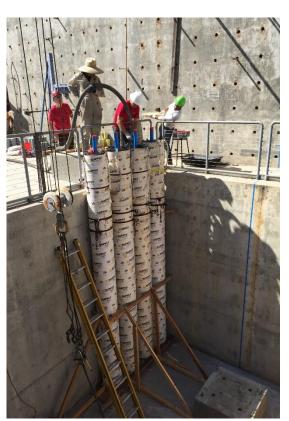
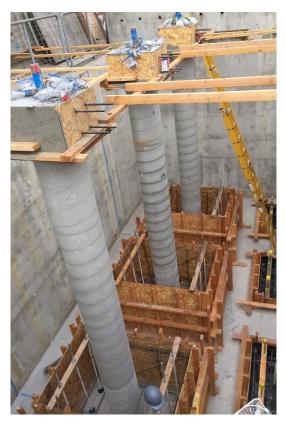
Figure 5. Concrete pour for all three rock-socketed specimens, plus one extra pile (not described in this paper), Pile placement in rock-socket formwork right before concrete placement (right)

Figures 4-6 illustrated the construction sequence of the test specimens inside the soil pit. The sand was placed in the pit by dry pluviation using a self-designed and calibrated sieve system attached at the bottom of a concrete hopper, then leveled upon reaching the design height. The intent was to create a relatively loose sand deposit so as to maximize the force effects that reached the rock socket to exaggerate the stiffness contrast between the rock socket and overburden soil. The calibration process included the iteration of adequate fall heights as well as the assembly of multiple sieve openings until the desired relative density was reached. The relatively low in-situ density of 20% provided a strong impedance contrast between the soil and rock materials. Additional in-situ testing of the soil material via cone penetration (CPT) and dilatometer testing (DMT) were used to estimate the soils E-modulus and shear wave velocity; test results are omitted for brevity. The in-situ moisture content of the soil was 6%. The fill sand had a friction angle of 35 deg and cohesion of 5.0 kN/m2 [100 psf], determined through direct shear testing (per ASTM D3080). The average in situ density and relative density were 14.6 kN/m³ [93 pcf] and 20%, respectively.

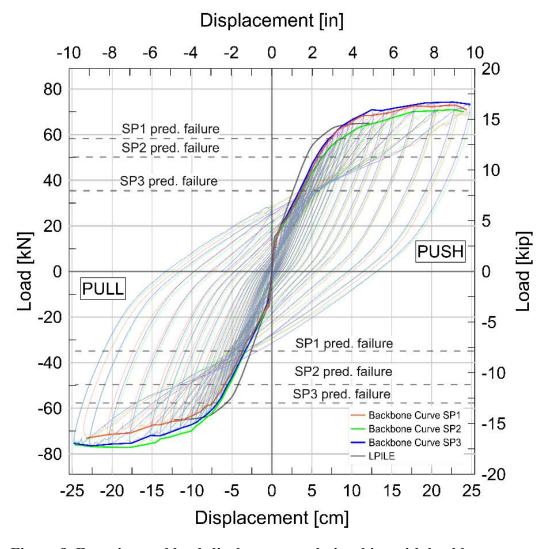
Figure 8. Experimental load-displacement relationships with backbone curve

Figure 8 shows the experimental load displacement behavior of all specimens with their respective backbone curves. Specimen 1 reached an ultimate load of approximately 72 kN [16.2 kips] at a corresponding pile head displacement of 17.8 cm [7.0 in] in push direction, and approximately 72 kN [16.2 kips] at a corresponding pile head displacement of 20.0 cm [7.8 in] in the pull direction. Similarly, Specimen 2 reached ultimate resistance at 71 kN [16 kips] and 17.8 cm [7.0 in] in push direction, and approximately 79 kN [17.8 kips] at a corresponding pile head displacement of 17.8 cm [7.0 in] in pull direction. Specimen 3 reached an ultimate capacity of 77 kN [17.3 kips] at 20.0 cm [7.8 in] of lateral displacement in pull direction and almost similar load levels in push direction.

All specimens behaved identically up to "concrete cracking", i.e., up to a displacement level of 0.64 cm [0.25 in] and a corresponding load of 13.34 kN [3 kips] (about 20% of the ultimate load). The yield displacement was approximately 6.35 cm [2.5 in] at a corresponding load of 8 kips (about 50% of the ultimate load) after which the piles accumulated substantial permanent deformations for repeated loading cycles. Figure 8 also includes a comparison between the

experimental and predicted load displacement curves as well as the predicted failure load levels in flexure (SP1) and shear (SP2 and SP3). The experimental data show that the predicted failure loads have been exceeded by 23%, 53%, and over 100% for SP1, SP2, and SP3 respectively.

The almost identical specimen behavior suggests flexural dominated failure modes for all pile specimens. Specifically, the predicted shear failure due to potential shear amplification near the rock-socket interface would have caused an early failure of SP 2 and SP3 at approximately 52 kN [11 kips] and 35 kN [7.8 kips], respectively, which was not observed experimentally. Instead the pile specimen SP2 and SP3, which were insufficiently reinforced for a potential shear amplification, performed identically to the pile (SP1) which was sufficiently reinforced for the shear amplification and resisted a lateral load of more than 1.6 times the predicted failure limit state.

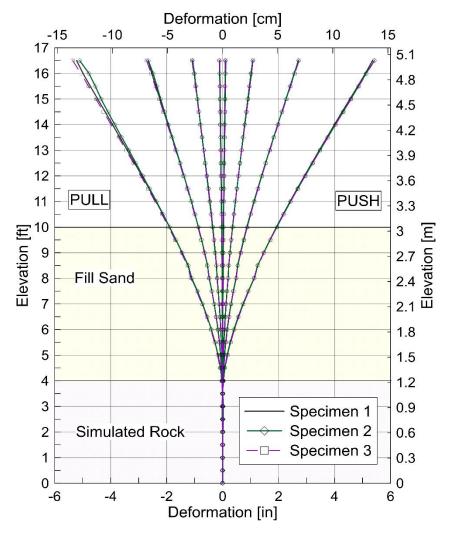
Figure 9. Inclinometer profiles for Specimen 1, 2, and 3 at selected lateral pile head displacement levels (inclinometer readings)

Figure 9 shows the lateral deformation profiles recorded through the inclinometer instrumentation. Measurements indicate that no deformation occurred within the rock socket. Small lateral pile deformations are noticeable beyond 15 cm [0.5 ft] above the rock socket.

Deformed shapes were similar for all specimens and in both, "pull and push" directions. Curvature profiles [not depicted for brevity] suggest the formation of a plastic hinge within 60 cm [2 ft] above the rock-socket which corresponds to 1.2 m [4 ft] below the ground surface (i.e., about 3 pile diameters (3D)) and agrees well with crack patterns observed upon excavation.
