1                   **Geologic Controls on Erosion Mechanism on the Alaska Beaufort Coast**

43       **Abstract**  
44

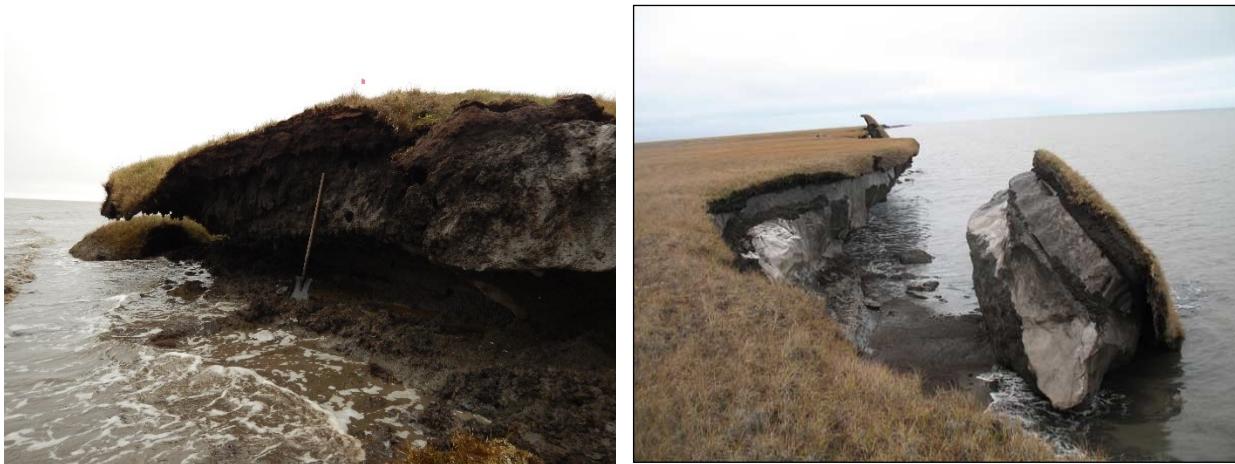
386 Figure 3. Photos of (a) an erosional niche from Elson Lagoon Alaska and (b) a fallen block by  
387 Drew Point, Alaska (image courtesy of Christopher Arp of the Alaska Science Center, U.S.  
388 Geological Survey).

83 Army Corps of Engineers (2009) has designated 26 Alaska communities (including Barrow,

84 Figure 3a) “Priority Action Communities” due to the threat of erosion.

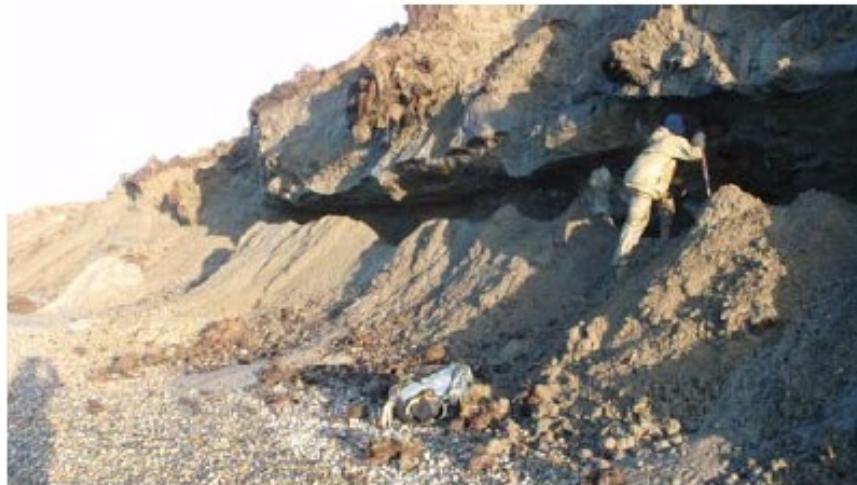
397 Figure 5. Photo showing material that has slumped onto the beach face following bluff face  
398 thaw at Barter Island (2011 image courtesy of Li Erikson, U.S. Geological Survey). The bluff  
399 height is about 10 m and the sediment areal density is about  $600 \text{ g/cm}^2$ , based on USGS data.  
400 Interestingly, the photo was taken soon after the 2008 niche erosion / block collapse event and  
401 the niche is still in evidence.

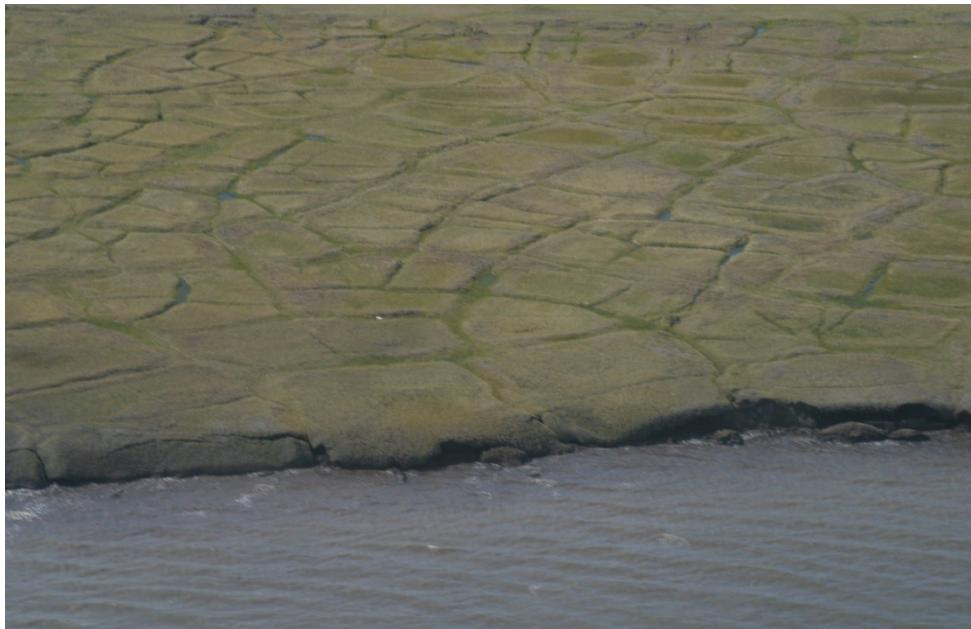
421 [USGS Lat: 71 17' 17.72" N Lon: 156 25' 53.39" W UTC: 22:33:38 09 Aug 2006 IMG\\_0088.JPG](#)

422 Figure 8. Example photo of coastal bluffs where niche erosion / block collapse was the  
423 predominant mechanism (image courtesy of Ann Gibbs, U.S. Geological Survey).

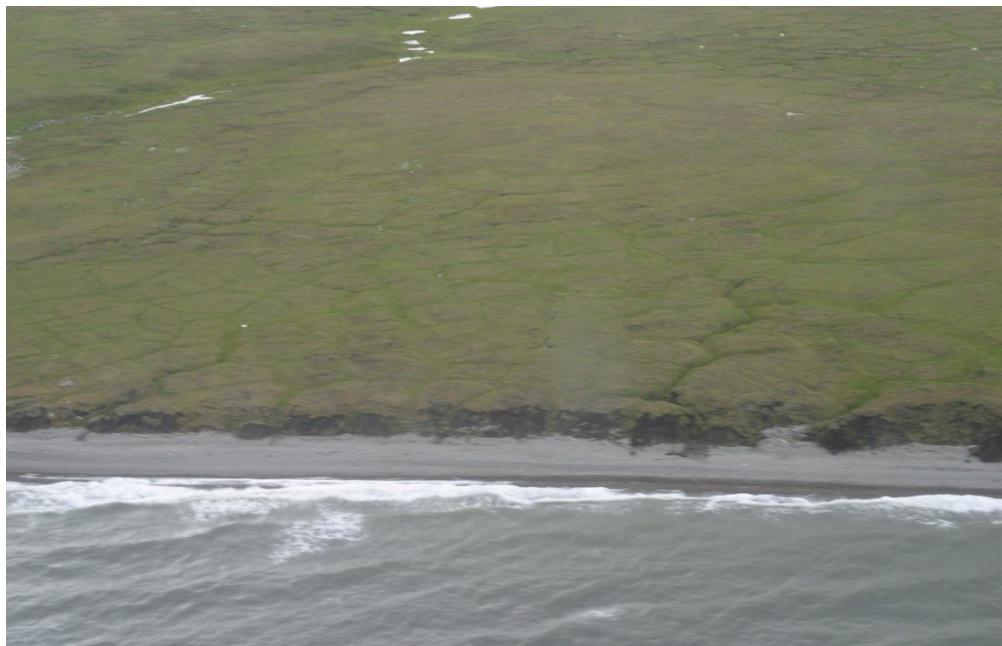
427    USGS Lat: 70 0' 11.98" N Lon: 144 31' 37.79" W UTC: 18:14:30 08 Aug 2006 IMG\_8211.JPG

428    Figure 9. Example photo of coastal bluffs where bluff face thaw / slumping was the

429    predominant erosion mechanism (image courtesy of Ann Gibbs, U.S. Geological Survey).
