Impacts of 2020 Beirut Explosion on Port Infrastructure and Nearby Buildings

Salah Sadek, M.ASCE¹; Mayssa Dabaghi, A.M.ASCE²; Timothy M. O'Donnell, S.M.ASCE³; Paolo Zimmaro, M.ASCE⁴; Youssef M. A. Hashash, F.ASCE⁵; and Jonathan P. Stewart, F.ASCE⁶

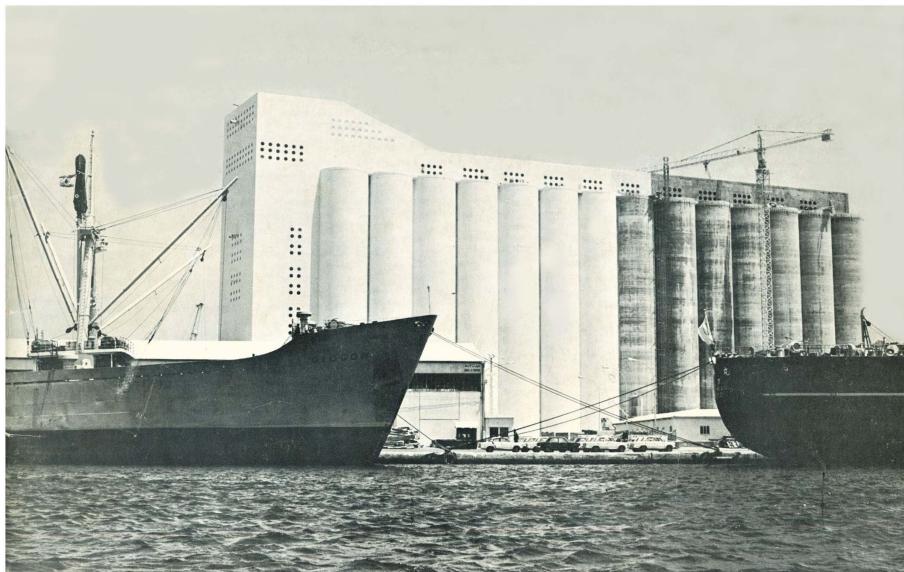
Fig. 3. Phase-I grain silos completed and Phase-II silos nearing completion. (Reprinted from Ministry of Public Works and Transport 1970.)

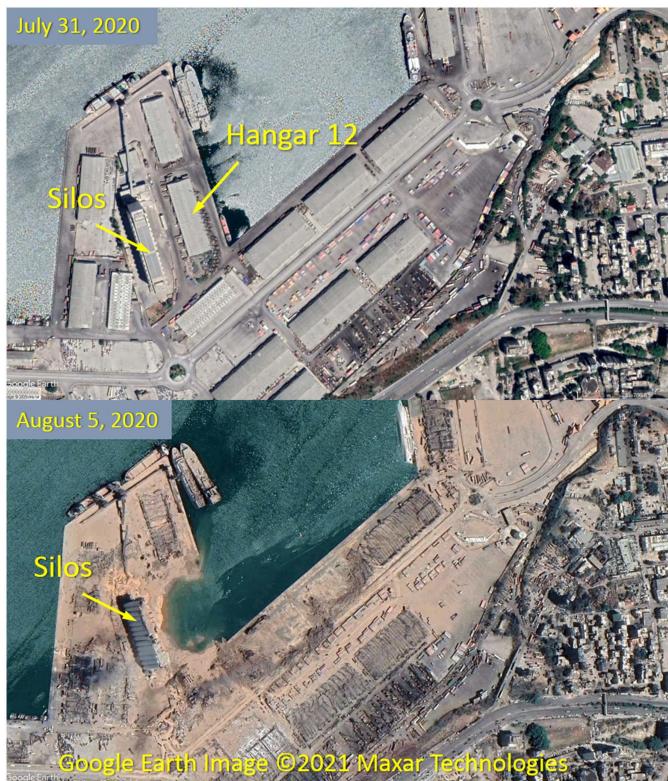
The blast at Hangar 12 left a crater nearly 120 m in diameter. Fig. 10 shows before and after aerial views of Hangar 12 and the crater. In the aftermath of the event, detailed bathymetric surveys were conducted by teams from the Lebanese army using boat-mounted bottom profilers, which provide water depths to ~1-cm resolution. The nominal preexplosion depth in Basin 3 was 10.5 m (this depth was maintained to accommodate the needs of cargo ships serviced by the Port). Fig. 11(a) shows the postevent depth contours four days after the blast, and Fig. 11(b) shows a west-east cross section through the crater.

Fig. 10. Aerial views of ground zero (Hangar 12) prior to July 31, 2020, and immediately following explosion (August 4, 2020). (Base map © 2021 Google Earth; Image © 2021 Maxar Technologies.)

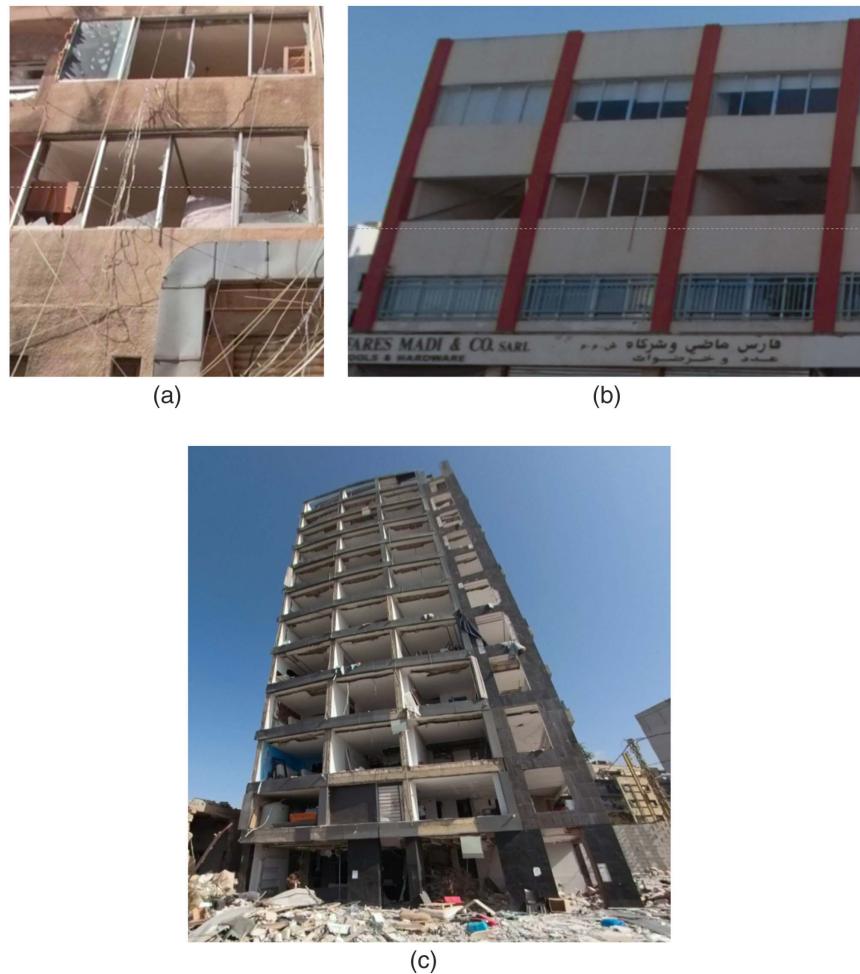
Fig. 14 shows façades assigned to Damage classes Wxx-1, where damage was mainly related to broken windows [Fig. 14(a)], Wxx-2, where windows were broken and frames were damaged [Fig. 14(b)], and Wxx-3, the highest façade damage level, where there was complete blow-out of panels within building frames [Fig. 14(c)]. The photos shown were taken in different districts of Beirut.

Fig. 14. Façade damage levels: (a) Wxx-1, damage to windows only; (b) Wxx-2, damage to windows and frames; and (c) Wxx-3, complete blow-out of panels within building frames.
