## Rigid pavement icing: misting tests on a model pavement column under simulated cold fronts inside a freezer

# Rigid pavement icing: misting tests on a model pavement column under simulated cold fronts inside a freezer

Department of Civil Engineering, University of Texas at Arlington, Arlington, USA

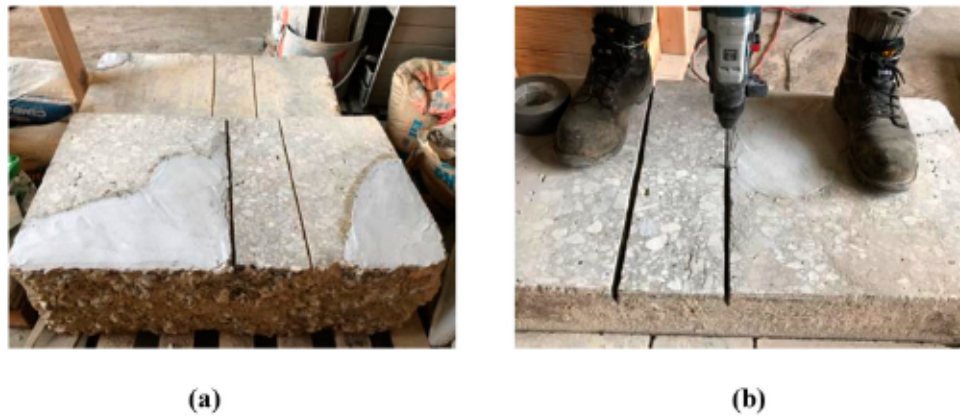
Figure 2. (a): Slab after repair (b): Drilling holes for sensor heads.

achieve a smooth mating surface. Six holes were drilled into the grooves at a depth of 2 cm to accommodate the sensor heads of thermistors (Figure 2a, b). The gap around the sensor heads was then filled with commercial mason mix.

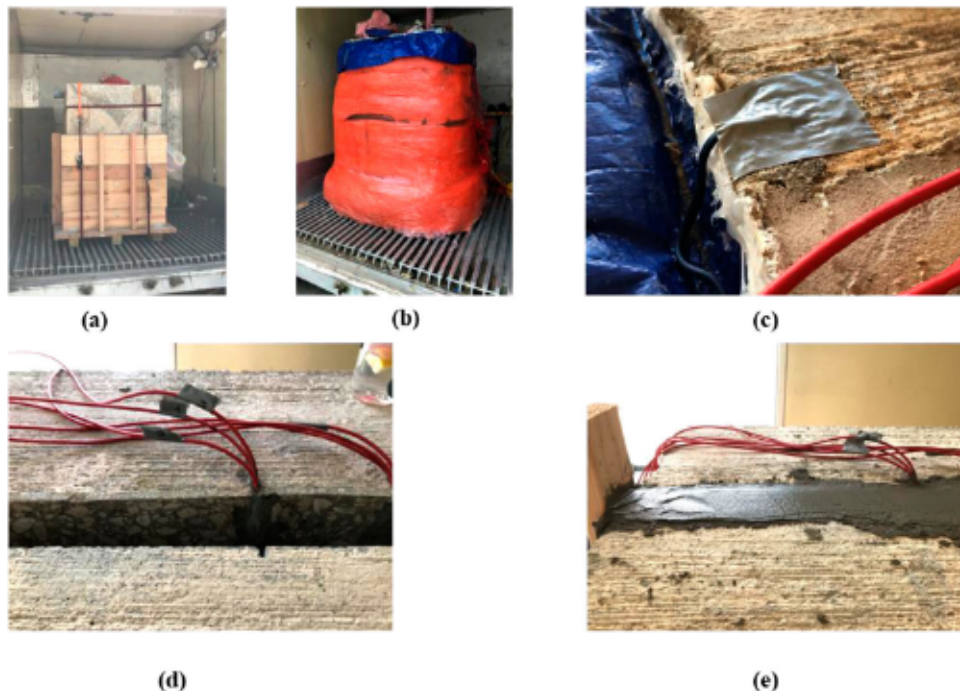
Figure 3. (a): Complete system installed in the freezer box (b): Insulation wrapping (c): Installation of edge surface thermocouple (d): Gap between the slabs prior to filling (e): Gap after filling.

The two slab pieces were placed on top of the soil using an overhead crane. The slab along with the box were moved into a freezer box using a forklift. Inside the freezer box, the gap between the two slab pieces was filled with the same commercial mason mix used to fill the gap around the sensor heads in the slab body. After baseline testing, the cooling and warming in the body of the slab was found to be uniform, confirming that the mason mix did not have an impact on temperature. The box was wrapped in R30 insulation and heavy-duty plastic wrap. The perimeter of the slab was also wrapped in R30 insulation, covered with a blue tarp, and sealed with silicone and Gorilla Glue to prevent water infiltration during misting operations. R30 insulation material was used to fill the gap between the box and the floor. The surface thermocouples were also installed at this time (Figure 3a through 3e).

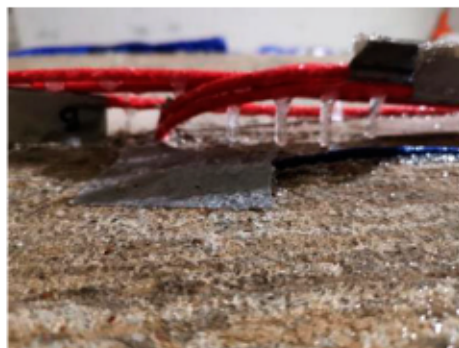
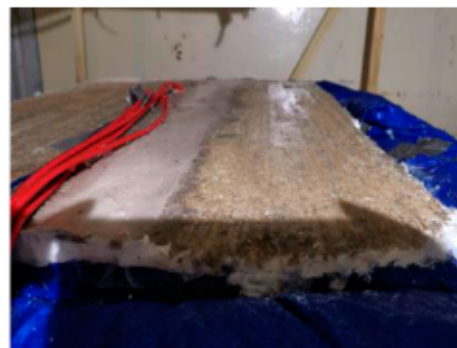
**Figure 14.** Final slab condition showing the formation of glaze.

Figure 14 shows the final slab condition. Due to the very fine mist and the slower rate of droplet deposit onto the surface, the formation of a thin glaze of ice is observed 12 min after the start of the misting. This glaze is similar to the icing glaze that forms during a freezing rain, drizzle, or fog event.

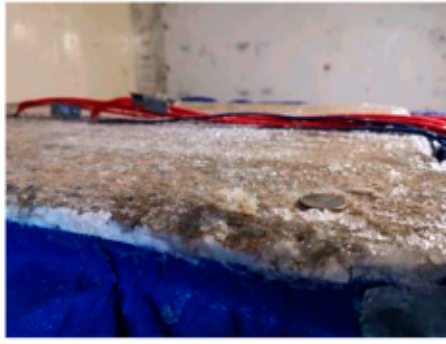
Figure 20. Final slab condition with ice formation on slab surface after misting.

temperature decrease and the body of the slab did not reach freezing conditions at any point during the 46-hour test. Figure 19 shows the soil temperature at mid-depth (98 cm below slab surface) as well as the temperature at the soil/slab interface (52 cm below slab surface). Both layers do not experience any significant temperature change. This can be attributed to the thermal capacity of the soil preventing any appreciable temperature decrease. Ice formation was observed 10 min after misting began, with the ice continuing to solidify after misting ended. Due to the slower rate of discharge, the layer of ice was thick and uniform throughout the slab surface (Figure 20).
