# Monitoring epoxy coated steel under combined mechanical loads and corrosion using fiber Bragg grating sensors

**Abstract:** Fiber Bragg grating (FBG) sensors have been applied to assess strains, stresses, loads, corrosion, and temperature for structural health monitoring (SHM) of steel infrastructure such as buildings, bridges, and pipelines. Since a single FBG sensor measures a particular parameter at a local spot, it is challenging to detect different types of anomalies and interactions of anomalies. This paper presents an approach to assess interactive anomalies caused by mechanical loading and corrosion on epoxy coated steel substrates using FBG sensors in real time. Experiments were performed by comparing the monitored center wavelength changes in the conditions with loading only, corrosion only, and simultaneous loading and corrosion. The theoretical and experimental results indicated that there were significant interactive influences between loading and corrosion for steel substrates. Loading accelerated the progress of corrosion for the epoxy coated steel substrate, especially when delamination in epoxy coating was noticed. Through the real-time monitoring from the FBG s

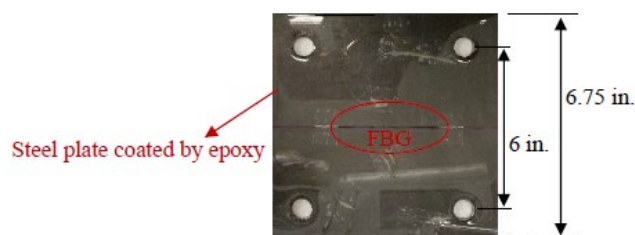
Fig. 5 An example embedded FBG sensor.

In all the experiments, epoxy coated steel plates were used as testing substrate. FBG sensors were embedded inside the epoxy coating at the central axis of the steel plate as shown in Fig. 5. A36 structural steel was used as the material of steel plates and their dimensions were 6.75 in.  $\times$  6.75 in.  $\times$  0.125 in. Epoxy resin (Duralco 4461) was used as the protective coating. The FBG sensors (os1100) manufactured by LUNA were used and the properties of the used FBG sensors are listed in Table 1 (provided by manufacture). The same FBG interrogator as in Fig. 1(b) was used to collect the Bragg wavelength changes.

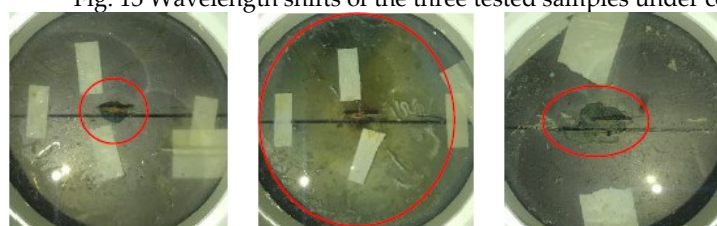
(a) (b) (c)

Fig. 14 Visual inspections of the three tested samples under combined loading-corrosion tests at the end of the experiments: (a) B1, (b) B2, and (c) B3.
