## Impact of 2021 Western European Flooding on Geo-Structures

Between July 14–16th, 2021, record rainfall and subsequent flooding resulted in the deaths of over 200 people and billions of dollars-worth of damage in Germany and Belgium. An NSF sponsored Geotechnical Extreme Events Reconnaissance (GEER) Association reconnaissance mission was undertaken by the authors to investigate the effects of flooding in Germany, Belgium, and the Netherlands. The two-week-long mission provided insight to the performance of various geostructures such as building foundations, roads, and bridges. This paper provides a summary of observations made by the US-based GEER team in collaboration with many local European colleagues. Key observations presented include a bridge case study, the impact of scour and erosion on different structures, and soil-structure interactions. A review of the data used to inform the reconnaissance mission as well as the data collection technologies used, including terrestrial LiDAR, UAV-Structure from Motion (SfM), and multispectral imagery, is also presented.

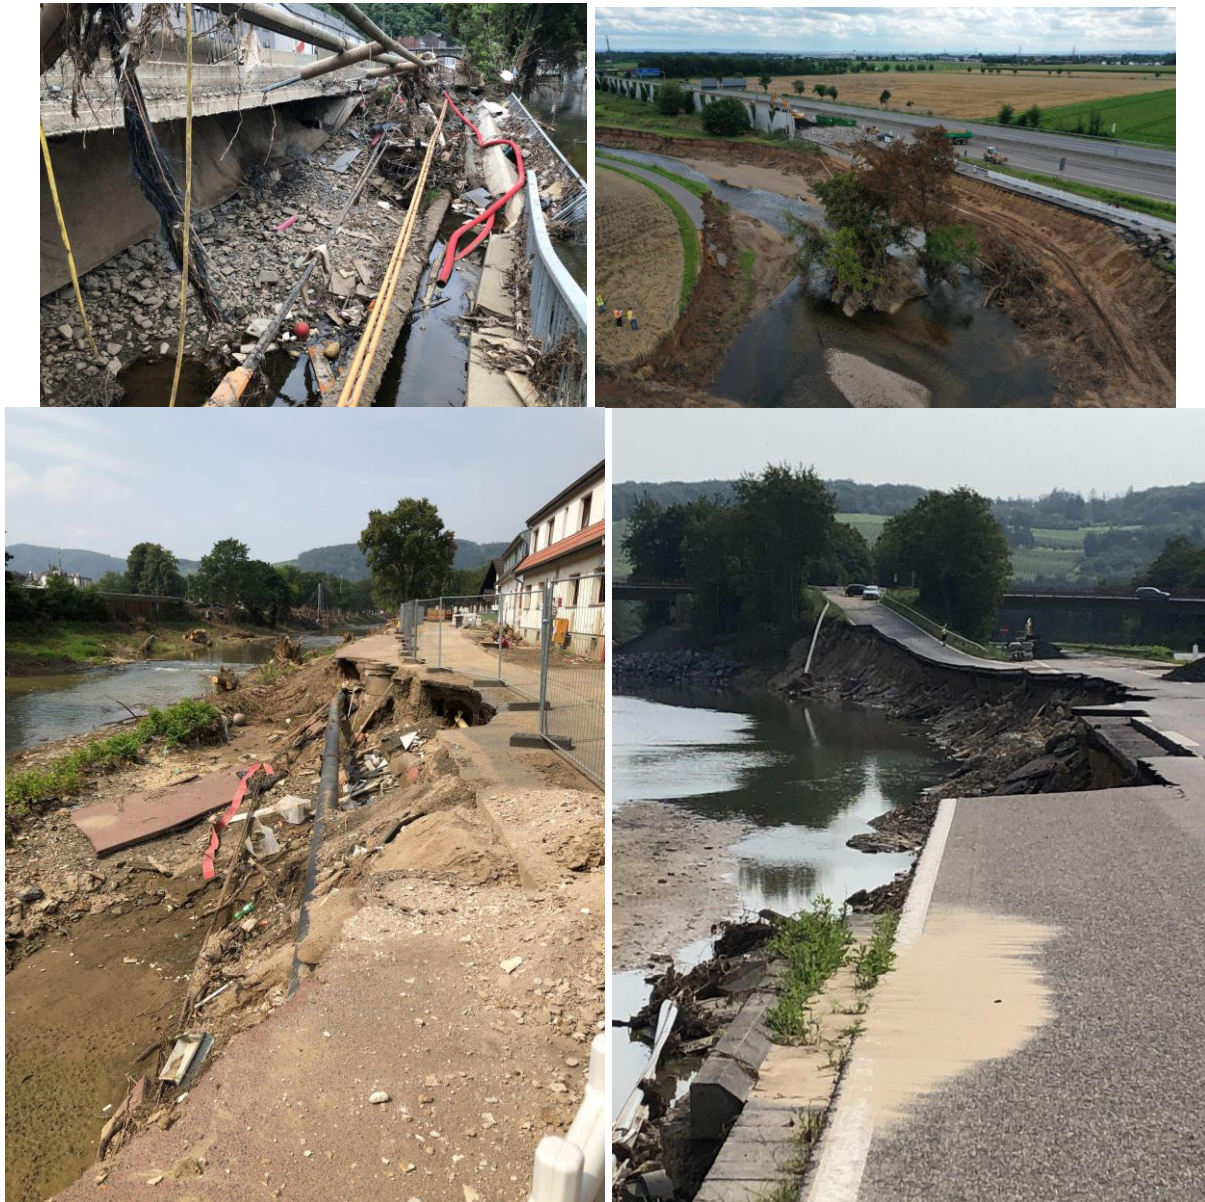
Figure 1a shows road damage in Chaudfontaine, Belgium. Shoulder pieces and railing are broken off, debris and deadwood remains entangled in the road remains. The subsurface layers are washed out, and geotextile is loosely hanging below the concrete layer. Figure 1b shows the collapse and erosion of the Autobahn A1 near Erftstadt-Blessem. This freeway section is located adjacent to the major floodplains of the river Erft and failure is associated with the draw-in of floodwaters into the Blessem gravel mine. One of the 2 lane offramp onto the A1 freeway, as well as its shoulder and noise barrier were destroyed. Large-scale erosion, with nearly landslide type of soil movement, was the main driver to this failure. The freeway intersection remains closed until spring 2022 (Wehman, J., 2022). Figure 1c shows road damage in Ahrweiler, caused by erosion of the embankment area and subsequent loss of stability. Consequently, utility lines, such as gas, electricity, water/wastewater and telecommunication networks were exposed and damaged. Figure 1d shows a similar embankment erosion to the road shown in Figure 1c. This damage was more complex and extended over several kilometers, including damage to nearby bridges and major wastewater pipelines.

**Figures 1 a-d: Observed building damage in various locations. a (Top Left): Chaudfontaine, Belgium (Lat: 50.58694, Lon: 5.65004); b (Top Right): Autobahn A1, Erftstadt-Blessem, Germany (Lat: 50.81338, Lon: 6.78907 ); c (Bottom Left): Ahrweiler, Germany (Lat: 50.53880, Lon: 7.10424); d (Bottom Right): Bad-Neuenahr Ahrweiler (Lat: 50.54669, Lon: 7.17881).**

Damage to road infrastructure, included bridge destruction, embankments erosions, road washouts, and collapse of noise barriers (Figure 1). Germany's Rhineland area reported more than 130 kilometers of damaged roads, amounting to more than 100 million euros in repair costs (Autobahn.de, 2021). Within the Ahr valley, over 74 kilometers of roads, paths, and bridges have been (critically) damaged. In some cases, repairs are expected to take months to years (Zeit Online, 2021). In the Eifel region, major freeway sections, such as the Autobahn A1/A62 intersection near Erftstadt-Blessem will be closed for repairs until at least early 2022 (Wehmann, 2021). The district of Euskirchen reported road damages accumulating to 4.4 million.

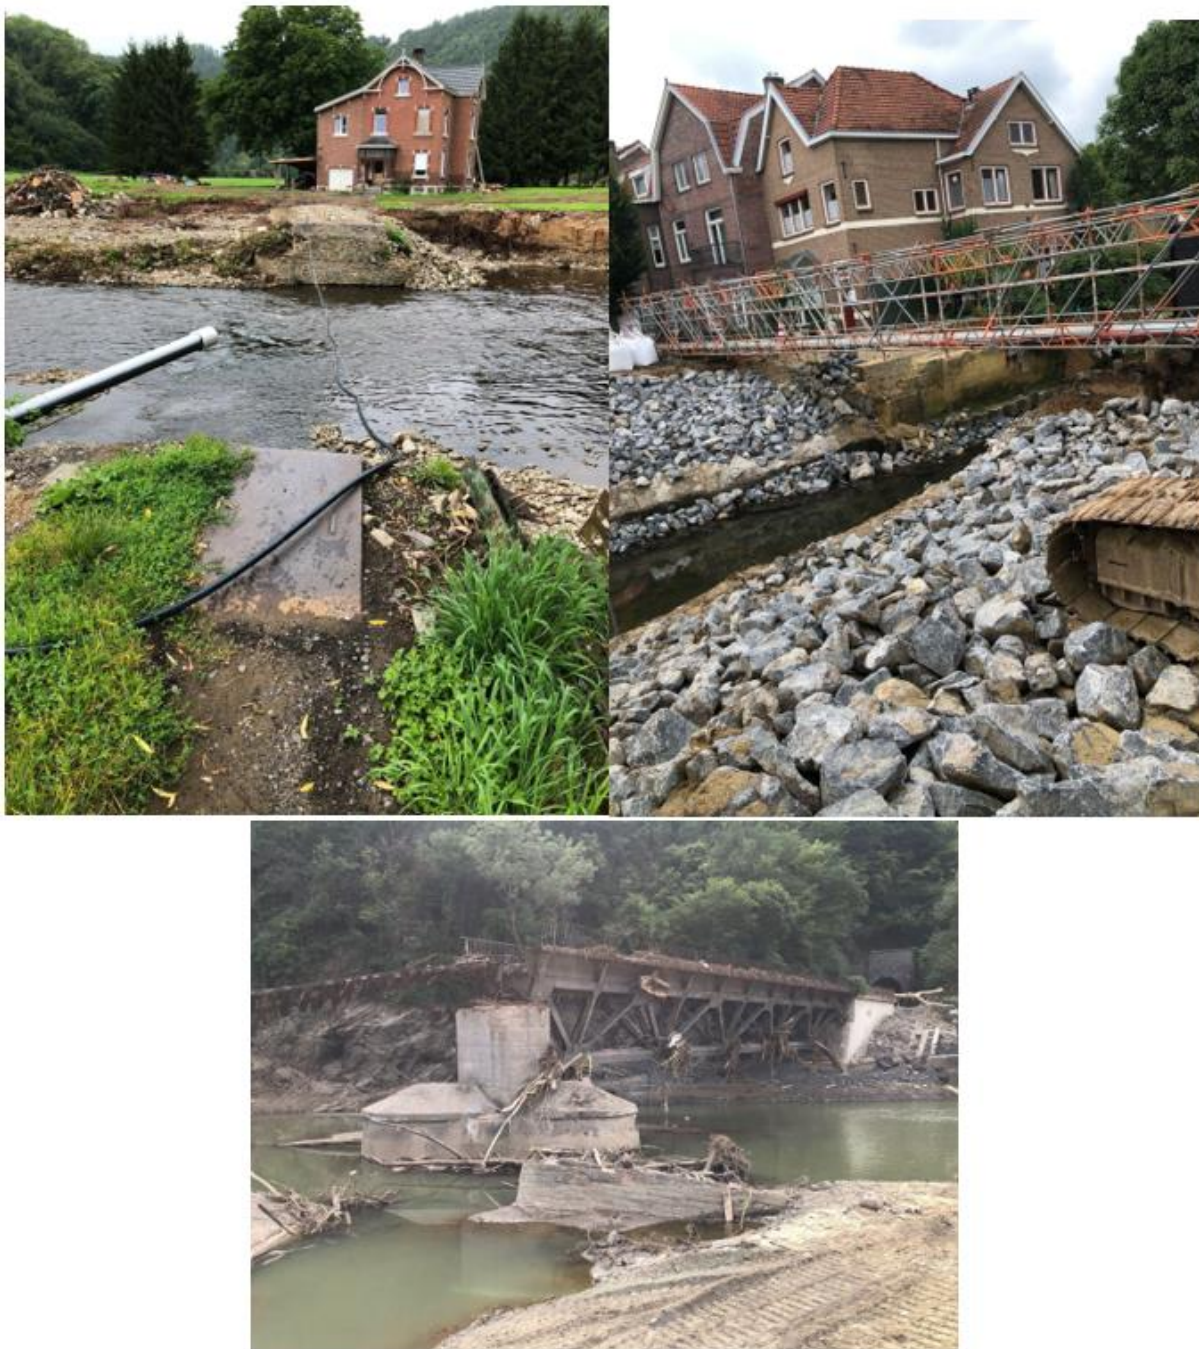
Figure 3 shows three bridge failures with different degrees of remediation efforts. Figure 3a shows the location of a previously small, pedestrian bridge that was lifted off of the abutments and washed out with little other visible damage. Figure 3b shows the previous location of a two-lane road bridge that connects two sides of the city of Valkenburg, Netherlands over the Geul River. Scour and erosion around the abutments led to the ultimate failure of this urban bridge. Figure 3c shows the failure of piers for a rail bridge in Germany. Minor tilting can be seen in the standing pier and the fallen remnants of another pier can be seen in front of the standing pier.

This bridge was located in one of the most severely damaged regions in the Ahr Valley, where scour and erosion not only destroyed this bridge, but washed away hundreds of homes as well.

**Figures 3 a-c: Three observed bridge failures observed in the reconnaissance mission. a (Top Left): Goffontaine, Belgium (Lat: 50.57217, Lon: 5.76563); b (Top Right): Valkenburg, Netherlands (Lat: 50.86523, Lon: 5.82950); c (Bottom): Mayschoß, Germany (Lat: 50.51815, Lon: 7.02690).**

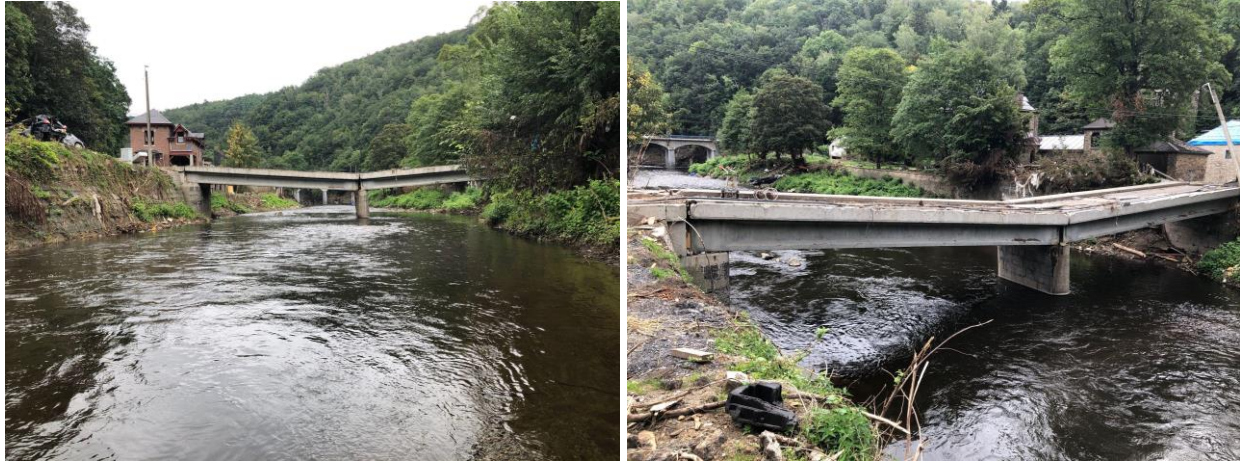
**Figure 4 a-b: Ry Fenderie bridge in Trooz, Belgium. Photographs taken via mobile phone. (Lat: 50.57080 Lon: 5.68953)**

Trooz, Belgium is located on the northern bank of the Vesdres River, the most heavily impacted region in Belgium. This classic beam bridge across the Vesdres provided a unique opportunity for the GEER team due to it being still standing, displaying obvious signs of damage, and there being little traffic around the study area to disrupt the collection of geospatial data. Two LiDAR scans of this bridge were taken; access points to the bridge were limited due to safety concerns and topographical constraints not allowing for convenient positioning of the LiDAR scanner. The bridge was still open to pedestrian foot traffic at the time of the visit, but was demolished as late as October 2021. A temporary bridge for pedestrian foot traffic has been built in its place.
