# Barrier Island Reconfiguration Leads to Rapid Erosion and Relocation of a Rural Alaska Community

Buzard, R.M.; Kinsman, N.E.M.; Maio, C.V.; Erikson, L.H.; Jones, B.M.; Anderson, S.; Glenn, R.J.T., and Overbeck, J.R., 0000. Barrier island reconfiguration leads to rapid erosion and relocation of a rural Alaska community. *Journal of Coastal Research*, 00(0), 000-000. Charlotte (North Carolina), ISSN 0749-0208.

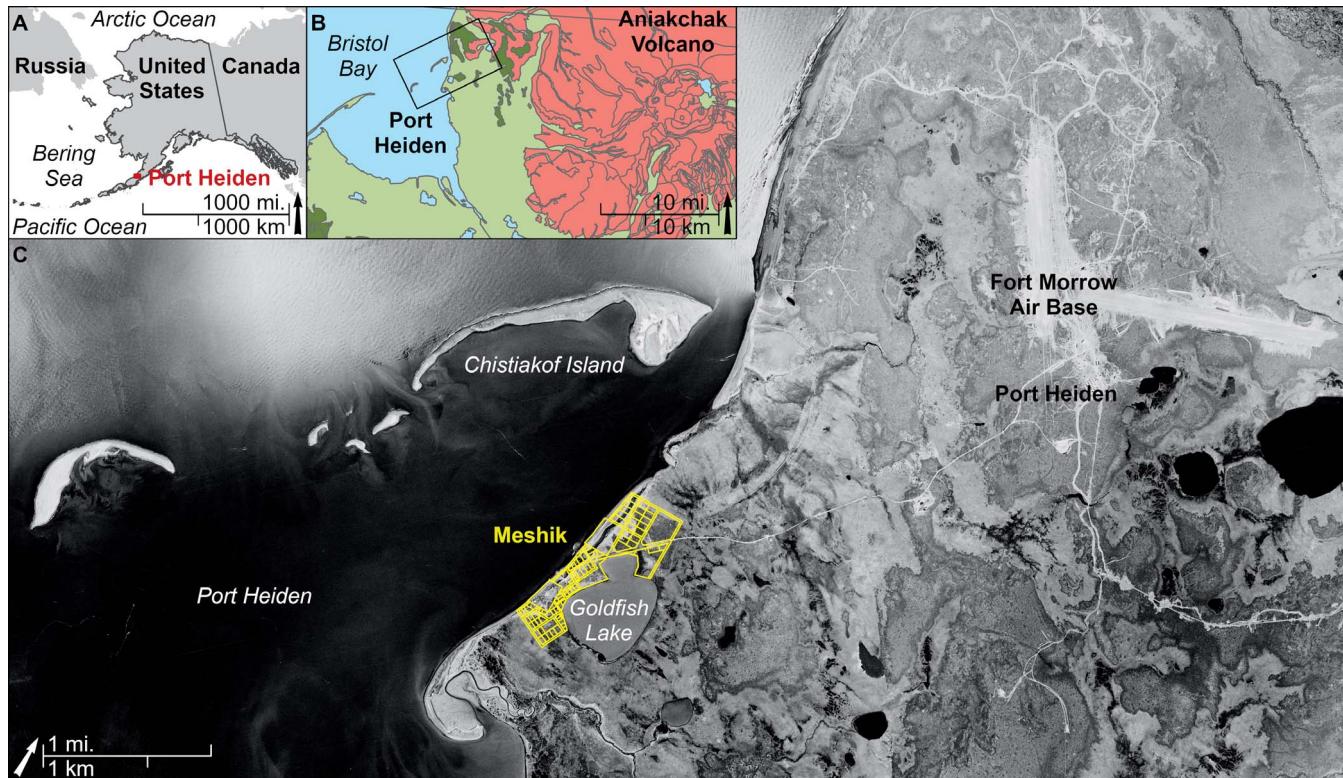
Figure 1. (A) Port Heiden is in SW Alaska, on the east shore of the Bering Sea. (B) Port Heiden is west of the Aniakchak volcano (igneous sediments in red). Most surficial geology consists of eolian or alluvium deposits (light green), with smaller areas of glacial sediments (dark green). (C) A 1957 image of the Meshik area (yellow) on the east shore of Port Heiden. A series of barrier islands existed, along with a channel along the coast that allowed southern alongshore currents to develop sand spits. The community eventually relocated along the road system south of the airport runways.

The focus of this study is to measure erosion and identify drivers of geomorphic change at the Alaska Native village of Meshik (Figure 1). Meshik was not in a hazard-prone area until the protective barrier island eroded away in the 1970s. After this, the mainland became one of the fastest-eroding shorelines in Alaska and the coastal community had to remove or abandon every structure, relocating inland to found the city of Port Heiden. By 2021, the former community footprint had entirely eroded away. This study investigates geologic and geomorphic parameters to develop a coastal evolution map, identifies the cause of rapid erosion, and compares environmental change and constants to discuss causal links. These results have

Meshik was located on the SE shore of Bristol Bay, near the Aniakchak volcano (Figure 1). The geologic history explains the genesis of surficial deposits and how they influence erosion rates. The settlement history details how Meshik was founded and relocated. This study examines nearly 15 km of shoreline around the townsite.

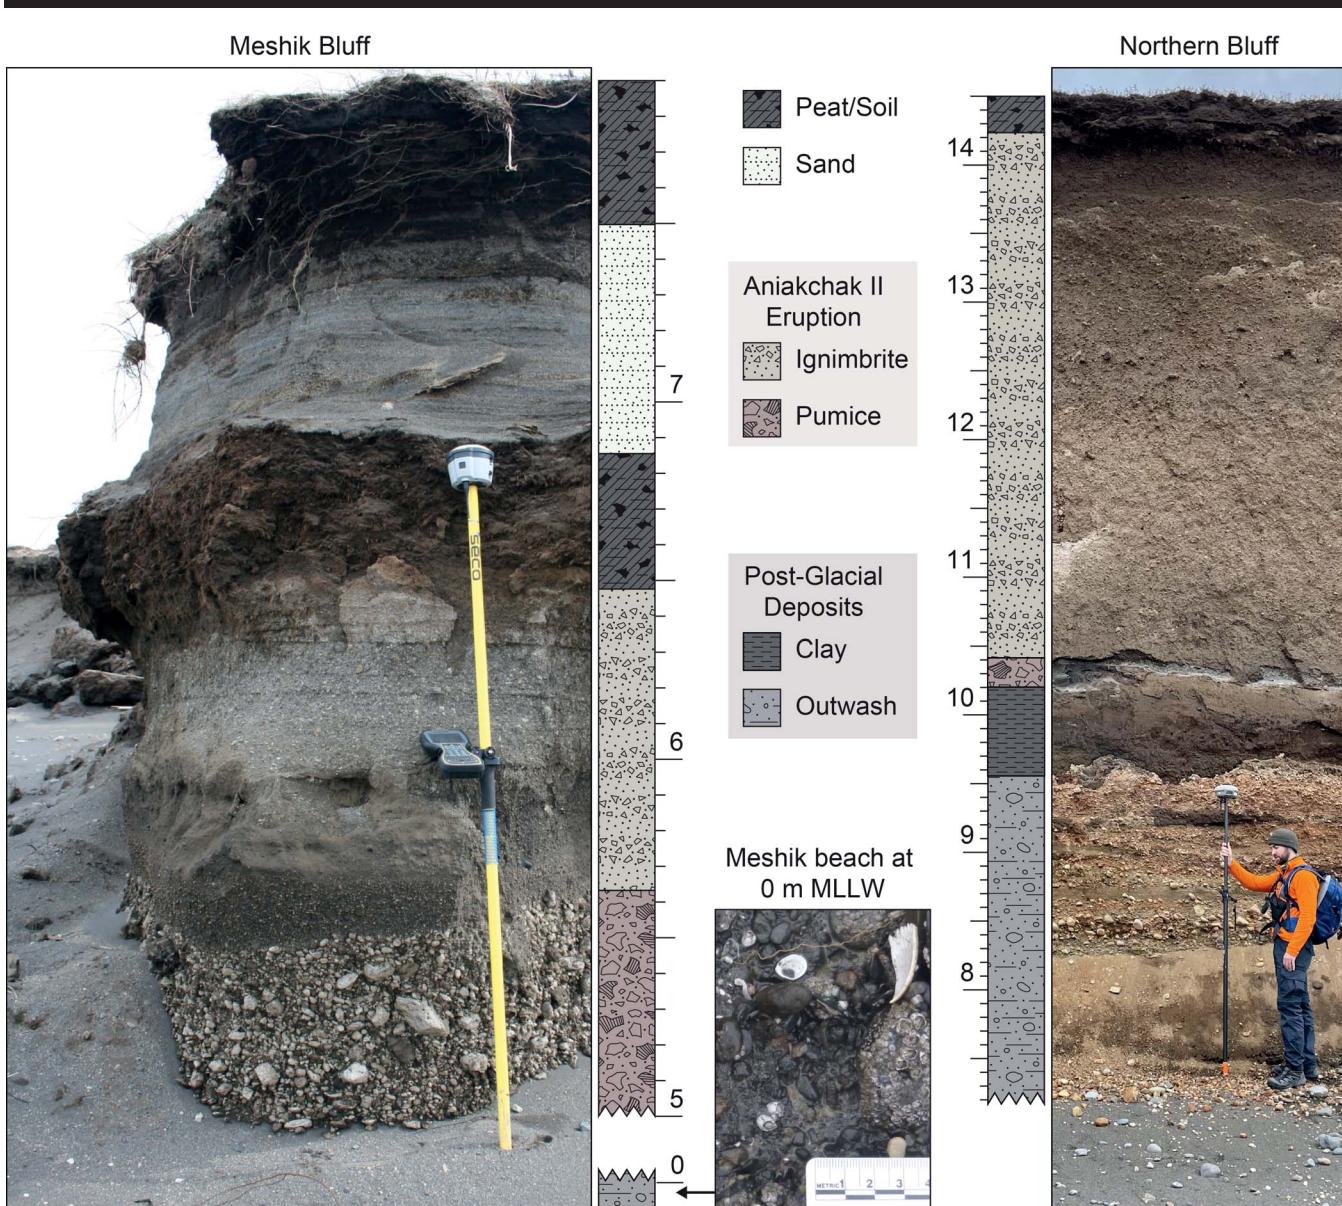
Figure 2. The stratigraphic column of Meshik bluff (left) and northern bluff (right) shows the postglacial, eruption, marine and lacustrine, and soil deposits. The scalebars are in meters above MLLW, and the survey pole is 2 m tall. At Meshik, the exact depth of the Aniakchak II eruption is not known, but the underlying outwash was observed near 0 m MLLW. All layers are nonlithified. Transition heights vary across the shoreline. The postglacial exposure at the northern bluff is typically between 1 and 3 m above the beach. The outwash exposure is partially obscured in the image by collapsed material pressed against the bluff by a storm.

composite layers (Bacon *et al.*, 2014). In  $3660 \pm 70$  cal. YBP, the Aniakchak volcano erupted so violently the entire dome exploded, sending pyroclastic flows into Bristol Bay and blanketing the Alaska Peninsula in ash. This caldera-forming eruption, named Aniakchak II, covered the glacial deposits in several meters of pumice and ignimbrite (pumice-rich ash; Bacon *et al.*, 2014; Figure 2).

change eventually uplifted the submerged landscape. Meshik's volcanic deposits are capped by sand and marine organics, atop which modern tundra soils have formed (Detterman *et al.*, 1981; Figure 2).

To summarize the geologic history, Meshik was built on the tundra soil with layers of unconsolidated volcanic debris below (Figure 2; Detterman *et al.*, 1981). The postglacial deposits under the community are only observable at low tide near the former Meshik coastline. The region is primarily unlithified, nonpermafrost sediments susceptible to erosion by marine energy, especially the pumice, which is less dense than water.

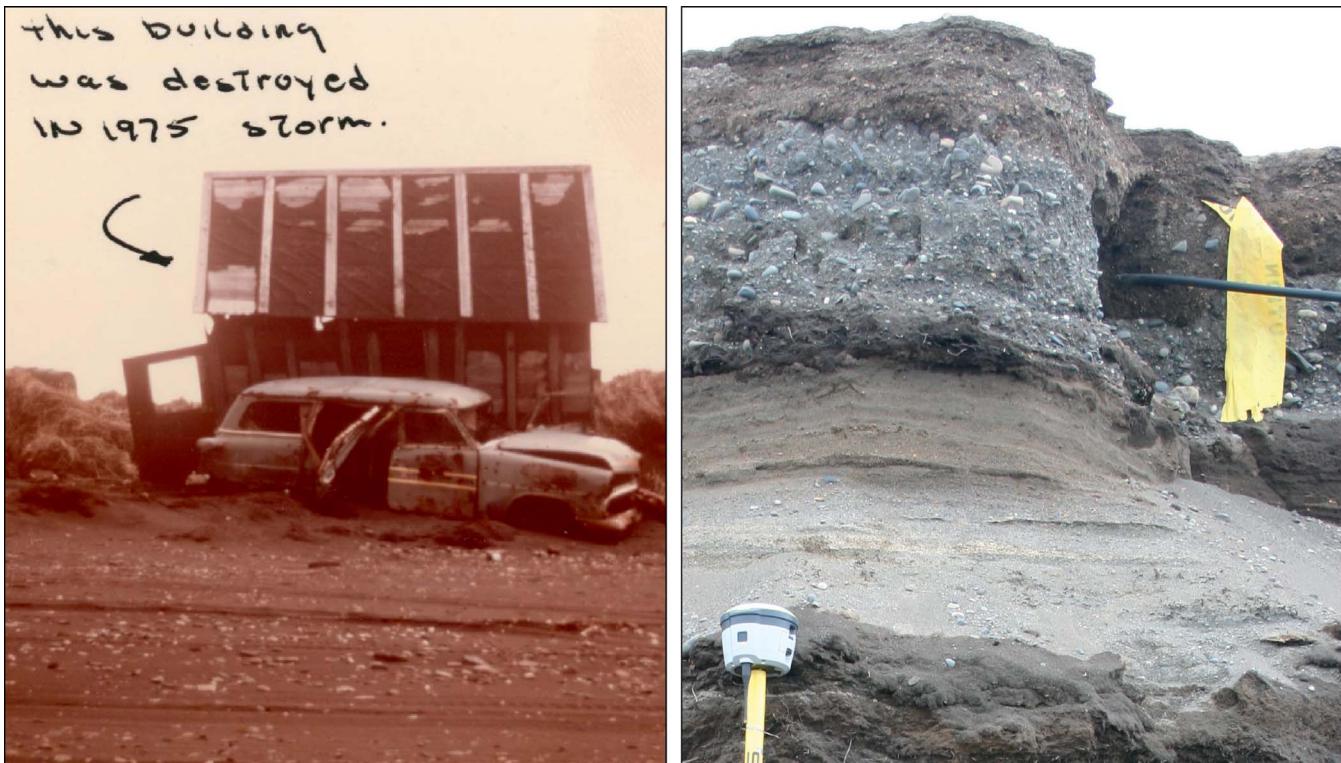
Figure 3. (Left) Photograph by Kvasager (1975) showing a structure and car destroyed by a 1975 storm. The beach is composed of glacially derived cobbles in sand. (Right) This picture of the eroded bluff underneath former Meshik shows the cobbles from the beach used for the road system. For scale, the GNSS antenna is 15 cm tall.

deposits (Community of Port Heiden, *personal communication*; Figure 3).

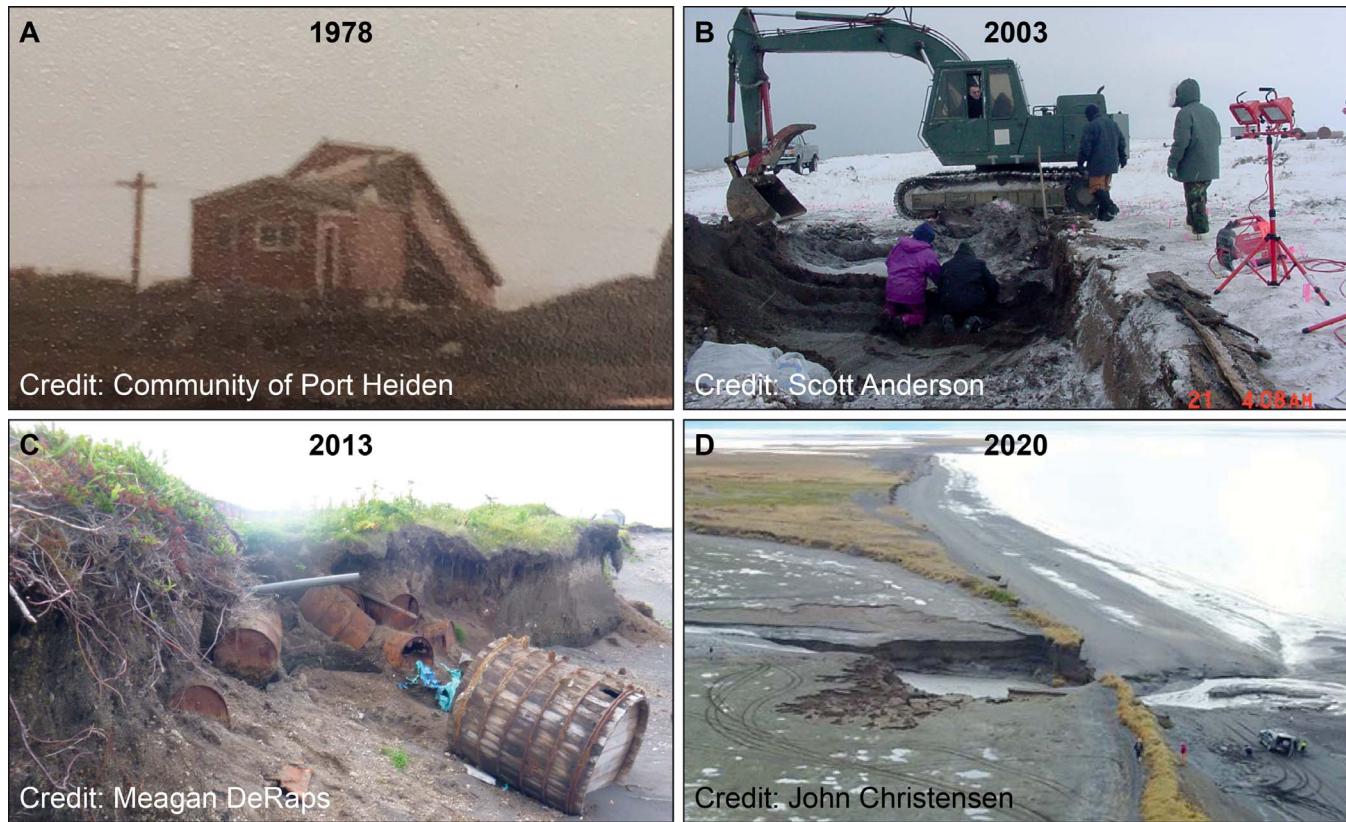
Figure 4. (A) Residence split in half after a storm eroded the ground underneath. (B) Residents exhume a mass grave site in winter conditions. (C) Fuel barrels and wooden septic tanks eroding from the bluff. (D) Erosion reached Goldfish Lake (left), draining it into Bristol Bay. For scale, see people and the vehicle in the bottom right. Nearly the entire community of Meshik would have been in this camera frame.

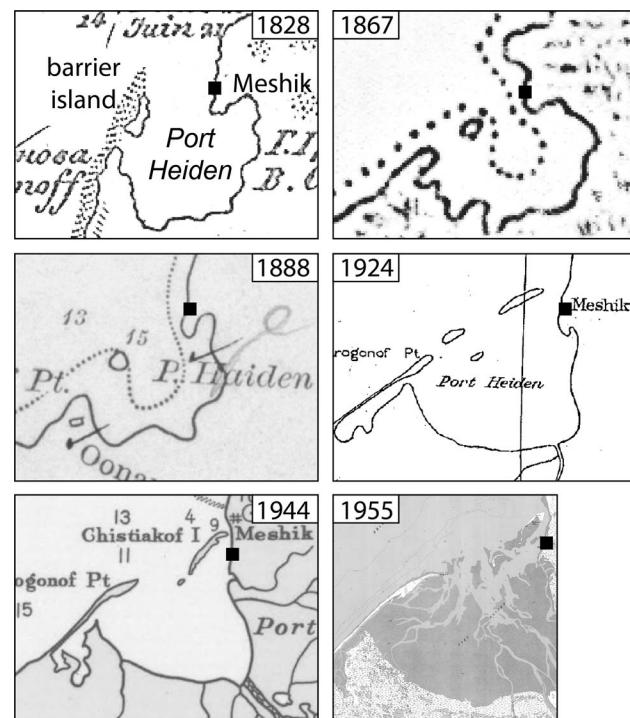
Figure 5. Maps illustrating Port Heiden from 1828 to 1955. Maps are not to scale and are not anticipated to accurately depict the shoreline in fine detail, especially further back in time. Meshik (black square) was first labeled on a map in 1924, so the position is estimated from 1828 to 1888. This comparison shows a general trend from a southwestward slightly elongated island to a northeastward elongated island, as well as the growth of Strogonof Point. Maps are by Khoudchine (1828), Lewis (1867), the U.S. Commission of Fish and Fisheries (1888), Smith and Baker (1924), the U.S. Coast and Geodetic Survey (1944), and the U.S. Geological Survey (1963; Port Heiden area based on 1955 data).

The reconfiguration of Chistiakof Island was a pivotal event. Maps from France, Russia, and the United States roughly show an island existed as early as 1828 and was located near the center of the bay mouth (Figure 5). By 1924, the elongated barrier island chain crossed the bay and Strogonof Point formed into a long spit. These early maps are not reliable for accurate island shape and position but confirm barrier islands

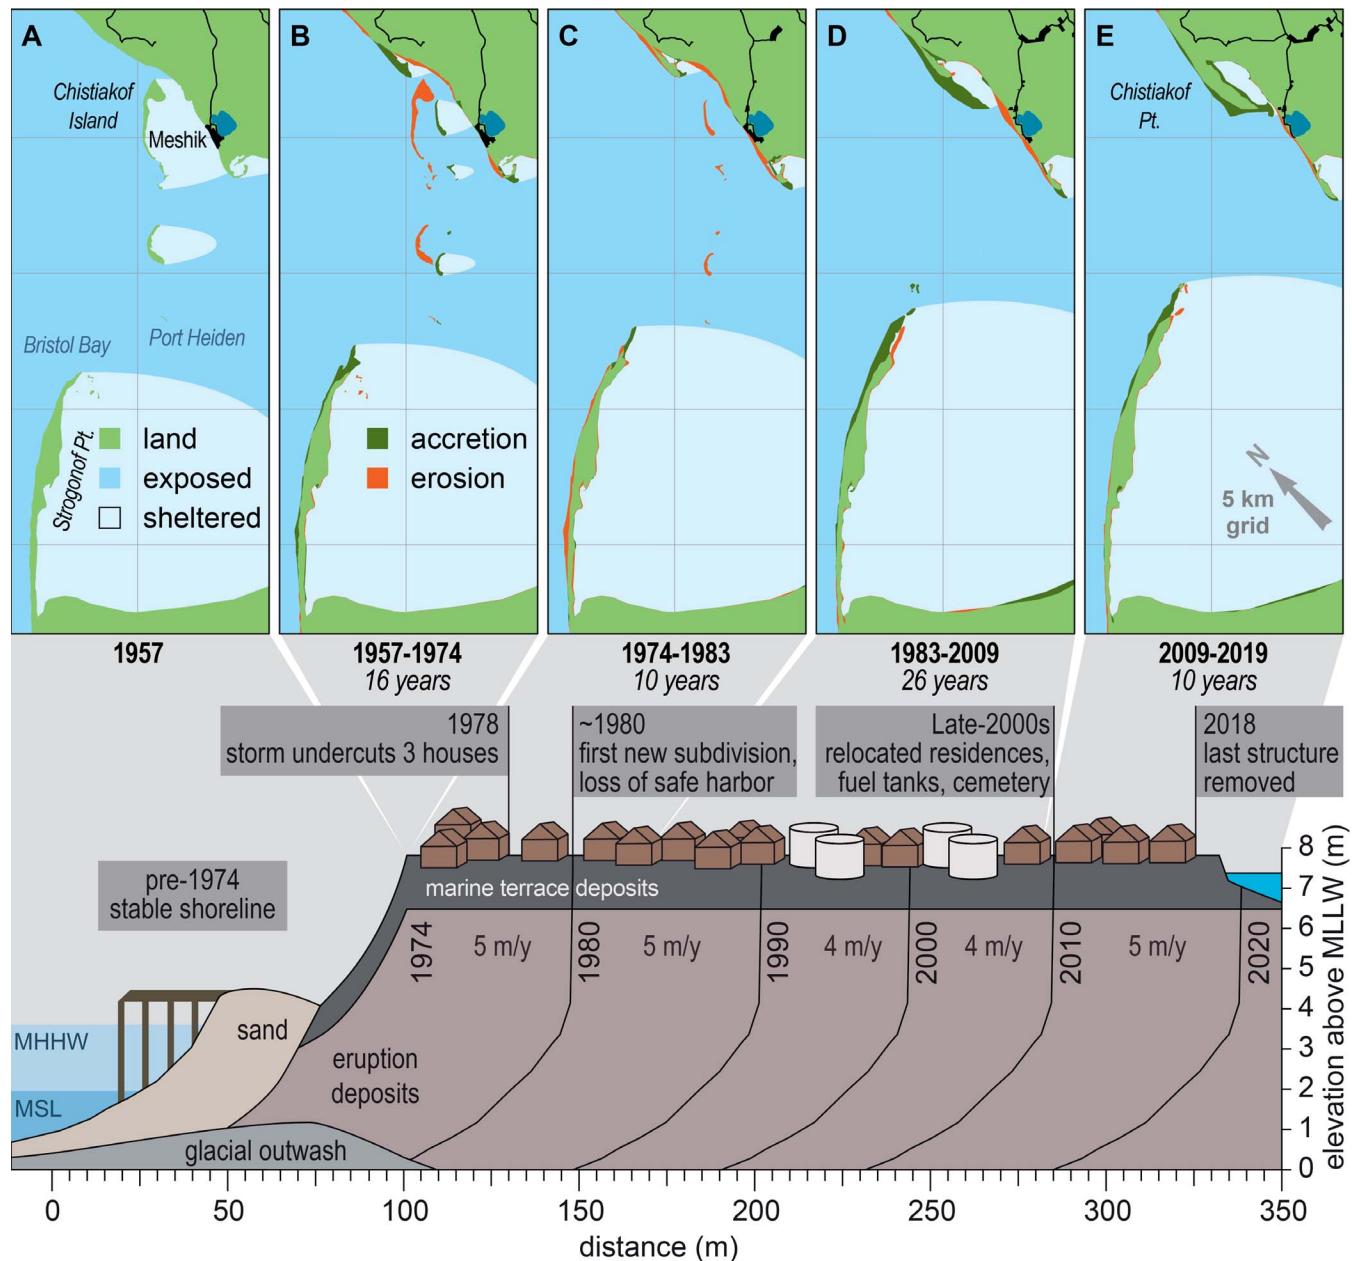
Figure 6. Erosion history of Meshik. (A–E) Timeline of barrier island and coastal erosion (orange) and barrier migration and formation (dark green). Coarse estimates of sheltered (light blue) and exposed (blue) waters conceptualize how the barrier reconfiguration influenced waves reaching Meshik. The lower plot shows the stable shoreline from 1957 and the erosion timeline, normalized by decade with inferred beach elevation profiles based on 2021 profile 102 at the former townsite. From 1957 to 1974, the barrier islands shrank and migrated toward the coast. Erosion began north and south of Meshik. After 1974, the islands submerged and erosion at Meshik increased to 5 m/y on average.

Figure 6 shows the history of barrier island migration (measured through aerial imagery) and community relocation. In 1957, 5.3 km of barrier islands crossed the entrance of Port Heiden, leaving three main openings of 5.0, 1.2, and 0.5 km in width. Between 1957 and 1973, the islands shrank and migrated toward the coast. Rapid coastal erosion occurred north and south of Meshik. The island is last seen in an aerial photograph acquired in summer 1977 by USACE. It completely

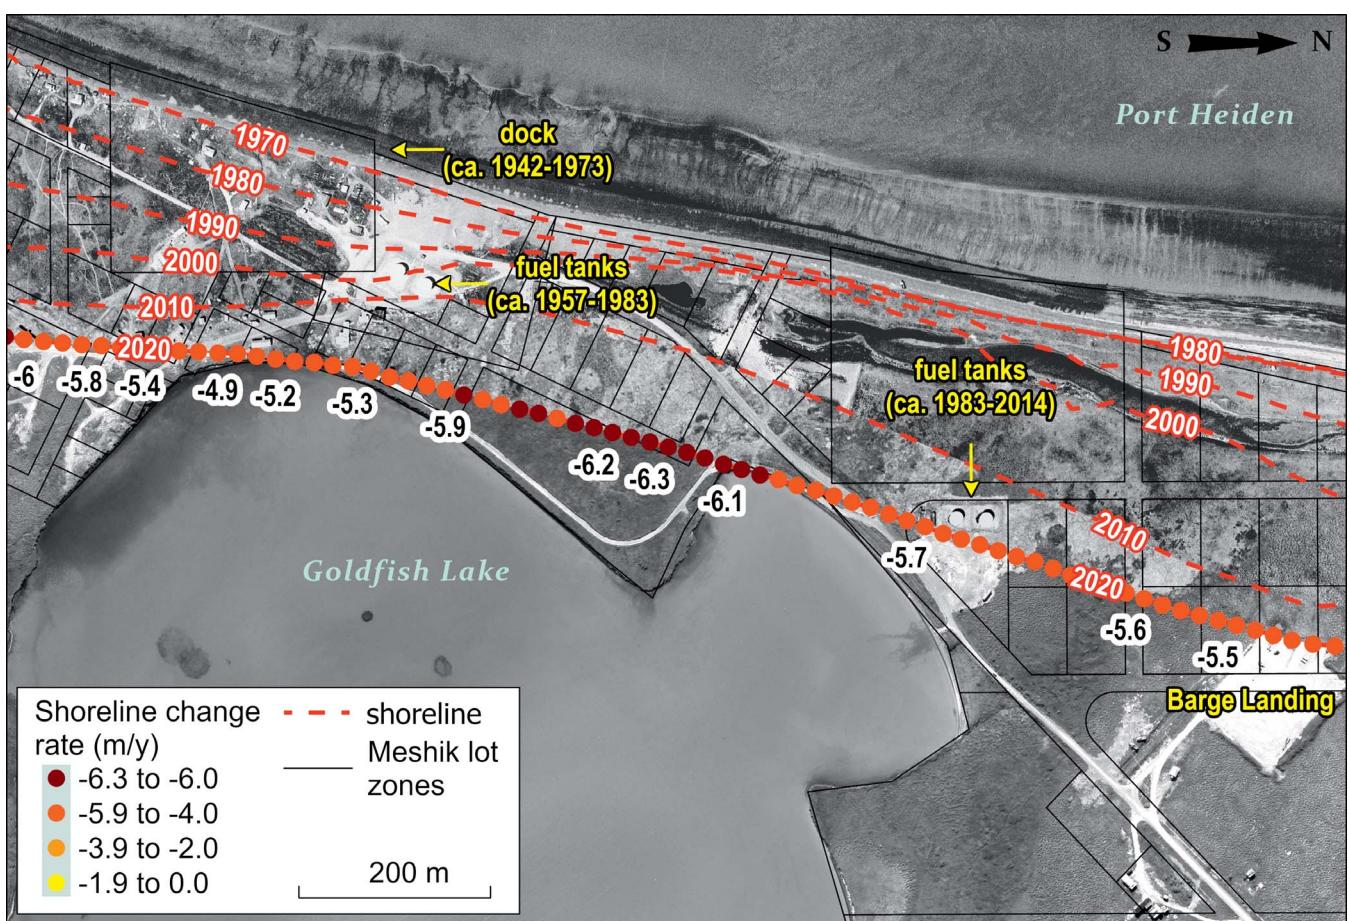
Figure 7. Shoreline positions interpolated per decade (dashed red lines) show the erosion history of Meshik. Most structures were built at the south end of the lake, but the zoned lots show how much property Meshik lost to erosion. The image is a composite from different periods to showcase infrastructure. The image of the shoreline is from 1974, showing the village, original fuel tank location, and the spit and back-barrier lagoon extending to the east. Barges landed near the dock, which had recently been destroyed by sea ice. At the 2010 line, the image is switched to 2002 to show the remaining structures to be relocated and the location to which the fuel tanks were moved. At the 2020 line, the image switches to 2019 to show the new barge landing site. The 2020 shoreline is symbolized by the WLR shoreline change rates from 1974 to 2021.

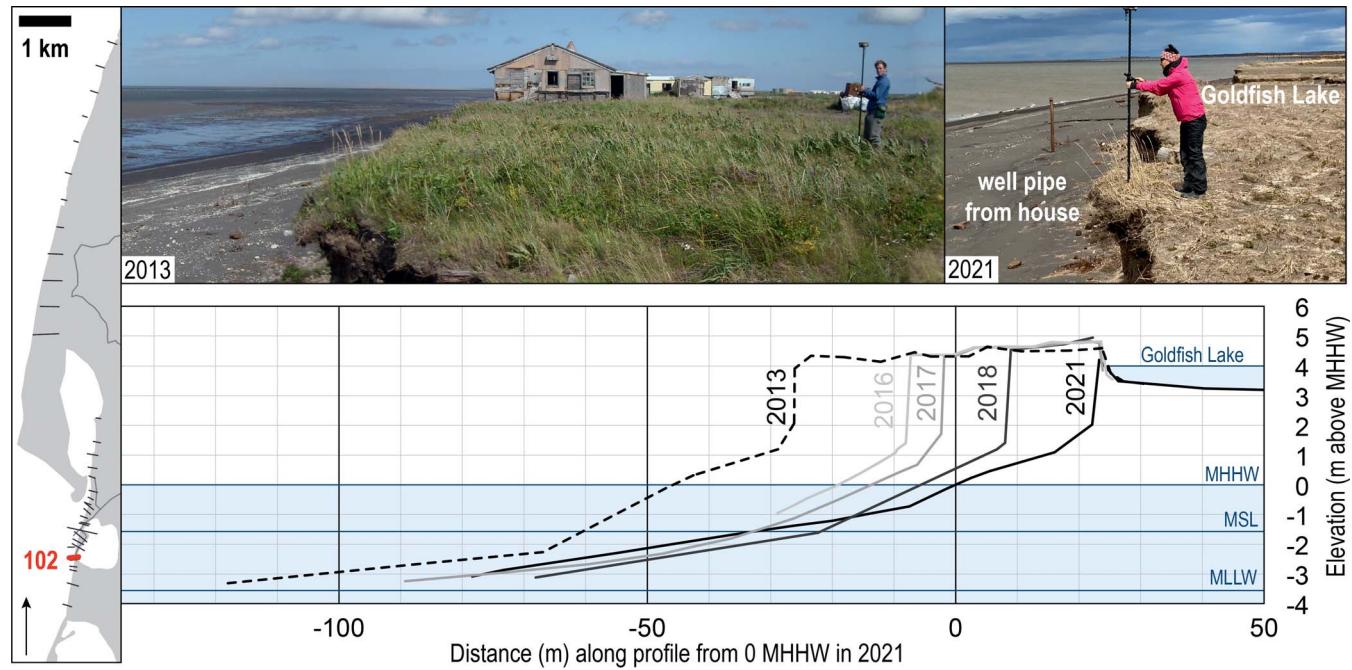
Figure 8. Elevation profiles at the Meshik townsit show steady erosion of about 50 m over 8 years (6 m/y). The beach elevation rose between 2018 and 2021, coinciding with when Goldfish Lake breached. All structures in the top image were removed by the City of Port Heiden.

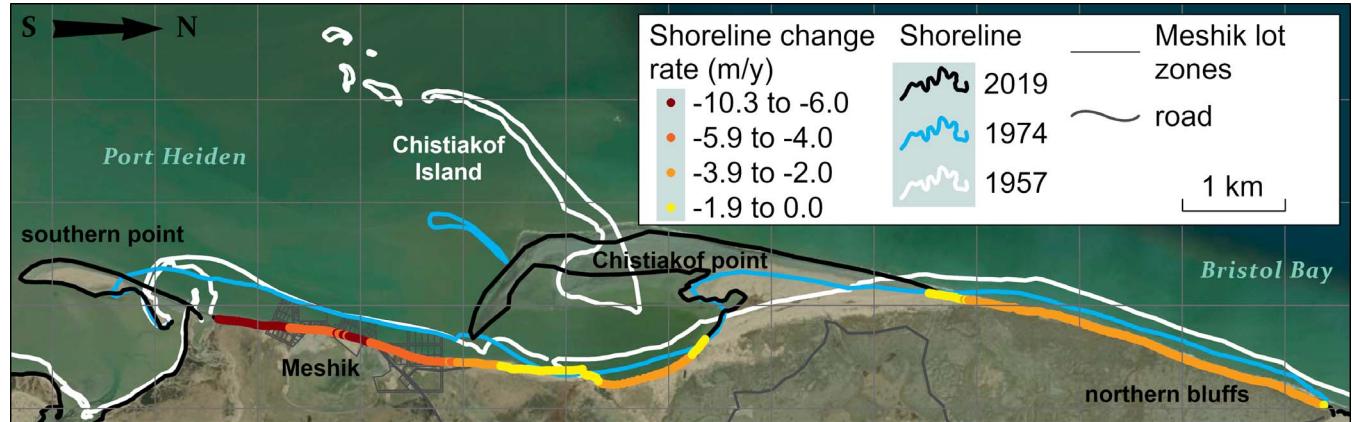
Figure 9. Shoreline change map of Port Heiden from Meshik to the northern bluffs. Shoreline change rates are symbolized with hot colors along the 2019 shoreline. Negative values indicate erosion. The black sections of the 2019 shoreline accreted or were not measured. The 1957 (white) and 1974 (blue) shorelines show the erosion timing and extent, as well as the reconfiguration of Chistiakof Island into a spit. Shorelines represent bluff top edges or vegetation lines. The shorelines of the islands and spits represent high-water lines. Most of Meshik's zoned lots (gray) eroded by 2019 (Image: Earthstar Geographics, ca. 2021).

between Meshik and northern bluffs, deposited by longshore currents. By 2002, the spits had disappeared, and the shoreline eroded 200 m (Figure 9). Over this period, deposited sediments formed a 2-km spit (accreting 44 m/y on average). This also protected the back-barrier coastline, and it began to stabilize. The spit reached more than 3 km by 2019, with the point nearly touching the mainland at the barge landing. Elevation profiles in the back-barrier showed a switch from erosion to accretion that followed the spit formation south (Figure 11).

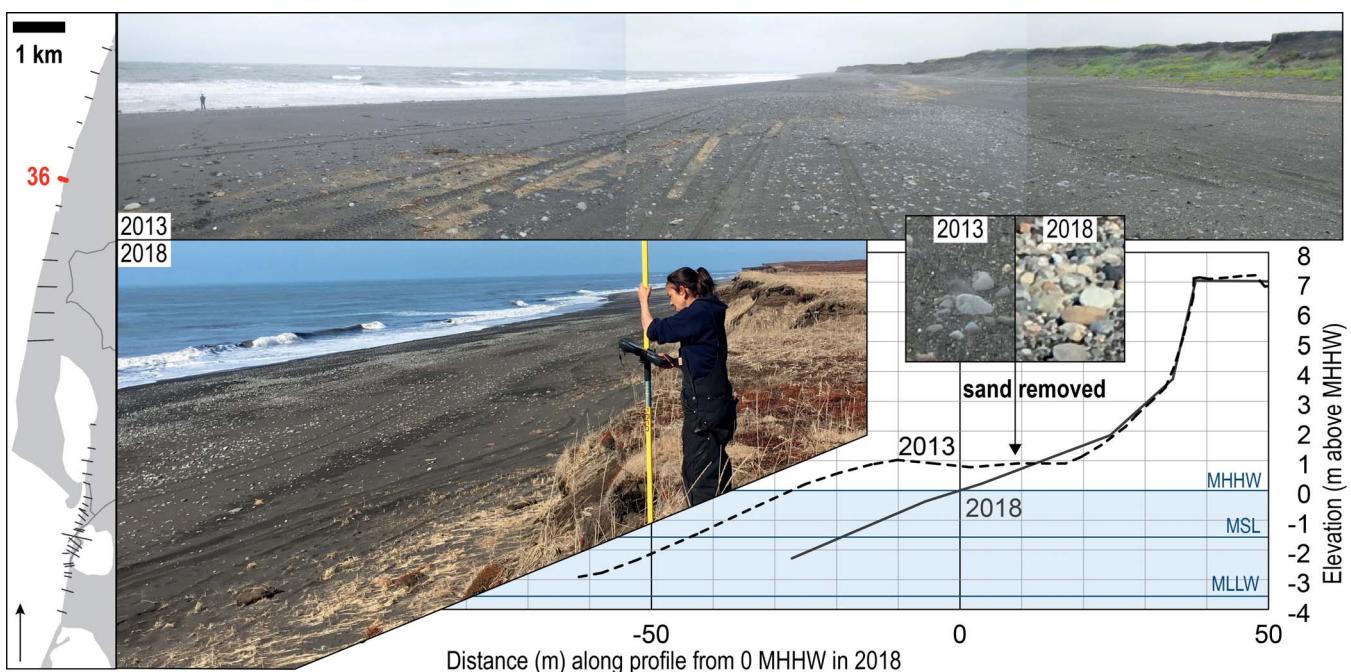
Figure 10. Elevation profiles north of Chistiakof point between August 2013 and April 2018 show bluff stability but beach erosion. The broad, sandy berm eroded away, leaving a ridge of glacially derived cobbles. This is likely the result of the February 2018 storm.

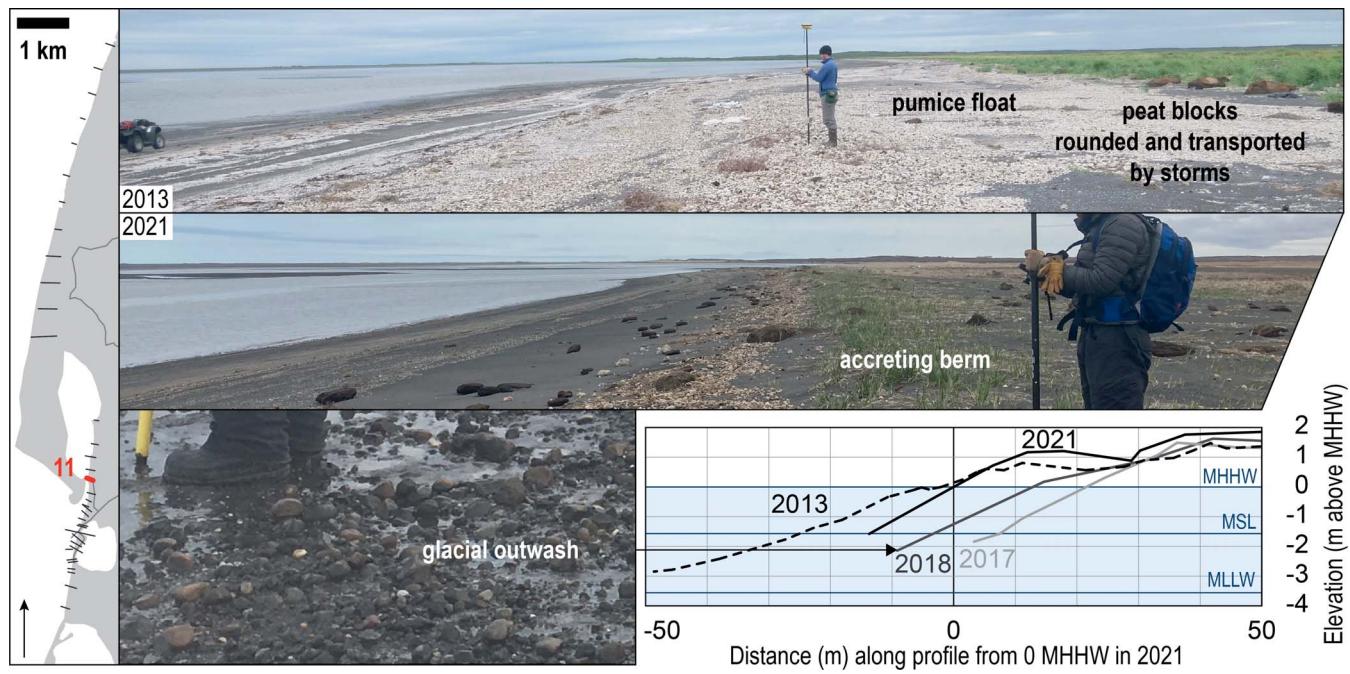
Figure 11. Elevation profile 11 behind Chistiakof point shows beach erosion from 2013 (dashed) to 2017 (light gray) and then accretion. The switch to accretion occurred earlier for back-barrier profiles farther north. Residents observed this area flooding during large storms, evidenced by the floated pumice, blocks of rounded peat, and small cobbles.

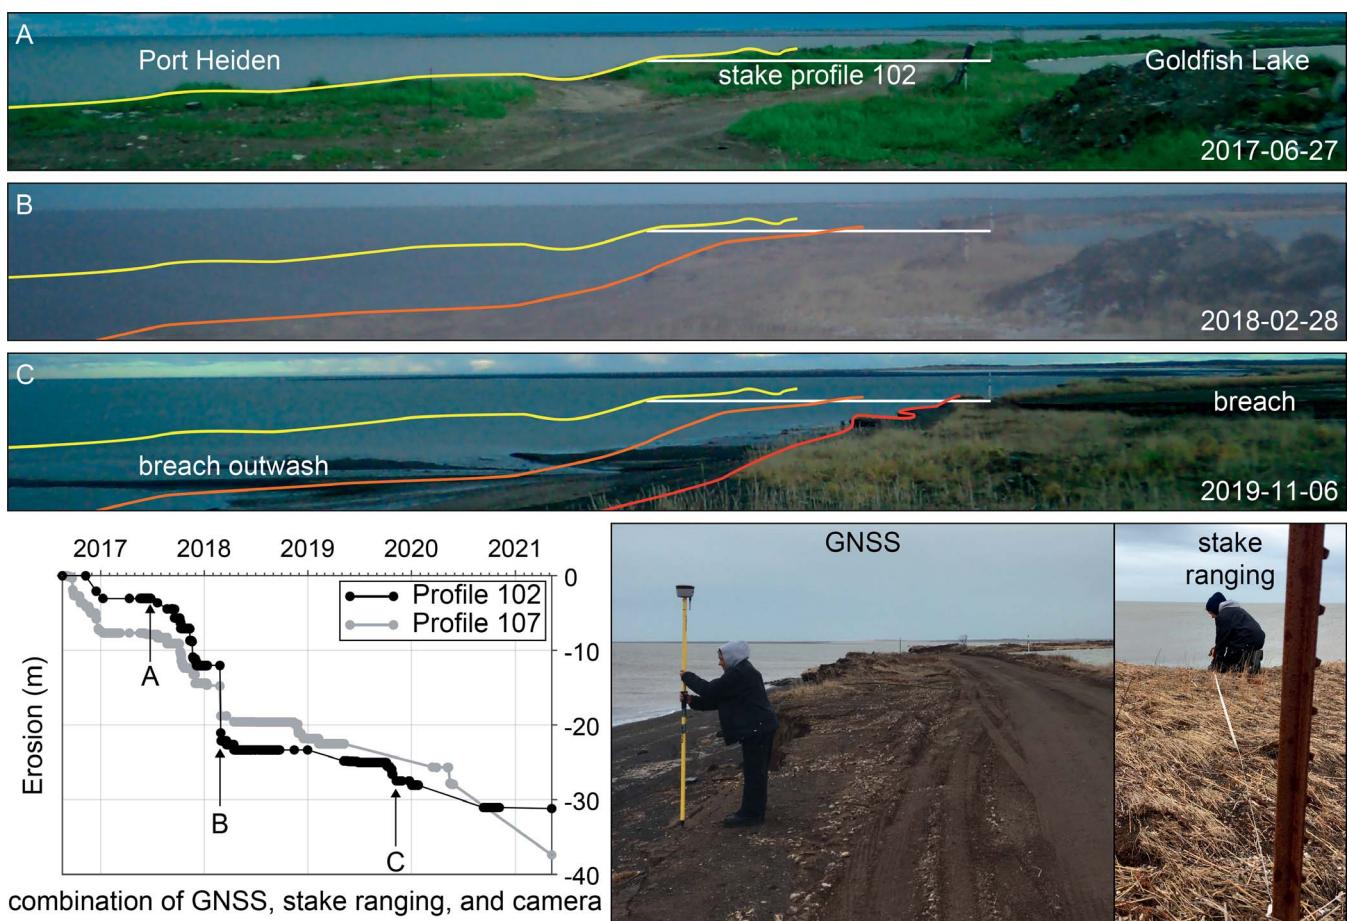
Figure 12. Erosion measurements at the former townsite of Meshik. (A–C) Time-lapse photos with annotated shoreline positions (sequentially yellow, orange, and red) and stake profile 102 (white) used for the plot below. The plot shows erosion along two profiles at either end of Goldfish Lake. Erosion typically occurred gradually, although one storm caused 6 to 10 m of erosion (B) on 28 February 2018. The bottom-right photos show Port Heiden Tribal Environmental Office staff measuring the bluff edge with GNSS and with measuring tape from a stake.

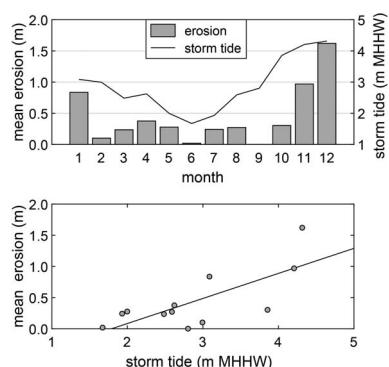
Figure 13. (Top) Mean monthly erosion distance (bars) compared with the average maximum offshore storm tide (tide + SWH). October through February have the greatest storm tide, but erosion is greatest from November through January. (Bottom) Linear regression shows that the maximum monthly storm tide somewhat explains erosion but is not statistically significant ( $y = 0.402x - 0.719$ ,  $R^2 = 0.54$ ,  $p = 0.07$ ).

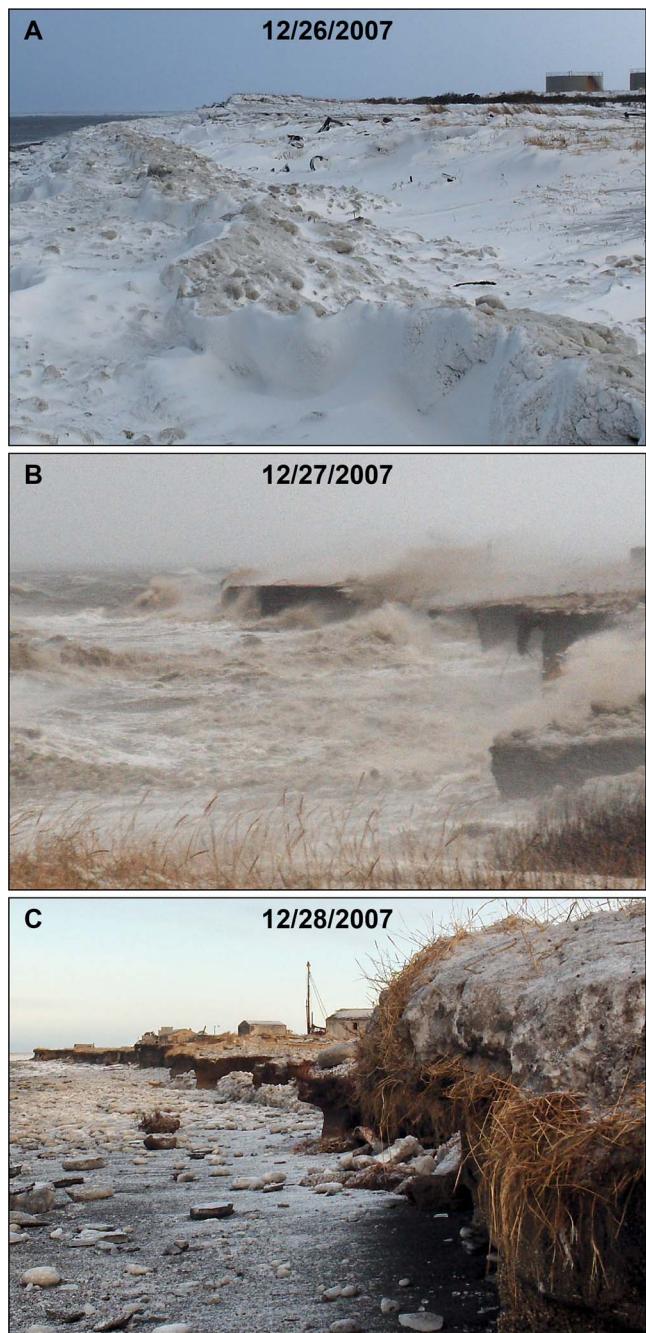
Figure 14. Three photos of the December 2007 storm showcase a typical storm eroding the bluff at Meshik. (A) The beach is covered in about half a meter of snow before the storm. (B) The storm tide reaches the bluff toe, and waves crash into the face. Bluffs have a vertical angle. (C) After the storm, the bluff is undercut and layers of peat are overhanging and slumping. The beach is covered in rounded ice and peat blocks.

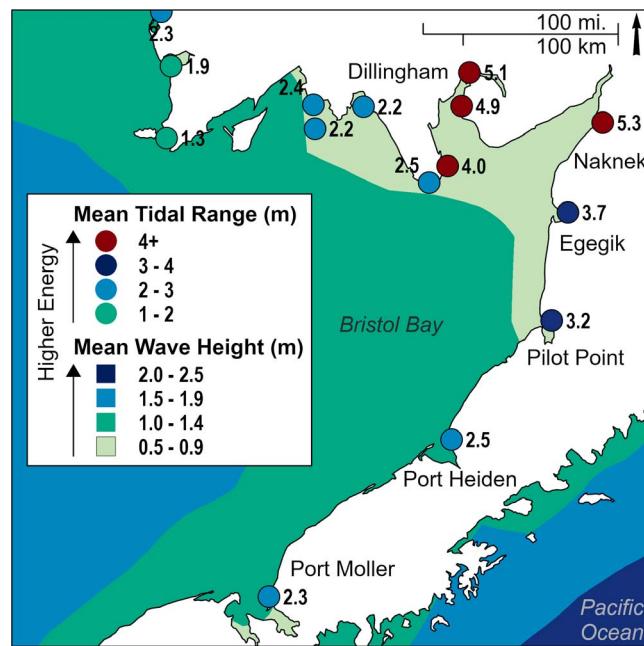
Figure 15. Mean tidal range (circles) and mean wave height of Bristol Bay. Green to blue symbolizes low to high energy conditions (respectively) where barrier islands could exist. Tidal ranges exceeding the limit of barrier islands are in red. Wave heights decrease and tidal range increases toward the head of the bay (NE). Tidal datums were provided by the NOAA Center for Operational Oceanographic Products and Services in 2021. Wave heights were calculated from monthly average SWH hindcasts by Hersbach *et al.* (2020).

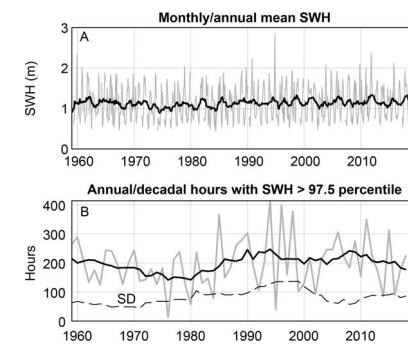
Figure 16. (A) Monthly (gray) and annual (black) SWH at Port Heiden. (B) Annual (gray) and decadal (solid black) hours when SWH is greater than the 97.5th percentile of the dataset. The decadal SD (black dashed) shows interannual variability. SWH is controlled for wave directions toward Port Heiden. SWH is not calculated when sea ice is present.

SWH is used to quantify the influence of waves (Hayes, 1979). Port Heiden's mean annual SWH is 1.14 m (Figure 16; Hersbach *et al.*, 2020), a common value for barrier islands (Mulhern, Johnson, and Martin, 2017). Storm surge and high water for long durations lead to the greatest erosion at Meshik (Fathauer, 1978; Kvasager, 1975), so SWH greater than the 97.5th percentile of waves is examined (Figure 16). There is no major difference in extreme SWH in the 1960s to 1970s compared with the study period, but 1959–74 was consistently stormy. Typically, there is greater interannual variability,

expressed by the SD (Figure 16). Coastal features achieve equilibrium by recovering after disturbances like storms. The continuous storminess in this period may have pressured Chistiakof Island toward an erosional regime.

Bay over this period, allowing less time for the barrier islands to recover (Figure 16). The increased storminess was not unusual, but sea ice also went into decline and became more variable. This increased net wave energy and the likelihood of storms making landfall. Even though the 1970s saw brief sea ice recovery, the island was already greatly reduced, and the community observed continuous storms erode the island remnants (Kvasager, 1975). After this point, sea ice declined significantly, and the island never reformed.
