Laboratory simulation of frost on a pavement column inside a freezer under a controlled environment

Taryn DiLorenzo, Omid Habibzadeh-Bigdarvish, Dongfeng Li, Zheng Fang & Xinbao Yu

Department of Civil Engineering, University of Texas at Arlington, Arlington, USA

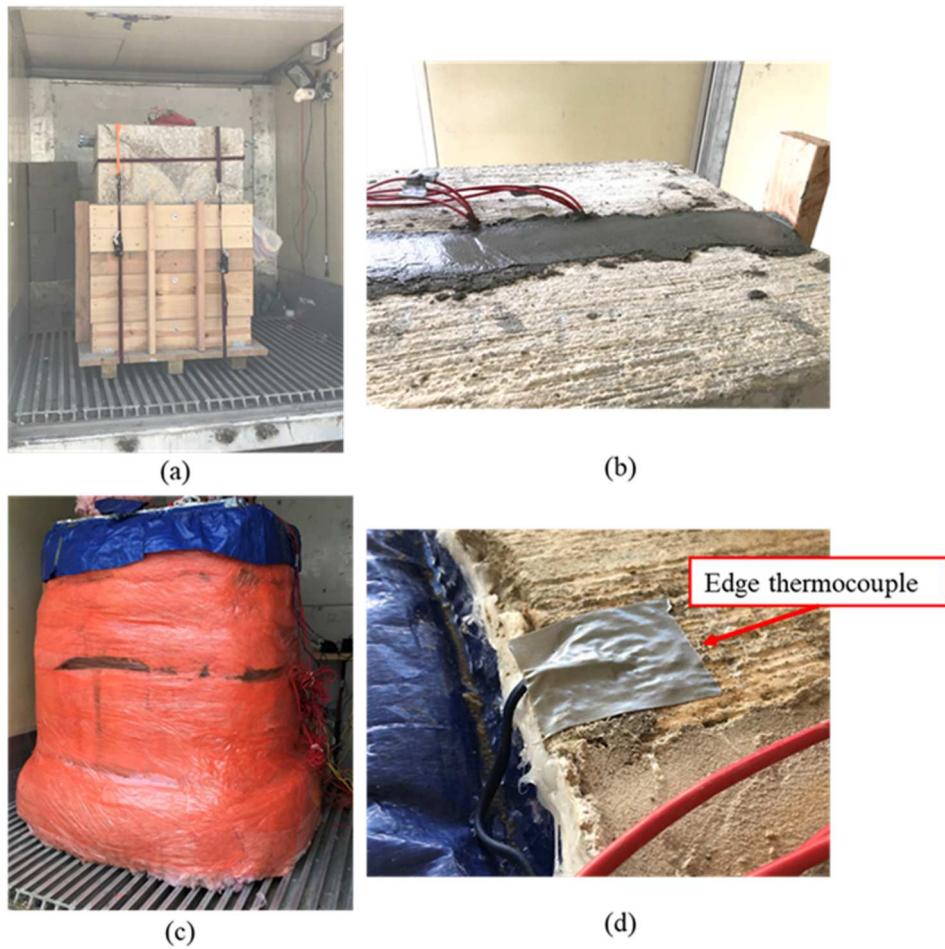
around the sensor heads in the slab body. Baseline testing for cooling and warming was performed and the temperature response of the slab body was found to be uniform, affirming no interfering effect from the mason mix. The box was wrapped in R30 insulation and commercial-grade plastic wrap. The edges of the slab body were wrapped in R30 insulation and roof tarping. It was then sealed with silicone and Gorilla Glue to prevent water infiltration during precipitation operations that occurred during ice formation testing (DiLorenzo *et al.* 2022). The pavement column was used to study the formation of icing on a pavement surface due to a precipitation event in DiLorenzo *et al.* 2022. R30 insulation material was used to fill the gap between the box and the floor and surface instrumentation was installed at this time (Figure 3a through 3d).

Figure 3. (a): Model column inside freezer box (b): Gap between slab halves filled (c): Model column wrapped in insulation and plastic (d): Installed edge surface thermocouple (after: DiLorenzo *et al.* 2022).

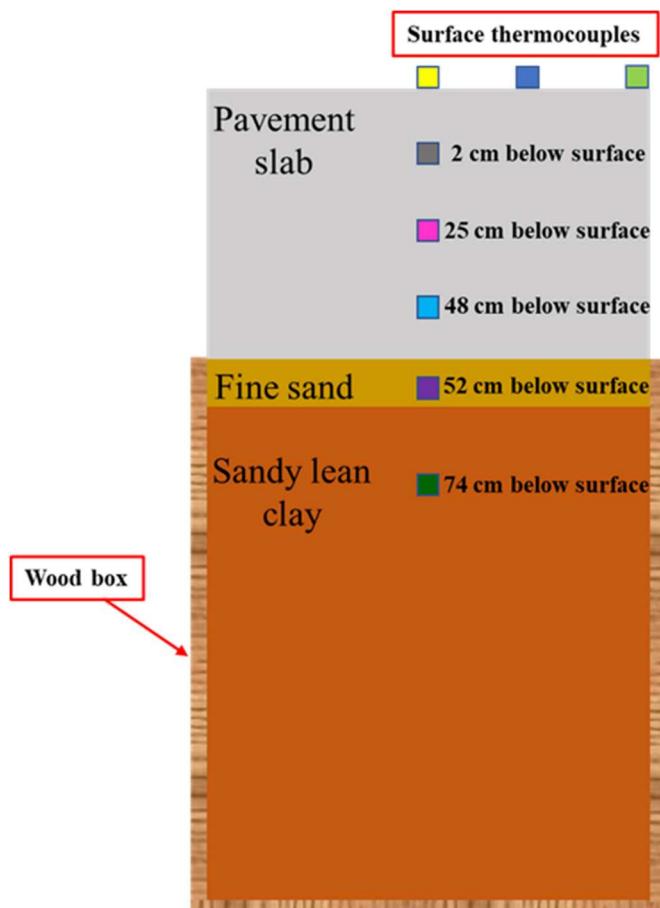
Table 1 presents a summary of the instrumentation used to record the temperature of the pavement slab. For the locations of the instrumentation, please refer to Figure 4. Thermistors placed at different locations in the column monitored the boundary conditions between the freezer box temperature, the slab, and the soil.

Six thermistors were installed in the slab body at 2, 25 and 48 cm below the slab surface. The sensors were placed in two vertical rows with each row containing three thermistors to record the temperature distribution in the vertical and horizontal direction. Three thermocouples were installed on the surface of the slab. The center surface sensor was installed over a row of slab body thermistors to monitor the vertical temperature distribution of the slab (Figure 4). A detailed description of the instrumentation can be found in DiLorenzo *et al.* 2022.

Figure 4. Instrumentation for pavement column.

This section presents the results of the frost test cases; a summary table of the results can be found below (Table 3). Sensor locations noted in Table 3 can be found in Figure 4.
