Journal of Wind Engineering & Industrial Aerodynamics

Performance of asphalt shingles under simulated hurricane winds and evaluation of current installation practices

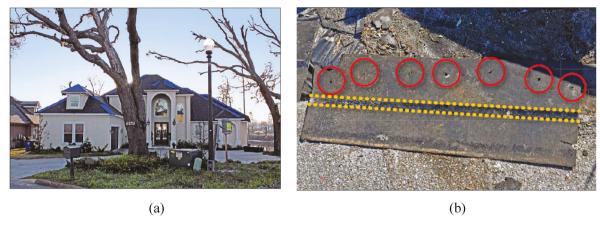
Fig. 5. Observed installation deficiencies after Hurricane Michael (a) unsealed shingles; (b) high-nailing (Source: FEMA, 2020).

Finally, the fourth observation is that most shingle failures were attributed to poor installation and construction practices. For example, most hip and ridge-cap shingles found in debris piles from Hurricane Michael (2018) were reported to have had no sign of roofing cement applied to them (FEMA, 2020). There were also reported cases where portions of shingles were left unsealed. Fig. 5a shows a residential house

built 3 years before Hurricane Michael that sustained damage only to its hip and ridge-cap shingles possibly due to unsealing of shingles (FEMA, 2020). Besides inadequate hand dabbing of adhesive material, incorrect application of the starter course in eave areas was also stated as another cause for shingle blowoff. Poor fastening practices were also major consistent observations reported to have affected shingle wind performance. Most fasteners were nailed higher than their appropriate location [see Fig. 5b], over-driven due to the usage of excessive pressure, or even missing in most cases.

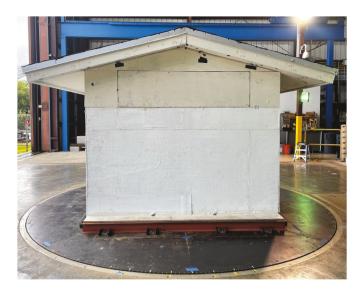
Fig. 8. Hip-gable roof at the WOW turntable.

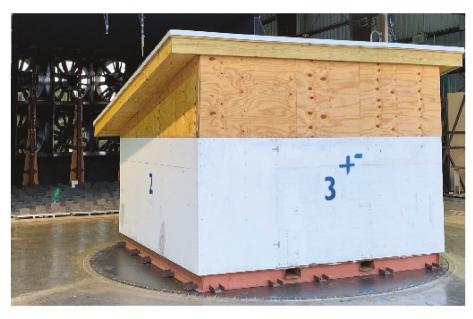
Fig. 9. Monoslope roof at WOW turntable.

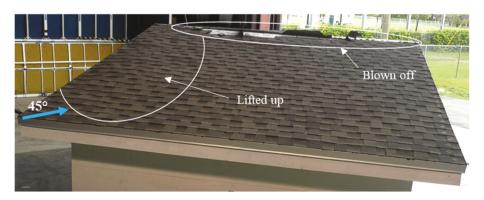
Fig. 21. Case 6: shingle blowoff at a 3-s peak wind speed of 56.8 m/s.

number of nails were able to increase the failure wind speed by 37% compared to the monoslope installed with FEMA's recommended practices. Even though this installation method provided improved performance, the failure wind speed observed is still below the design wind speed required in HVHZs according to the FBC and ASCE 7-22 (ASCE, 2022; Florida Building Code, 2020). Moreover, failures happened in this wind direction because shingles were already lifted and were pulled through their fasteners by dominant wind directions, especially from those directed to the upper corners at lower wind speeds, as shown in Fig. 20 (a, b). These failures, consistent with the aerodynamic study conducted by Tolera et al. (2022), were initiated near the upper corner of the monoslope due to wind flow directed to these corners (135°). Moreover, the aerodynamic study also reported significant pressure equalization (β < 1) in the failure zone. Even though negative cavity pressures reduced the net pressure acting on the shingle, the external suctions were high enough to cause shingle uplift. Such failure modes are contrary to the basic assumption that shingle failures are initiated by local aerodynamics, mostly expected in flow reattachment areas (ASTM International, 2020a; Dixon et al., 2013; Peterka et al., 1997). Additionally, this installation method produced improved performance at the rake edge relative to the other installation techniques. Effectively securing the rake edges against cavity pressurization shifted the first place in which failure began from the rake edges to the upper corners (see Fig. 21), contrary to the two failure mechanisms discussed in subsections 3.1 and 3.2. Even though interior shingles located behind the rake edge adhesives were also pulled through their nails, these shingles were not blown off [see Fig. 21].
