# Alpine hillslope failure in the western US: insights from the Chaos Canyon landslide, Rocky Mountain National Park, USA

**Abstract.** The Chaos Canyon landslide, which collapsed on the afternoon of 28 June 2022 in Rocky Mountain National Park, presents an opportunity to evaluate instabilities within alpine regions faced with a warming and dynamic climate. Video documentation of the landslide was captured by several eyewitnesses and motivated a rapid field campaign. Initial estimates put the failure area at 66 630 m<sup>2</sup>, with an average elevation of 3555 m above sea level. We undertook an investigation of previous movement of this landslide, measured the volume of material involved, evaluated the potential presence of interstitial ice and snow within the failed deposit, and examined potential climatological impacts on the collapse of the slope. Satellite radar and optical measurements were used to calculate deformation of the landslide in the 5 years leading up to collapse. From 2017 to 2019, the landslide moved  $\sim 5 \text{ m yr}^{-1}$ , accelerating to  $17 \text{ m yr}^{-1}$  in 2019. Movement took place through both internal deformation and basal sliding. Climate a

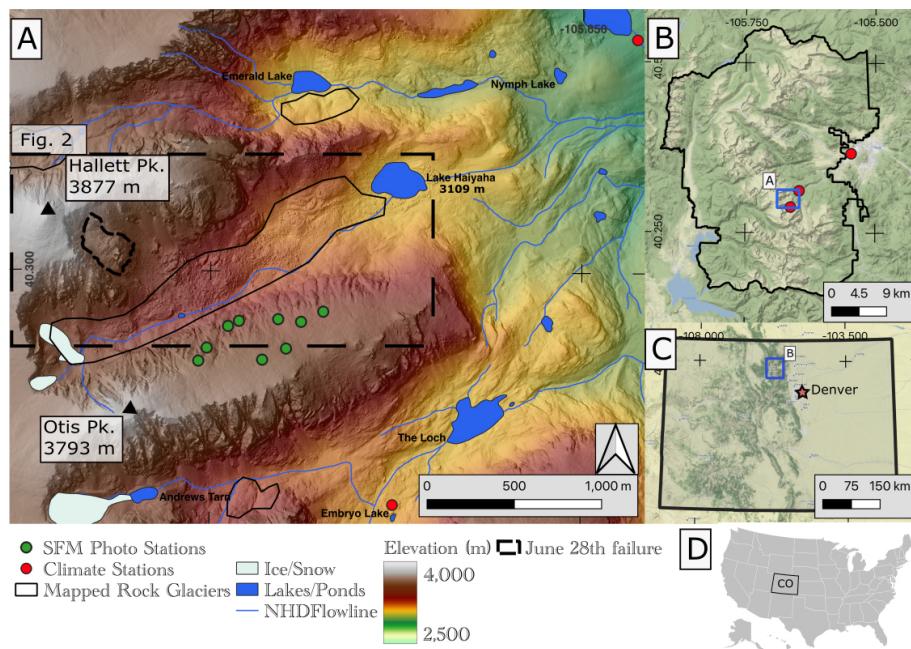
**Figure 1.** Overview of the landslide area. **(a)** Hillshade with hypsometric tint from a 1 m lidar digital elevation model (DEM) of the Chaos Canyon landslide and the surrounding topography. Highlighted are the outlines of mapped rock glaciers (Johnson et al., 2021), the nine photo locations used in the structure from motion survey, and the two climate stations used in climate reconstructions for the slide. Lakes, streams, and ice–snow bodies are from the National Hydrography Dataset (NHD) (USGS, 2019). Imagery predates 28 June failure. **(b)** The location of panel **(a)** within Rocky Mountain Park. **(c)** The location of panel **(b)** within Colorado, USA. **(d)** The location of Colorado **(c)** within the USA.

The Chaos Canyon collapse took place during a sunny early-summer day at 03:31 PM LT on 28 June 2022 in Rocky Mountain National Park (RMNP), Colorado, USA (Fig. 1). The event was first reported through social media from bystanders situated at Lake Haiyaha (Fig. 1) and directly beneath the slide. These social media posts resulted in a rapid response from Earth scientists who initially sought to investigate (1) if the failure was spontaneous or part of a longer lived behavior; (2) the mechanisms contributing to this collapse – such as a landslide, the collapse of a rock glacier, and the role of cryogenic processes in general – perhaps related to climate; and (3) the amount of material mobilized by the collapse. More broadly, this investigation developed through a desire to understand whether this failure is part of the global trend toward cryosphere instability and the degradation of permafrost conditions driven by climate change (Geertsema et al., 2022; Patton et al., 2019). Mass movements in alpine regions have been documented with increasing frequency in the European Alps, Canada, and Alaska (Dai et al., 2020; Geertsema et al., 2022; Lacroix et al., 2022); however, few such observations have been made in the coterminous United States. Despite the lack of observed climate-driven landslides in the coterminous US, these high-elevation slope failures pose a potentially high risk to an ever-increasing number of people who spend time in alpine environments. RMNP was visited by  $\sim 4.4$  million people in 2021, making it the 14th most visited National Park in the US (NPS, 2022). As the climate warms, developing awareness around future alpine hazards within RMNP and across the broader western US cordillera is an important priority.

tially active rock glacier, with the landform that failed on 28 June mapped as Quaternary talus (Figs. 1 and 2).

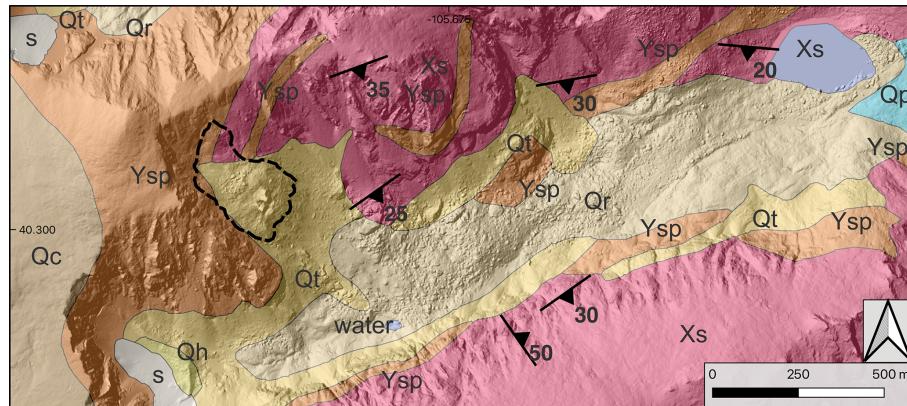
**Figure 2.** Geologic context of the Chaos Canyon landslide, perched above the canyon floor atop a contact between the Silver Plume Granite (Ysp) and a biotite schist (Xs). Note that there is a foliation dip toward Chaos Canyon at  $35^{\circ}$ . Other lithic designators are as follows. Qc – Quaternary colluvium; Qr – Quaternary rock glacier; Qt – Quaternary talus; Qh – Quaternary till; s – snow. Water bodies are not colored. The dashed black line is the extent of the 28 June 2022 failure. Underlying geologic data are from Braddock and Cole (1990).

We hypothesize that permafrost within the slide deposit thawed and became intermittent due to the changing climatic conditions within Chaos Canyon over the last  $\sim$  30 years, likely reducing the stability of the landform. Coincident with warming temperatures, we observed an increasing rate of horizontal displacement of the landslide over the past 5 years, with evidence suggesting both basal sliding and internal deformation (Figs. 5 and 6). Thawing permafrost, combined with internal deformation and some surface cracking (Fig. 5), may have provided an increased availability of flow paths for snowmelt and rain to penetrate into the slide mass, increasing the hydrostatic pressure and promoting destabilization of the deposit on 28 June (Figs. 7b, 11, and 12c; Bogaard and Greco, 2016). Building on this discussion, we further posit that the 28 June collapse is likely due to a combination of factors: continued rate weakening and localization of a shear plain beneath the landslide in concert with a decrease in permafrost throughout the landslide. The former primed the landslide to be more sensitive to pore-water pressure increases, even from an unexceptional snowmelt year like 2022, and the latter provided more pathways for snowmelt to ultimately reach the failure plane and increase the pore-fluid pressures to the point of failure. Additionally, the adverse dip of the underlying Proterozoic biotite schists may have played a role in mobilizing some of the landslide downslope (Fig. 2).

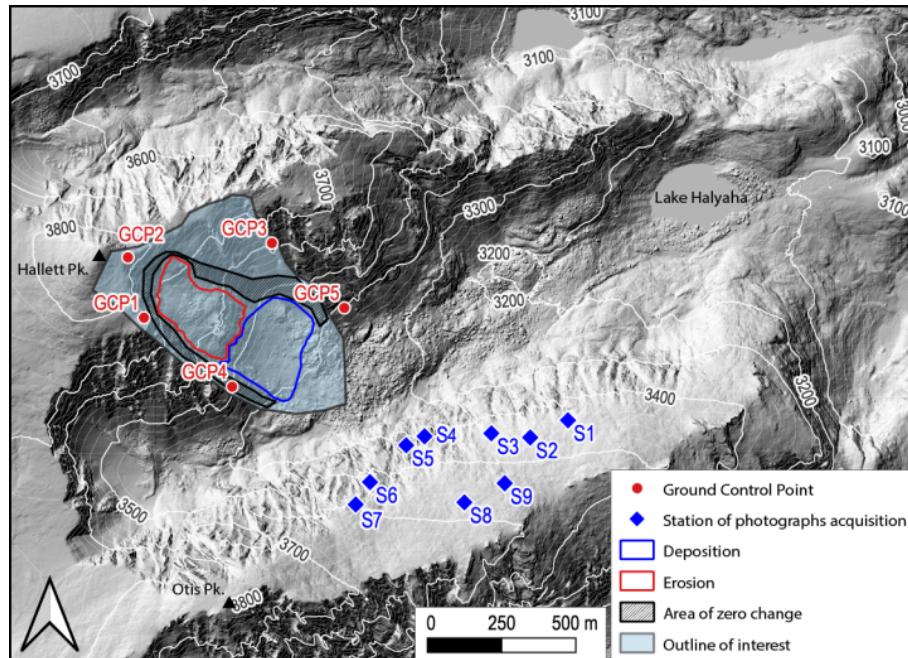
**Figure 3.** Location of the stations where the photographs were acquired (S) and the ground control points (GCPs) used to create the post-collapse DEM. Hillshade and elevation lines were computed using the 1 m DEM provided by the USGS program National Map 3DEP and acquired in 2017. Areas of erosion and deposition were derived from differencing the 2017 DEM and our 8 July SfM DEM.

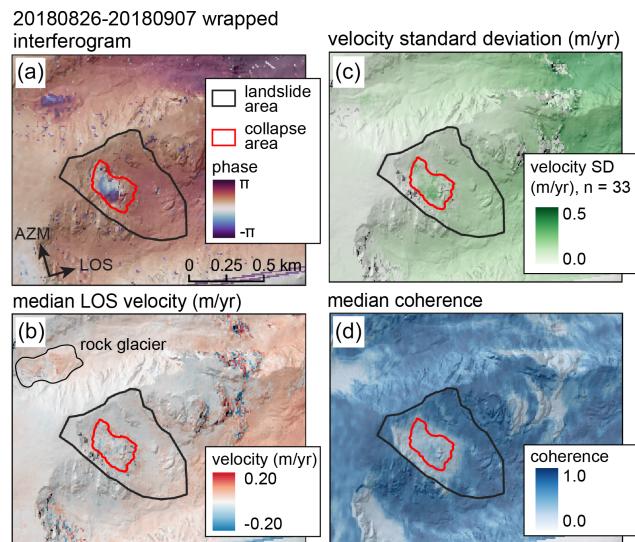
**Figure 4.** InSAR-derived LOS velocity of the landslide prior to the 28 June collapse. Interferograms come from Sentinel-1 ascending track 151. **(a)** A wrapped interferogram from the summer of 2018 showing clear landslide deformation of roughly 10 cm in 12 d. **(b)** Median LOS velocity of the failure area and landslide area. Interferograms with short temporal baselines and high median coherence on the landslide slope were used to create the velocity map. Positive values (red) correspond to motion away from the satellite along the satellite LOS. Note the spatial inconsistency of signals within the landslide. Negative velocity values at lower elevations are caused by topography-correlated atmospheric noise. **(c)** Standard deviation of LOS velocity. **(d)** Median coherence of the failure area and landslide area.

For all tracks, median coherence within the landslide boundaries was low ( $0.36 \pm 0.17$  for ascending track 78,  $0.37 \pm 0.16$  for ascending track 151, and  $0.52 \pm 0.16$  for descending track 56; Fig. 4d). A total of 12 wrapped interferograms from ascending tracks 78 and 151 show clear evidence of landslide displacement beginning in August 2015 (Figs. 4b and A2a, A3). Median LOS velocities in the landslide were not distributed in a manner consistent with cohesive downslope displacement. Instead, we observed patches of apparent upslope and downslope LOS velocity, along with patches of apparently stable area, scattered across the landslide surface in no clear pattern, which is due to unwrapping errors caused by the high deformation gradient (Figs. 4b, A2a, and 6; Itoh, 1982; Handwerger et al., 2015). Thus, the median velocity does not provide a reliable indicator of landslide activity. By comparison, for all tracks, a rock glacier in the cirque to the north has a more spatially consistent downslope velocity signal (Fig. 4b), while rocky, flat areas above and below the landslide appear mostly stable outside of topography-correlated atmospheric noise.

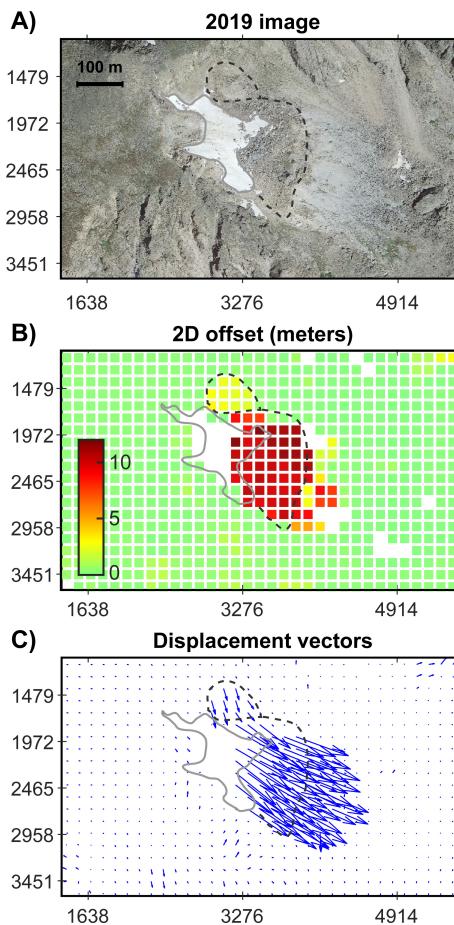
**Figure 5.** Results of digital image correlation for the Chaos Canyon landslide comparing © Google Earth imagery from September 2016 and August 2019. **(a)** A 2019 photo of the slide with a snow patch highlighted (solid gray line). Dashed lines highlight the crest of the main slide as well as a smaller adjoining slide thought to be secondary in response to undermining. **(b)** Scaled 2D offset magnitude. Blank cells are areas omitted during filtering; these mostly occur in snow-covered areas and at the toe of the steep frontal slope. Movement of the main body is 10.5 m on average. **(c)** Displacement vectors. The main Chaos Canyon slide and secondary adjoining slide show different displacement magnitude and orientation (dashed lines repeated from **a**). Coordinates are pixels in east ( $x$ ) and north ( $y$ ) orientations; image scaling is approximately 0.21 m per pixel.

Results of digital image correlation (DIC) analysis are shown in Fig. 5. We observe a broad area of relatively large-magnitude displacement corresponding to the top surface of the landslide: in the  $\sim 3$  years (i.e., the period 2016–2019) between images this area moved on average  $10.5 \pm 0.5 \text{ m}$  (Fig. 5b). Maximum displacements of 11.5 m were found on the northern portion of the slide surface. The main landslide body showed southeast-trending movement with consistent displacement vectors (Fig. 5c). Areas of low correlation between images, and those which were filtered in post-processing, were located in the region covered by snow in the 2019 image (Fig. 5a) and near the toe of the slope (Fig. 5b). We also observed an adjacent movement near the northern head of the landslide with lower-magnitude displacements ( $\sim 2 \text{ m}$ ) and more southerly oriented movement than the main body. Here it appears that a portion of the talus adjoining the main slide body is moving in response to motion of the main slide away from its toe. A visible scarp had developed in the 2019 image at the head of this smaller sliding body. The mean displacement azimuth for the main slide

body is  $117^\circ$  clockwise from north, while the smaller northern portion is moving at an azimuth of  $162^\circ$ . Finally, movement detected on and at the toe of the steep frontal slope has similar orientations only slightly lower in magnitude than at the crest ( $\sim 8$  m). This may indicate evidence supporting a basal sliding mechanism for slide movement that together with some amount of internal shear could generate the displacement pattern measured (Fig. 5b).

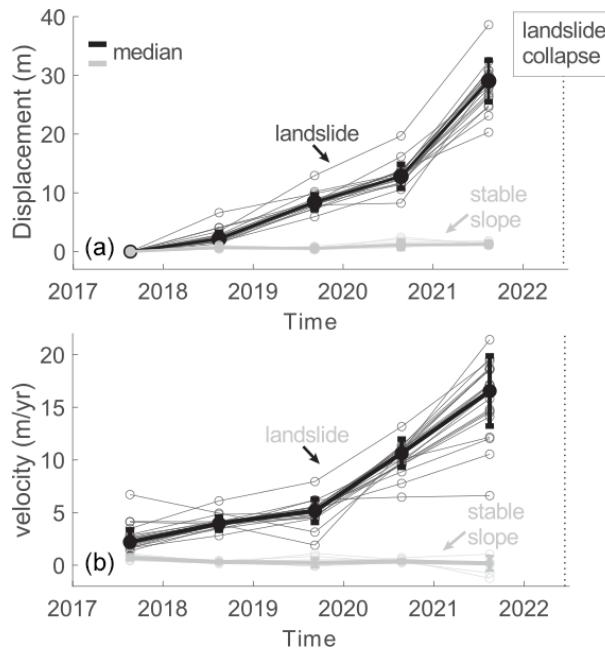
**Figure 6.** Image correlation results from Planet images taken in 2017, 2018, 2019, 2020, and 2021. (a) The thin gray lines are horizontal displacements of every pixel mapped within the landslide. The black line is the mean displacement with  $1\sigma$  bars. The thick gray line shows the same statistic but for stable areas outside the landslide. A greater sampling of Planet images reveals increasing displacements moving toward the present. (b) The mean and  $1\sigma$  uncertainty envelopes of velocity and for the landslide (black) and pixels examined outside of the footprint of the landslide (gray). The pixels outside the landslide show no systematic movement compared with the accelerating landslide.

Initial rates of horizontal displacement were slow at  $\sim 5 \text{ m yr}^{-1}$  between 2017 and 2019, but the landslide rapidly accelerated after 2019 to a moderate rate of  $\sim 17 \text{ m yr}^{-1}$  (for velocity classes see Cruden and Varnes, 1996). We identified no clear climatological forcing that led to the acceleration in 2019; however, there is the potential for a progressive weakening of the failure surface beneath the landslide (Eberhardt et al., 2016) and/or potential slip localization to a single shear plane with landslide movement (Viesca and Rice, 2012; Scuderi et al., 2017). Both of these phenomena suggest that through continued and repeated movement of the landslide, the landslide weakens and accelerates until its ultimate catastrophic failure. Similar behavior, wherein increases in sliding velocity result in weakening of the failure surface, has been modeled to occur in fault zones (Ito and Ikari, 2015). Given that the Chaos Canyon landslide has several years of slow and then accelerating movement, it is a strong candidate for further analysis of potential rate weakening or shear zone development.

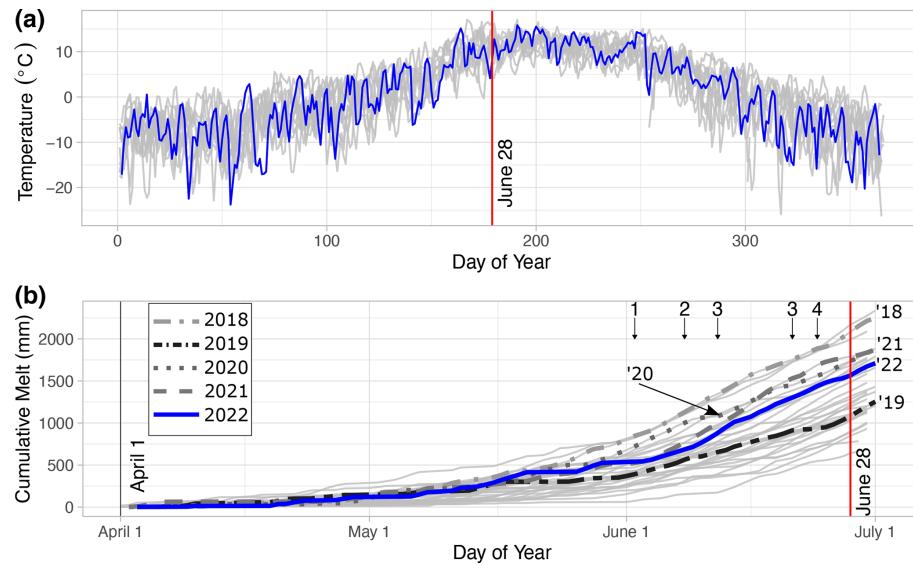
**Figure 7.** Climate analysis of the Chaos Canyon landslide. **(a)** The mean daily temperature series estimated for  $\sim 3668$  m, the elevation at the top of the slide. The year 2022 is highlighted in blue. Temperature series for 1990 through 2021 are gray lines. The collapse occurred on 28 June 2022. **(b)** The calculated cumulative snowmelt for the past 32 springs. The year 2022 is the blue line, with 1990–2021 snowmelt seasons shown in gray. Inset numbers highlight dates for frames from Planet imagery in Fig. 8. The snowmelt curves for the previous 4 years (2018, 2019, 2020, and 2021) are also highlighted.

Our detailed climate analysis shows that the Chaos Canyon landslide collapsed as average daily temperatures were increasing to their summer peak  $\sim 21$  d later (Fig. 7a). The year 2022 was not atypical compared to previous years over the last 3 decades. It was not remarkably warmer than past years in the winter months, nor were spring temperatures significantly warmer than typical. However, the temperature series does indicate that the collapse may have taken place

as warming increased the rate of snowmelt. This observation is further supported by the cumulative snowmelt we calculated at the elevation equivalent with the top of the landslide (Fig. 7b). Snowmelt begins in April with melt increasing rapidly after 1 June. Compared with the 1990–2021 seasons, 2022 had slightly higher melt than most of the previous 32 years, with the 11th highest calculated melt from April–1 July. Notably, 2018, 2020, and 2021 had greater snowmelt than the 2022 season, making 2022 unremarkable in terms of snowmelt volumes. However, these calculations do indicate that the collapse took place during the peak snowmelt for the spring season (Fig. 7b). This is bolstered by the Planet imagery in Fig. 8. Panel (a), 2 June through 24 June, shows a significant decrease in snow extent across the landslide in clear accordance with the snowmelt calculations in Fig. 7b.

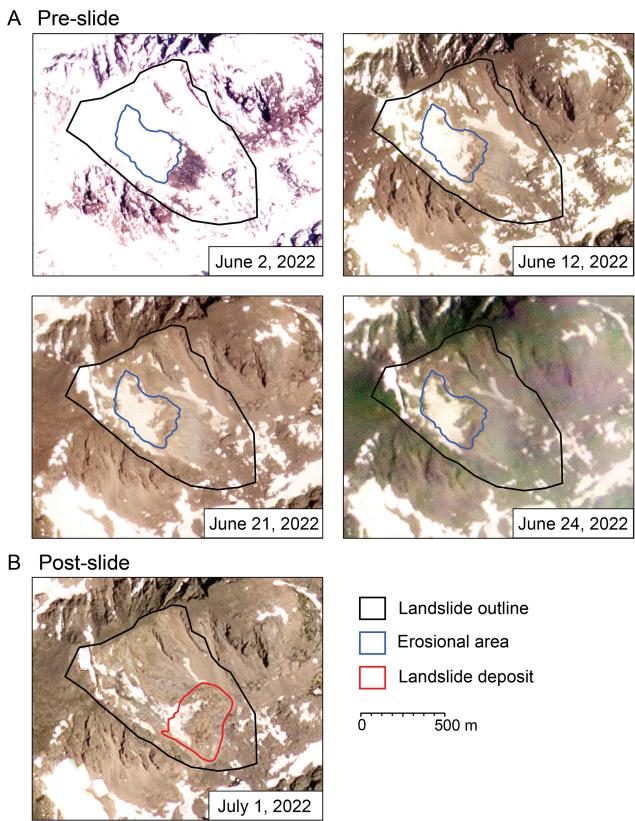
**Figure 8.** Planet imagery of upper Chaos Canyon in the days preceding the collapse (**a**: pre-collapse). Images are from 2, 12, 21, and 24 June. Frames show a decrease in snow coverage. Frames are also referenced in Fig. 7b. Satellite imagery further supports the conclusion that the landslide collapse took place during a period of rapid snowmelt (**b**: post-collapse). The landslide deposit after the 28 June collapse is highlighted. Pieces of the permanent snow patch have been translated with the landslide. Imagery thanks to Planet-Team (2017).

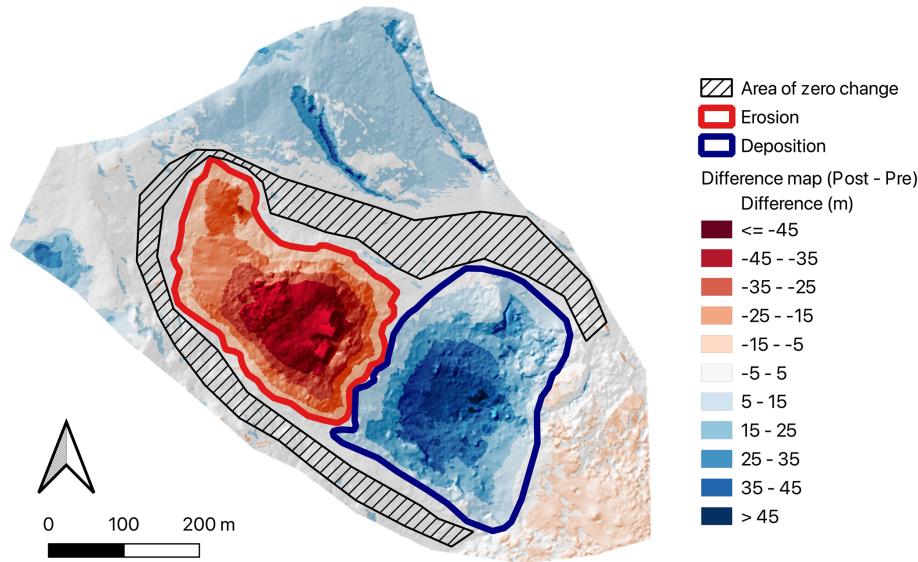
**Figure 9.** DEM of the difference between post- and pre-event topography. Negative values indicate erosion (red), positive values indicate deposition (blue), and green values indicate regions of zero change. The dashed area indicates regions where no visible change took place during the event and were used to calculate the accuracy of the DEM.

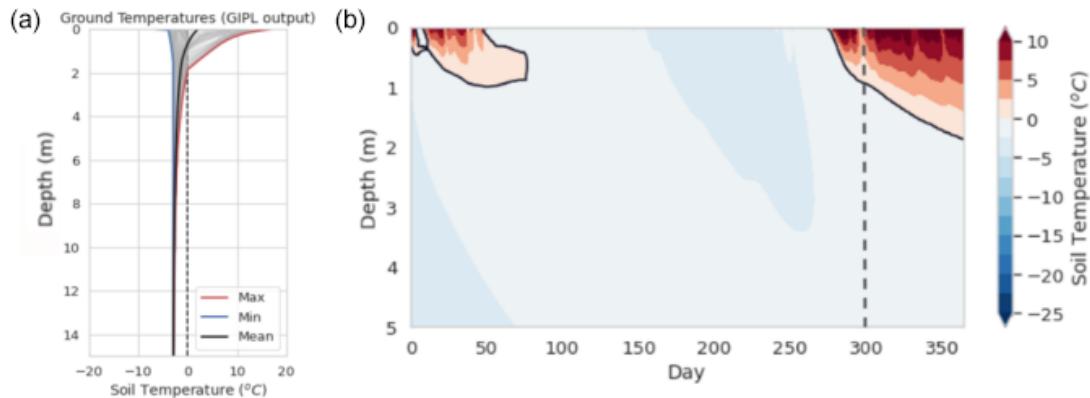
**Figure 10.** Simulation results of the combined snow and soil temperature model over the water year from October 2020–October 2021. Panel (a) shows soil temperature as a function of depth, with even maximum temperatures below  $\sim 2$  m depth never reaching above  $0^{\circ}\text{C}$ . Panel (b) shows soil temperatures with depth at the Chaos Canyon landslide across a single water year. This result mirrors the depth of the active layer shown in (a). The dashed vertical line is 28 June. Note that the days are based on zero as 1 October, the start of the water year.

The presence of permafrost conditions (Fig. 10) in the pre-collapse deposit opens the possibility that ice occupied interstitial spaces between clasts (Kenner et al., 2017; Eriksen et al., 2018). If a continuous ice layer was present within the pre-collapse deposit, snowmelt may have been channeled to

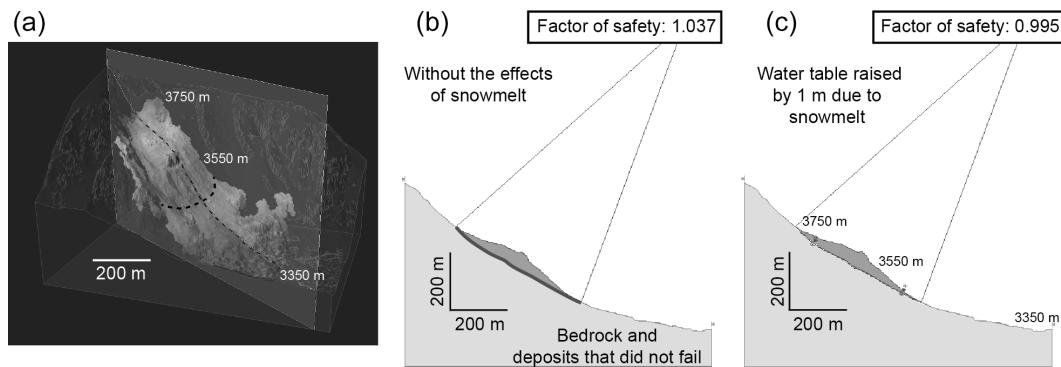
**Figure 11.** Output from limit equilibrium slope stability analysis. (a) View of the pre-collapse topography in three dimensions. The pre-collapse deposit is shown in gray. See Fig. A6 for a color version. The thick dashed line represents the lower edge of the piece of the deposit that failed on 28 June, which is also shown in (b) and (c). The thin dashed line shows the cross section also shown in (b) and (c). (b) Limit equilibrium analysis showing the global minimum slip surface and factor of safety for the simulated pre-slide deposit (purple) using the program Slide2. The failure surface (see the red line) is located at the transition between the purple body that moved during the collapse and the underlying material. (c) Limit equilibrium analysis showing the global minimum slip surface and factor of safety for the simulated pre-collapse deposit with the effects of a water table 1 m above the contact between the pre-collapse deposit and the underlying bedrock.

To explore the role of snowmelt as a potential trigger of the landslide, we simulated a slight rise in the water table within the pre-collapse deposit. We expect that a basal shear plane is well developed at the base of the pre-collapse deposit because the landslide has been accelerating and has undergone large displacements (Figs. 5 and 6). The inclusion of this wa-

ter table reduced the resistive forces in the system, leading to a global minimum factor of safety of 0.995 and thus failure of the landslide. The pre-collapse deposit thus appears to be highly sensitive to a reduction of normal stress associated with a rising water table, likely associated with spring snowmelt.

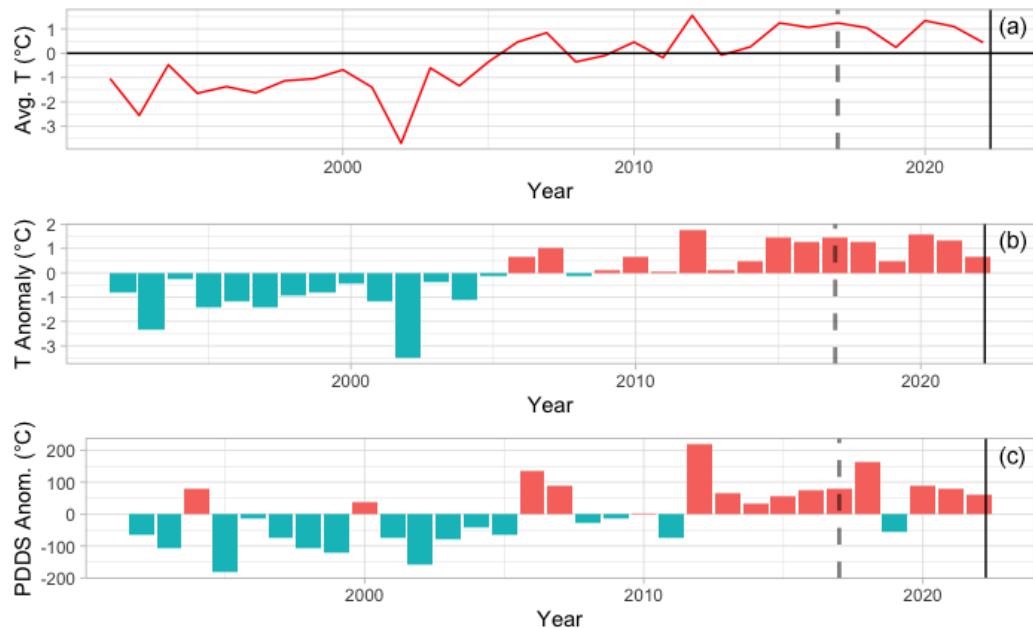
**Figure 12.** Temperature trends across the top of the Chaos Canyon landslide using the Bear Lake SNOTEL record and the calculated local lapse rate. Panel (a) shows average annual temperature from 1991 to the 2022, clearly showing a warming trend that begins in 2006. Panel (b) shows the annual temperature anomaly from the 31-year average; cooler colors correspond to a negative anomaly and warmer colors to a positive anomaly. Here, the warming is even more visible as a positive temperature anomaly consistent across every year after 2009. Panel (c) shows the PDDS anomalies calculated for the first 6 months of the calendar year for the past 31 years at the slide elevation (Braithwaite and Hughes, 2022). While the PDDS anomalies show more fluctuation than the other indicators, after  $\sim$  2012 the PDDS is mostly greater than in the preceding 21 years. Moreover, PDDS has been directly linked with snowmelt and is a closer proxy for potential melt that could penetrate the slide mass. The gray dashed line is the first date of image correlation data, and the dark black line is the failure date of the Chaos Canyon slide.

Temperature trends at the top of the landslide, approximated from the Bear Lake SNOTEL, show a clear warming signal across the past 3 decades (Fig. 12a and b), with a consistent positive temperature anomaly after 2009. Warming temperatures have been documented to correspond to landslides in both high-elevation and high-latitude landscapes, particularly where permafrost or ground ice is present (e.g., Cossart et al., 2008; Deline et al., 2021; Patton et al., 2019). Increased temperatures lead to permafrost thaw and decrease slope stability through either a change in the physical conditions of the slope (e.g., reduced cohesion) or hydrologic conditions (e.g., increased pore pressure and hydrologic conductivity; Patton et al., 2019).

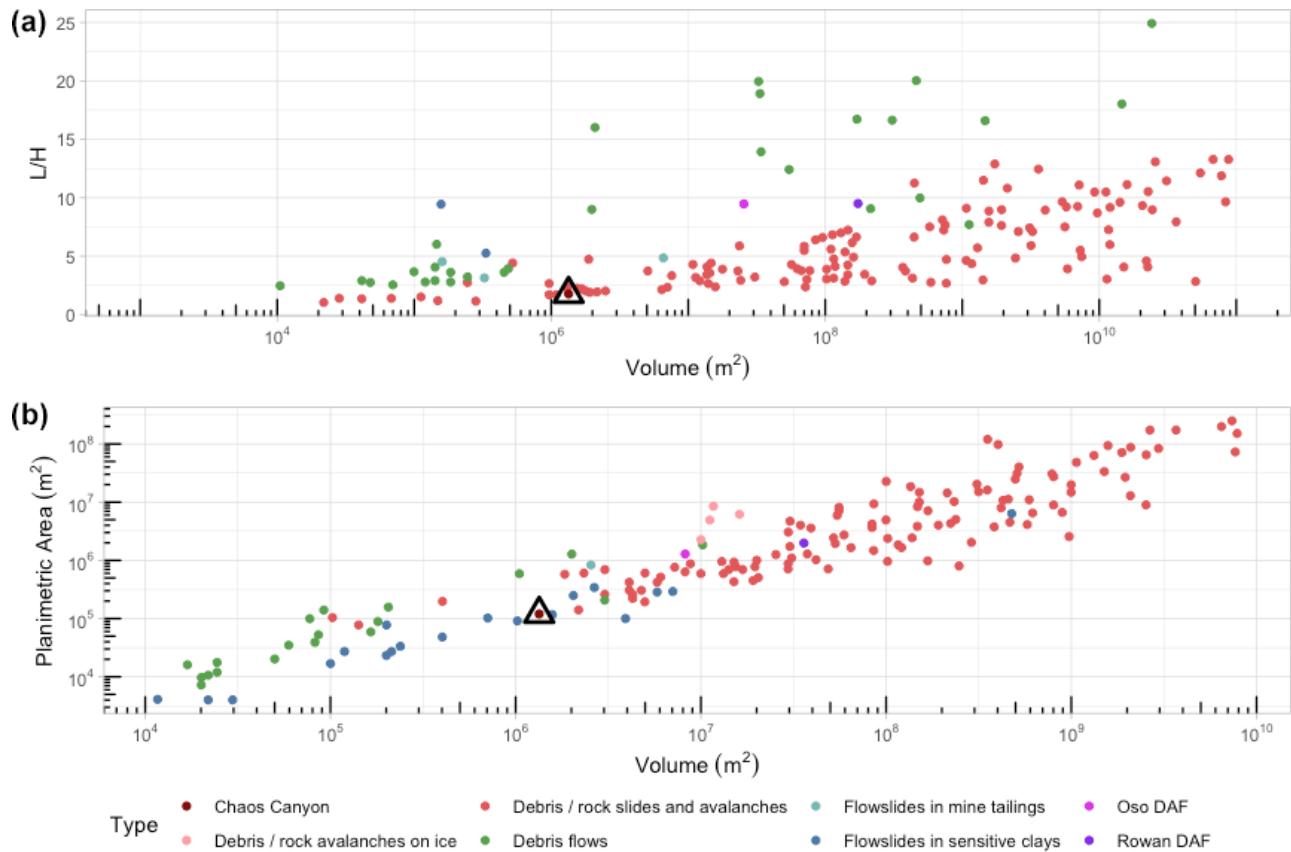
**Figure 13.** Landslide mobility indices. Panel (a) shows the commonly used maximum landslide travel path ( $L$ ) over landslide height ( $H$ ) versus landslide volume. The Chaos Canyon landslide (marked as a red dot with a black triangle) has a low  $L/H \approx 1.8$  and falls within the field of other debris slides, rockslides, and rock avalanches (Iverson et al., 2015). Panel (b) shows that the Chaos Canyon landslide inundated an area consistent with a power-law relationship between landslide area and volume, as discussed in Griswold and Iverson (2008).

any given source area (Iverson et al., 2015). Several studies have also shown a positive relation between the volume of mobilized material ( $V$ ) and the mobility index ( $L/H$ ). A compilation of this mobility index versus landslide volumes is given in Fig. 13a. The Chaos landslide has a mobility value of  $L/H \approx 1.8$  and fits within ranges of earlier documented rockslides of similar volumes (Fig. 13a). The total inundated area of the Chaos landslide ( $\text{m}^2$ ) also follows earlier documented trends between landslide extent and volume (Fig. 13b). An alternative mobility index for landslides is calculated as  $A/V^{2/3}$ . The mobility coefficient for the Chaos landslide of  $A/V^{2/3} \approx 10$  is at the lower end of earlier documented mobility values of high-mobility landslides (Gris-

wold and Iverson, 2008). Landslides with very high mobility coefficients are debris flows on ice or landslides in very wet environments where basal liquefaction plays a role (e.g., the OSO landslide where  $A/V^{2/3} \approx 30$ ; Iverson et al., 2015). The lower value of  $A/V^{2/3}$  for the Chaos landslide indicates limited mobility where ice and water probably played a minor role in controlling landslide runout. However, this does not mean that the changes in internal ice and water were not potential contributory factors to the 28 June collapse. Perhaps this landslide would have been more mobile if it had collapsed prior to the observed warming we document (Fig. 12), which was likely paired with a decrease in interstitial ice.

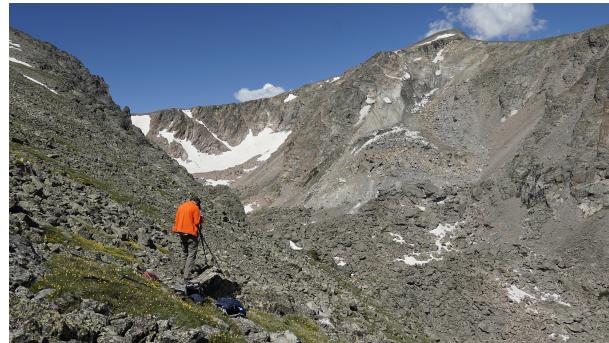
**Figure A1.** Photo of the slide taken from south-southwest during the SfM survey – 1 week after the collapse. Photo credit: Benjamin Lehmann.

The Chaos Canyon landslide sits above the treeline in the alpine reaches of Rocky Mountain National Park (Fig. A1). The pre-collapse landslide extended from  $\sim 3450$  to  $\sim 3660$  m in elevation. Based on pre-collapse satellite imagery, the landslide is a diamictite, composed of grains ranging from fine sediments to large boulders ( $\sim 10$  s of m). The slide occurred along the contact between the middle Proterozoic Silver Plume Granite and the early Proterozoic biotite schists (Fig. 2) with a moderate foliation dipping to the southeast and toward Chaos Canyon (Braddock and Cole, 1990). A deposit in the bottom of Chaos Canyon was mapped by Braddock and Cole (1990) and Johnson et al. (2021) as a poten-

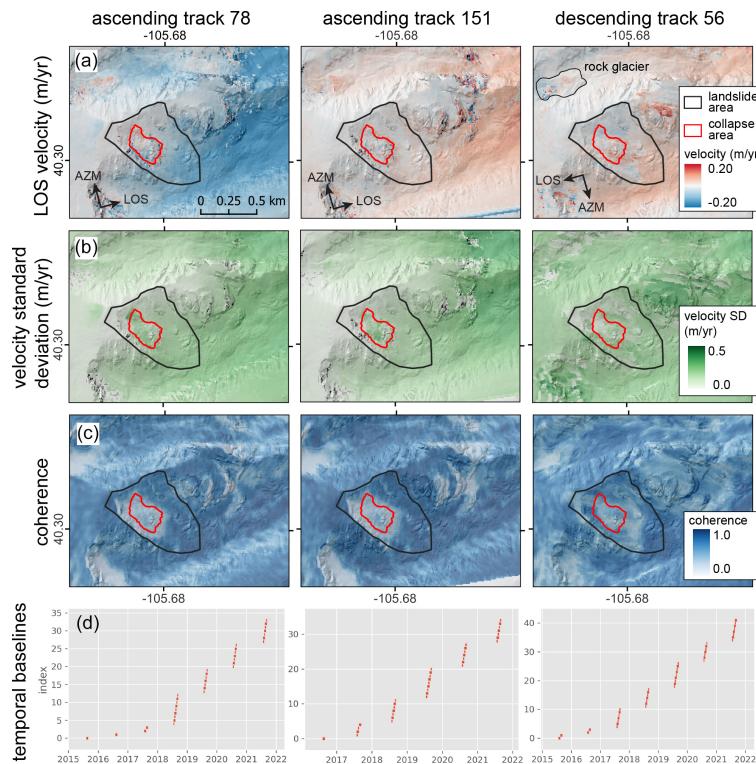
**Figure A2.** InSAR-derived median LOS velocity of the landslide feature prior to catastrophic failure. Sentinel-1 interferograms from ascending track 78, ascending track 151, and descending track 56 with short temporal baselines and high median coherence on the landslide slope were used to create each velocity map. **(a)** Median LOS velocity of the landslide feature and surrounding area. Positive values (red) correspond to motion away from the satellite along the satellite LOS. Note the spatial inconsistency of signals within the landslide. Apparent topography-correlated displacements are caused by atmospheric noise. **(b)** Standard deviation of median LOS velocity. **(c)** Median coherence of the landslide feature and surrounding area. Coherence is related to the similarity of scatterers in the images that form our interferograms. Note the low coherence over the landslide feature, which indicates that the surface of the feature is changing appreciably. **(d)** Temporal baselines of all available 6, 12, and 24 d Sentinel-1 interferograms from late summer. Each bar spans the temporal baseline of a single interferogram, beginning and ending at the primary and secondary acquisition dates.

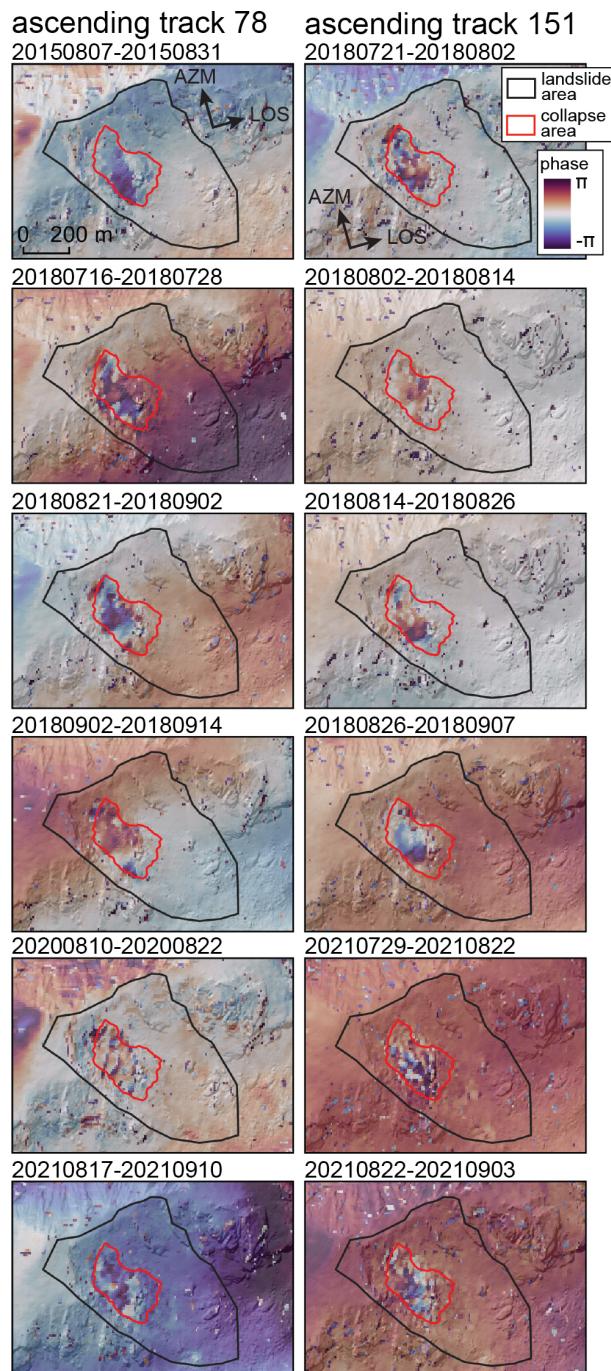
**Figure A3.** Wrapped short-baseline interferograms showing clear evidence of landslide displacement. Displacements more than twice the radar wavelength, as shown here, result in errors during unwrapping. The displacement signal is not as clear in other interferograms due to strong atmospheric noise and/or low coherence of the moving area. Interferograms (left) from ascending track 78. Interferograms (right) from ascending track 151.

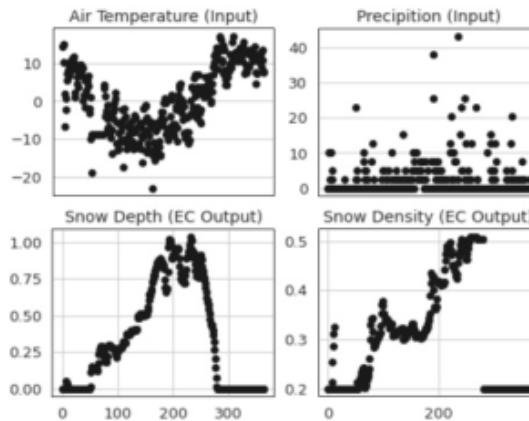
**Figure A4.** Simulation results of the combined snow and soil temperature model over the water year from October 2019–October 2020. Daily air temperature and precipitation inputs are derived from correcting and extrapolating the lower-elevation meteorological station at Bear Lake, RMNP. Snow depth and density are modeled by the snow model and are subsequent input for the GIPL heat conduction model.

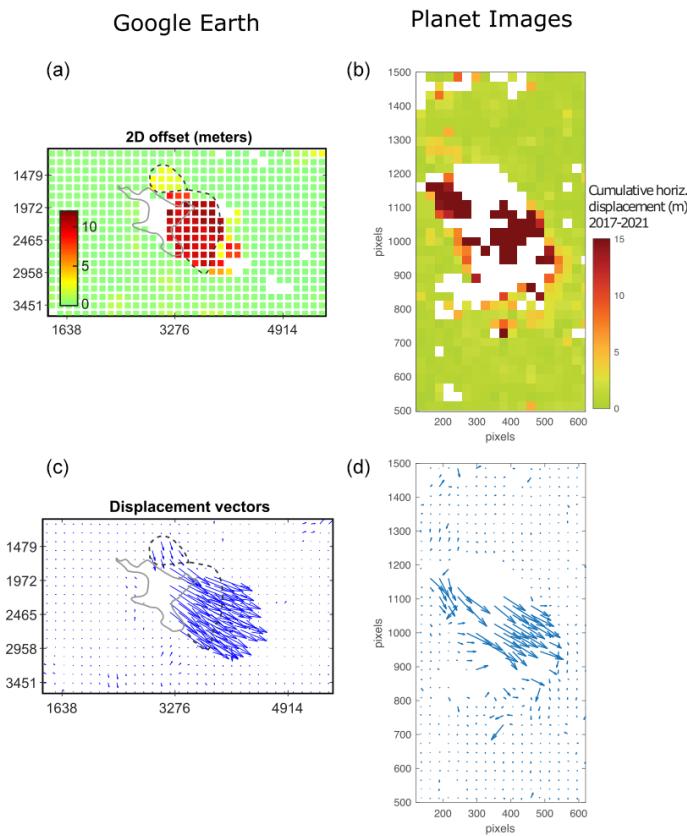
**Figure A5.** Direct comparison between pixel-tracking methods. Note that the Google Earth results are from 2 years of comparison; the Planet imagery includes multiple years of imagery. Panels (a, c) show the Google Earth method, tracking horizontal displacements over the Chaos Canyon landslide. Panels (b, d) show the Planet-imagery-based pixel-tracking results. While there are some differences between the results given, the different frames used, and different snowpack positions, overall the results are quite similar, with the Planet images providing more frames across multiple years than the Google Earth images.

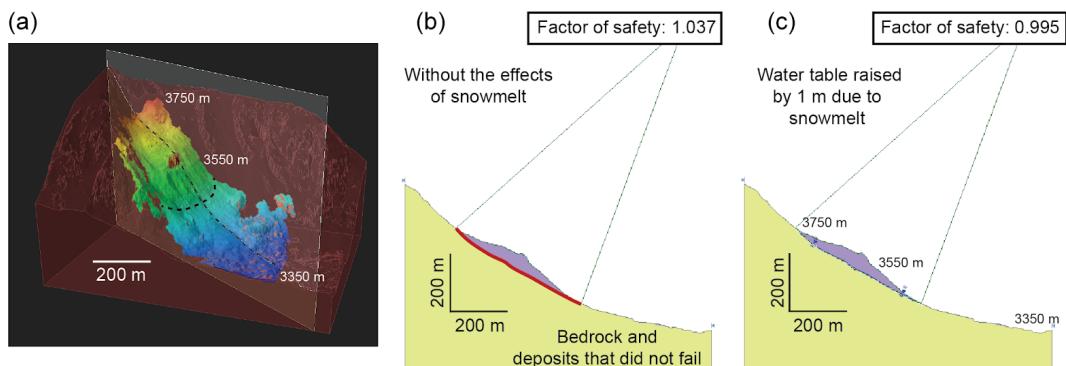
**Figure A6.** Output from limit equilibrium slope stability analysis. (a) View of the pre-collapse topography in three dimensions. The pre-collapse deposit is shown in red, yellow, and blue. The thick dashed line represents the lower edge of the deposit that failed, which is also shown in (b) and (c). The thin dashed line shows the cross section also shown in (b) and (c). (b) Limit equilibrium analysis showing the global minimum slip surface and factor of safety for the simulated pre-slide deposit (purple) using the program Slide2. The failure surface (see the red line) is located at the transition between the purple body that moved during the collapse and the underlying material. (c) Limit equilibrium analysis showing the global minimum slip surface and factor of safety for the simulated pre-collapse deposit with the effects of a water table 1 m above the contact between the pre-collapse deposit and the underlying bedrock.

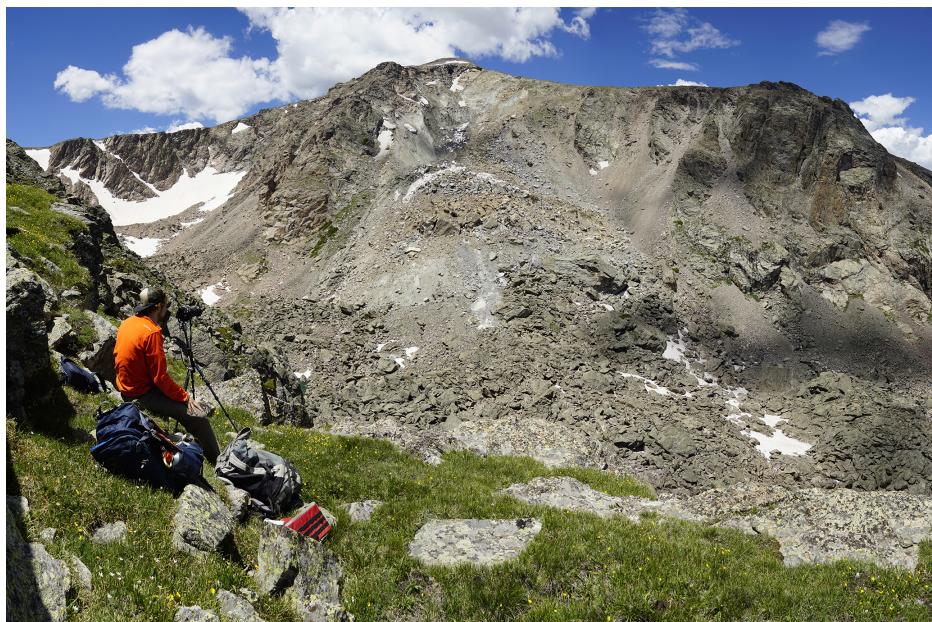
**Figure A7.** Photo of the slide taken from south-southwest during the SfM survey – 1 week after the collapse. Photo credit: Benjamin Lehmann.
