Scalable approach to create annotated disaster image database supporting AI-driven damage assessment

Abstract

Keywords Hurricane · Hurricane damage assessment · Component-level damage · Deep learning · Object detection

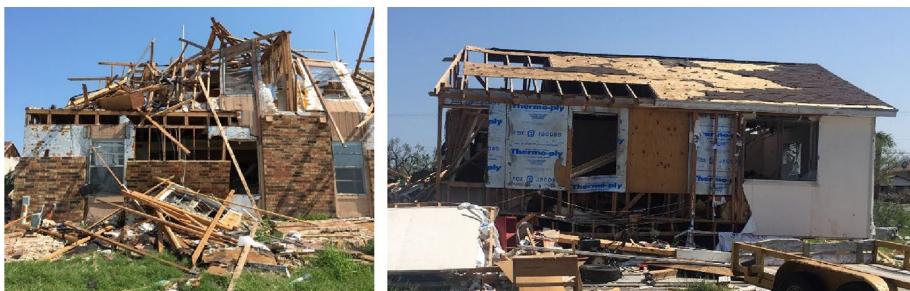
Fig. 1 Complex and unique damage patterns from destroyed buildings, post-Hurricane Harvey

In addressing component-level damage assessment, the precision required to analyze specific structural elements—like windows, doors, roofs, and walls—presents notable challenges. Traditional CNNs, including advanced variants like Mask-RCNN (Inc 2018), can effectively detect general damage to a building. However, identifying specific, intricate damages such as a cracked windowpane or dislodged roof tiles demands a level of detail and sensitivity beyond what general detection provides. Shadows, occlusions, and the heterogeneity in building design, materials, and orientation further complicate the task, making certain damages difficult to distinguish. Moreover, the feasibility of creating a comprehensive training dataset that covers the extensive range of possible damage patterns, especially in severely damaged buildings, becomes a significant limitation. Severely damaged structures often exhibit unique and irregular damage patterns, as depicted in Fig. 1,

where buildings are near collapse with leaning walls and scattered roof beams. Such variability and unpredictability in damage patterns pose a substantial challenge for traditional CNN architectures, emphasizing the practical limitations in preparing datasets that can accurately represent every possible scenario of post-disaster damage.

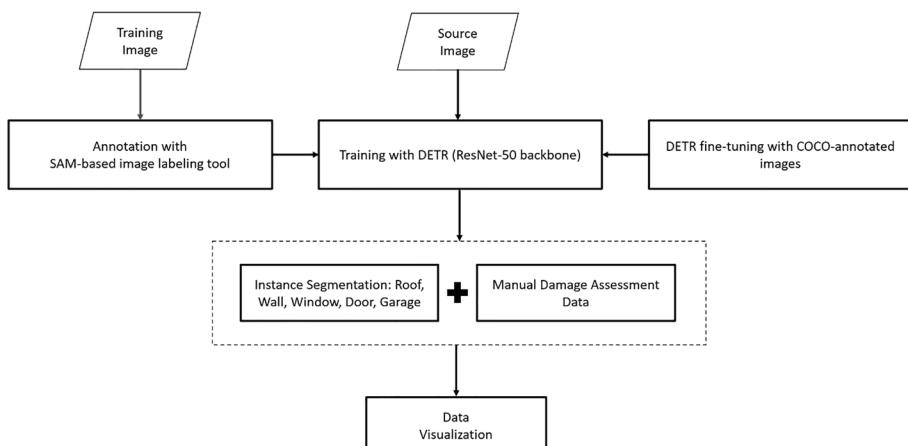
Fig. 2 Overall workflow

As illustrated in Fig. 2, the workflow begins with preparing training image data. This involves the collection of a diverse array of RGB images showcasing hurricane-induced building damage, each sized at 1080×810 pixels. These images form the bedrock for training the model to identify and outline various objects precisely. After data collection, the Segment Anything Model (SAM), a pre-trained instance segmentation model, is utilized for annotating the images, thereby ensuring efficient and high-precision labeling in readiness for the next phase. The model's core is powered by DETR (Detection Transformer), integrated with a ResNet-50 backbone, chosen for its robust object detection capabilities, blending the strengths of transformer models with deep residual networks. Training and validation data loaders are prepared to supply the model with annotated images, formatted in alignment with the COCO dataset standards, a prevalent format for object detection tasks. The DETR model undergoes fine-tuning to detect building components damaged by hurricanes. This process adjusts the pre-trained DETR model, initially trained on the COCO dataset, to accommodate the unique dataset and labels pertaining to hurricane damage assessment. The final step integrates the processed images with manual damage assessment data. A simple label-matching script facilitates the overlay of manual damage assessments onto the segmentation masks, achieving a comprehensive visualization. This

integration is carried out to produce a holistic visualization, with the output layer dimensions specified, ensuring a detailed representation of the damage assessment.

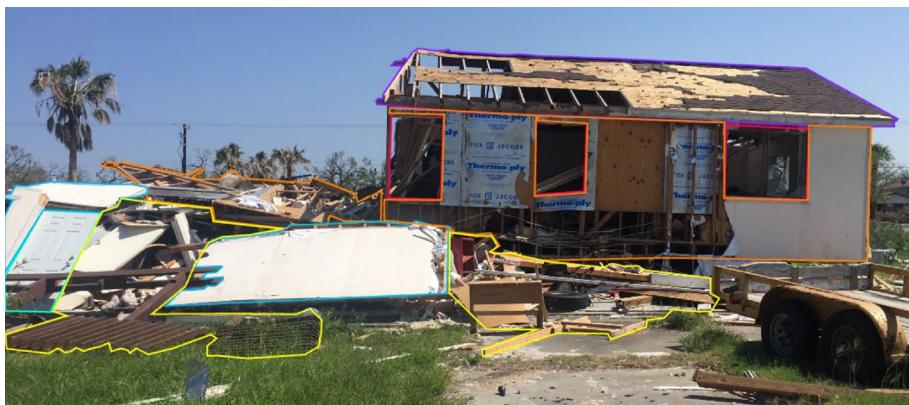
Fig. 3 Example of SAM-based image labeling

A Python-based script utilized with LabelMe (Wada 2021) was developed for the SAM-based image labeling inspired by Roboflow (Skalski 2023). Once an image is loaded, the user can draw a rectangle around any object they are interested in. The tool then automatically masks the area inside that rectangle and emphasizes the one critical identifiable object. Finally, it displays the original photo with the highlighted area and another version focusing on just the shaded object, allowing users to see the details clearly. If necessary, the generated mask can be edited before assigning a label. This process can be repeated until the mask has been generated and labeled to all desired objects in the image (Fig. 3).

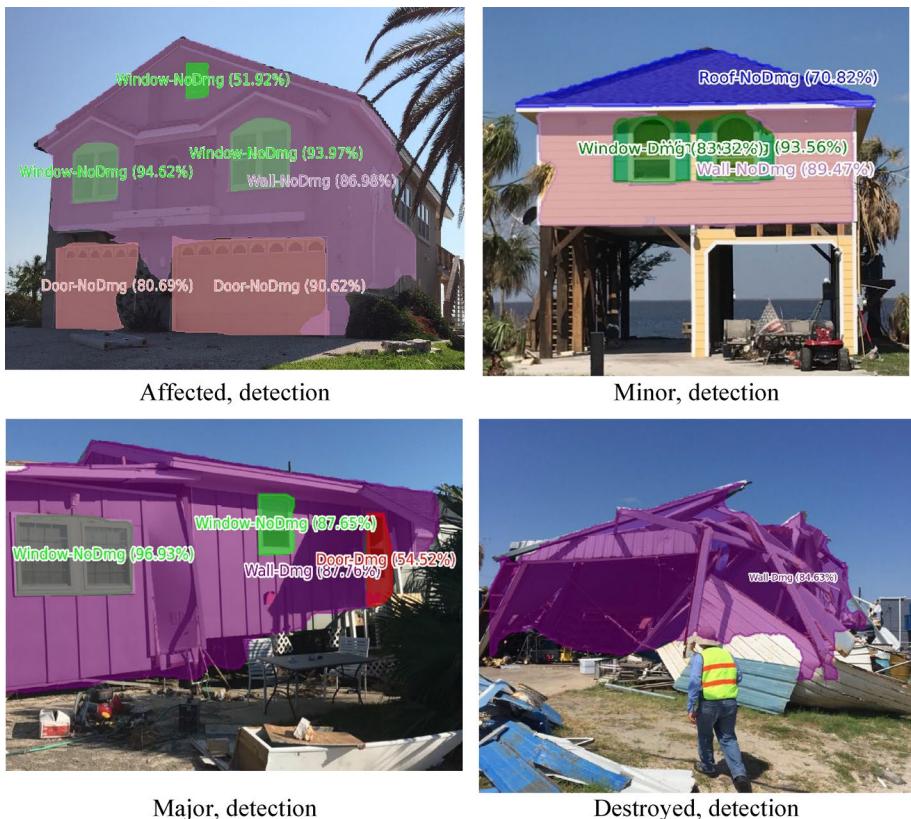
Fig. 4 Examples of damaged building component segmentation results

The source images, prior to processing, were grouped into four FEMA-defined damage categories to facilitate a nuanced evaluation of the model's detection capabilities (FEMA 2016). This categorization was employed to stratify the images according to the overall damage extent for comparison purposes, not as a direct part of the training dataset preprocessing. The categories are as follows: (1) Affected: Homes where damage is predominantly cosmetic; (2) Minor Damage: Homes with repairable non-structural issues; (3) Major Damage: Homes with structural impairments or other significant issues necessitating extensive repairs; and (4) Destroyed: Homes deemed a total loss. The test results depicted in Fig. 4 reflect the model's varying degrees of effectiveness in detecting component-level damage.

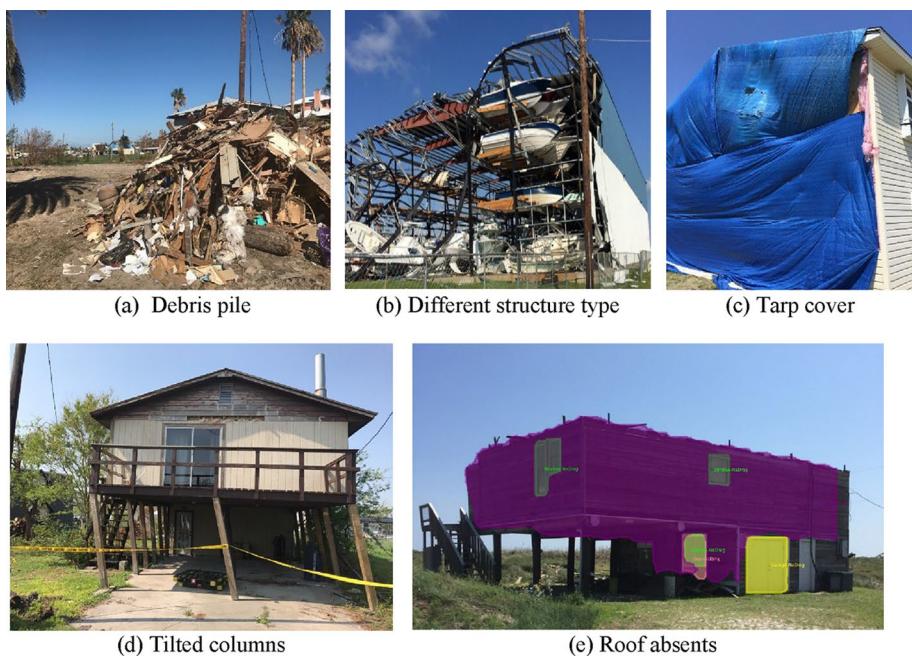
Fig. 5 Key challenges in automated damage assessment

- Data bias: Given that the vast majority of the training data originates from residential buildings, the detection process struggles with structures of a distinct type. For instance, Fig. 5b displays a damaged boat rack, which fundamentally differs from the training data. Consequently, damage detection on such datasets warrants re-evaluation. While the training data predominantly features exposed wooden structural components, a boat rack mainly consists of steel columns and beams.

- Obscured damage: Post-disaster structures are often shielded with blue tarpaulins (Fig. 5c) to prevent further damage. Such measures obscure the extent of building damage, rendering them unsuitable for detailed component-level damage assessment.

- Classification blind spot: Some structures display tilted or misaligned columns (Fig. 5d) due to the lateral forces exerted by hurricane events, greatly compromising their integrity and stability. However, some of these buildings may be mistakenly classified as undamaged, given the absence of labeled classes for tilted columns. Separate training

- Component absence challenge: The algorithm might identify buildings with walls and windows that seem structurally intact. Yet, a missing roof (Fig. 5e), evident from top-down analysis, signals considerable damage, emphasizing the necessity of a holistic assessment method. The complete absence of a component poses significant challenges in damage evaluation. This issue is among the most daunting in automated damage assessment, as specialized models are needed to distinguish missing elements—easily spotted by human observers but potentially overlooked by detection algorithms.
