## A hybrid model for post-earthquake performance assessments in challenging contexts

**Keywords** Haiti · Earthquake reconnaissance · Damage assessment · Housing · Vernacular architecture

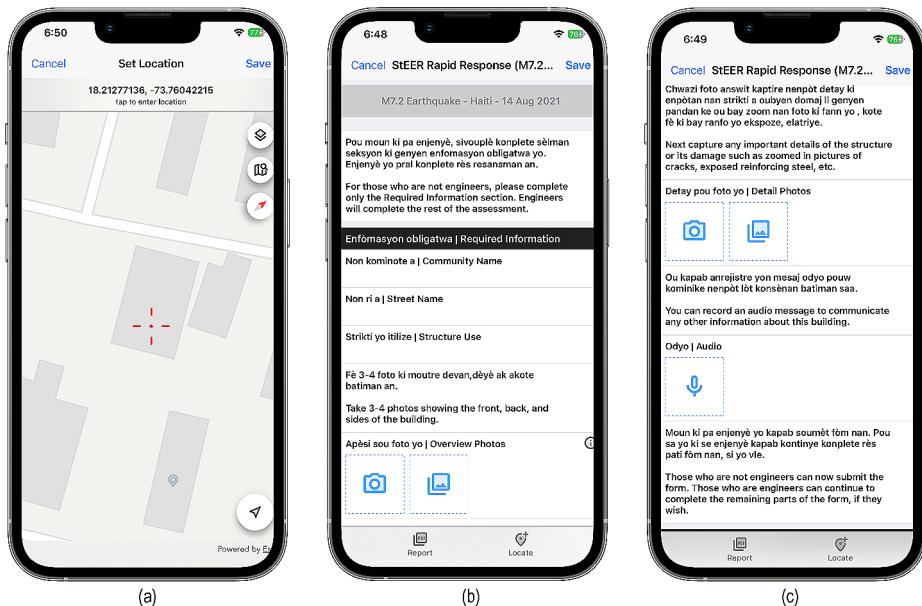
**Fig. 1** Screen captures of mobile app supporting tasks paraskilled to local data collectors: (a) geolocation using Open Street Maps (red cross is geolocation), (b) supplying general information and overview photos, (c) capturing detailed photos of damage and audio recordings

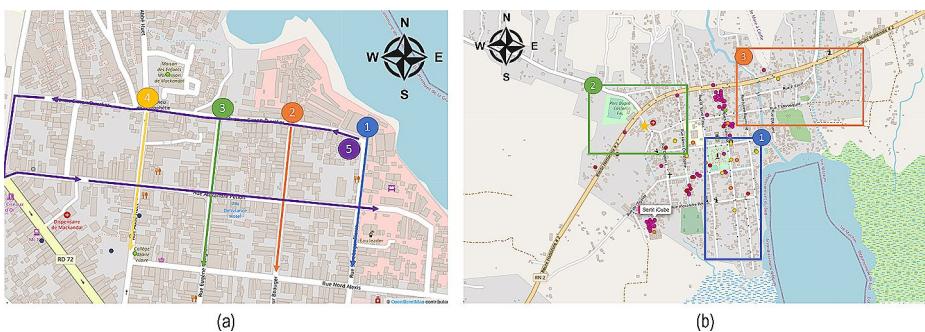
**Fig. 2** Examples of maps communicated daily to field data collectors to define the **(a)** route or **(b)** zone each team member should sample along/within for that day. Example **(a)** is from Jeremie (urban zone) and **(b)** Aquin (peri-urban zone)

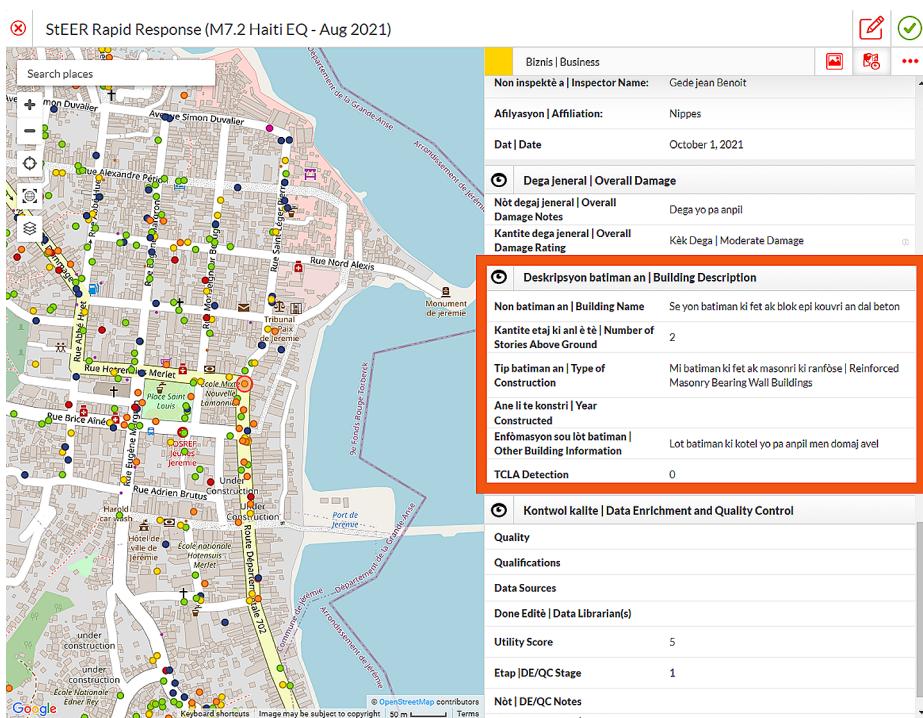
**Fig. 3** Screen capture Fulcrum record editing interface showing the map view and box highlighting fields to be updated by expert assessors. Pressing the pencil logo in the upper right corner allows fields to be edited

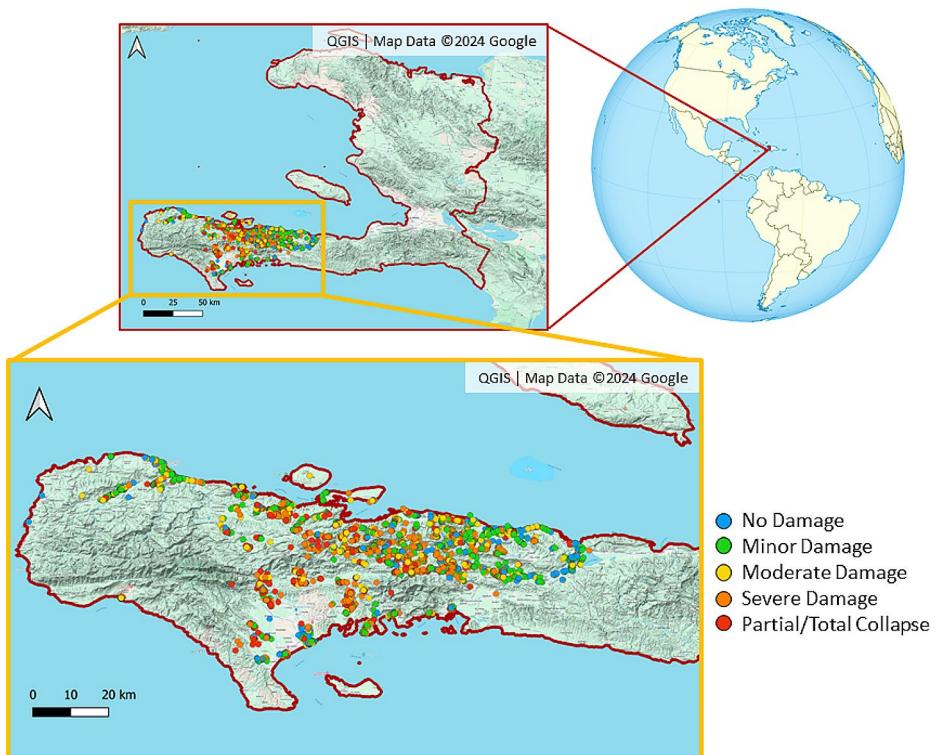
**Fig. 5** Geospatial distribution of rapid assessments completed following the 2021 Haiti earthquake, color coded by assigned damage rating

This hybrid rapid assessment created records for 12,699 buildings between 20 August and 29 October 2021, which were reduced to 12,536 following quality assurance processes. Records in Fig. 5 cluster around the major population centers in the three surveyed departments. Another notable cluster of records in the Sud Department, near the town of St. Louis du Sud, documented all buildings within a fixed radius of the one ground motion station that was operational at the time of the earthquake. By adopting a lightweight rapid assessment for the first wave of data collection, teams were able to move swiftly to capture perishable data despite the challenging conditions created by obstructed roads, gas shortages and unrest. Records in Sud and Nippes departments were acquired between 20 August and 8 October 2021, and in Grand'Anse from 28 September to 29 October 2021. At its peak, the effort leveraged 40 local data collectors per day and produced an open data set that ultimately reached areas that official government-affiliated assessment teams confined to primary and secondary roads could not.

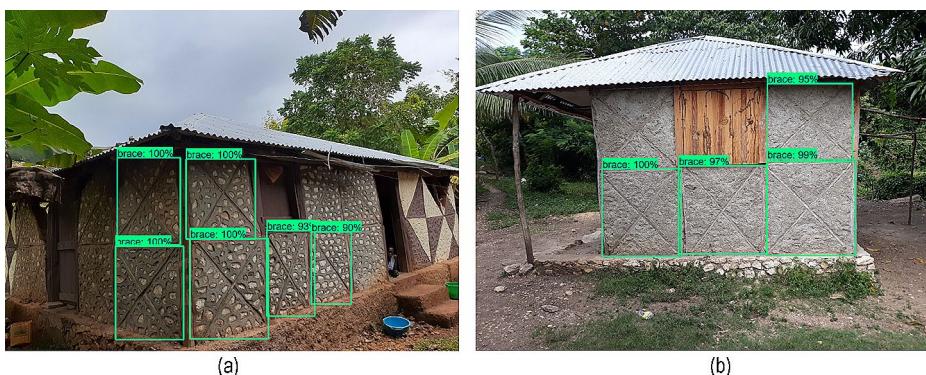
**Fig. 6** Examples of bounding box detection with prediction confidence on two TCLAs homes; home on the left is unfinished with braces clearly visible but braces can even be detected on the stuccoed home on the right

Brace detections are denoted by a bounding box and are evaluated by their level of confidence (see Fig. 6). As the goal was to maximize the number of TCLAs retained for detailed analysis by humans, we opted to relax the confidence threshold (set at 50%) and created a post-processor to flag a record as “possible TCLAs” whenever one or more unique bracing elements were detected in that image at a minimum of 50% confidence. A separate database of 61 images collected in Haiti after the 2021 earthquake as part of the USGS for Did You Feel It benchmarking (Kijewski-Correa et al. 2022) were manually labeled and used as a validation set. Manual labeling considered both NGO-constructed TCLAs as well as local replications of TCLAs by households. The TCLAs classifier achieved an accuracy of 66%, with 34% of ground truth positive images falsely classified as non-TCLAs, owing in part to the generous confidence threshold adopted.

False negatives were often due to the lack of color contrast between the stone infill material and the wooden bracing elements, as structures with distinct color gradients were successfully classified. Additionally, surface imagery captured by field data collectors in the Fulcrum database were not always level, resulting in a rotation of the brace plane or photos captured at an isometric angle, which often resulted in false negatives. These detection fail-

ures can be explained by the fact that the training set was derived from professional-grade photos of finished houses captured with level cameras positioned orthogonal to the front face of the building. Notably, most NGOs use paint to treat their wood posts and beams, adopting a fairly consistent painting scheme with a high color gradient between the paint on the wood posts and braces and the paint used for the infill. This training data was thus less likely to detect low-contrast TCLAs like those in Fig. 6. To ensure the model was robust to in-the-wild images taken at various angles and unpainted TCLAs, it was retrained for 20,000 additional steps with the 61 labeled images used in the prior validation. These photos were taken by the same field data collectors and were more representative of the diversity of image quality in the larger rapid assessment database. The refined model achieved an accuracy of 87% when adopting a minimum confidence threshold of 50%, with a false positive rate of 5.5%.

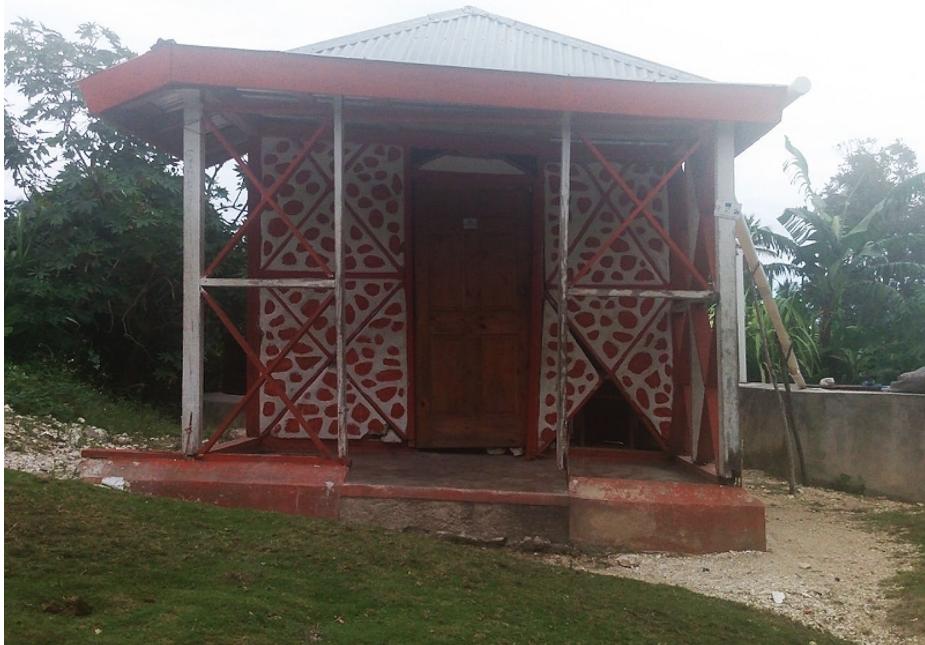
**Fig. 7** Example of TCLA with minor infill loss (Fulcrum ID: a39ea13e-050c-45bb-a557-7d4e6115c9e2)
