# Performance of Hurricane-Resistant Housing during the 2022 Arabi, Louisiana, Tornado

**Abstract:** Mitigating tornado damage remains a critical challenge for communities throughout much of the United States. Enhanced construction techniques typically used in hurricane-prone regions are often recommended as at least part of the solution, but the effectiveness of these techniques lacks empirical evaluation. This study investigates the performance of modern wood-frame residential structures in Arabi, LA, constructed to hurricane-resistant standards, that were impacted by a strong tornado on March 22, 2022. Field teams deployed beginning March 25, 2022, just three days after the tornado touched down, capturing perishable data on the building performance using vehicle-mounted surface-level panoramic cameras, forensic engineering investigations, and unmanned aerial systems. This paper describes the field deployments and identifies common failure mechanisms observed by the field teams. Analytical fragility functions are developed based on the load path observations and compared to empirical fragility functions generated from linking the building performance observations with wind speed

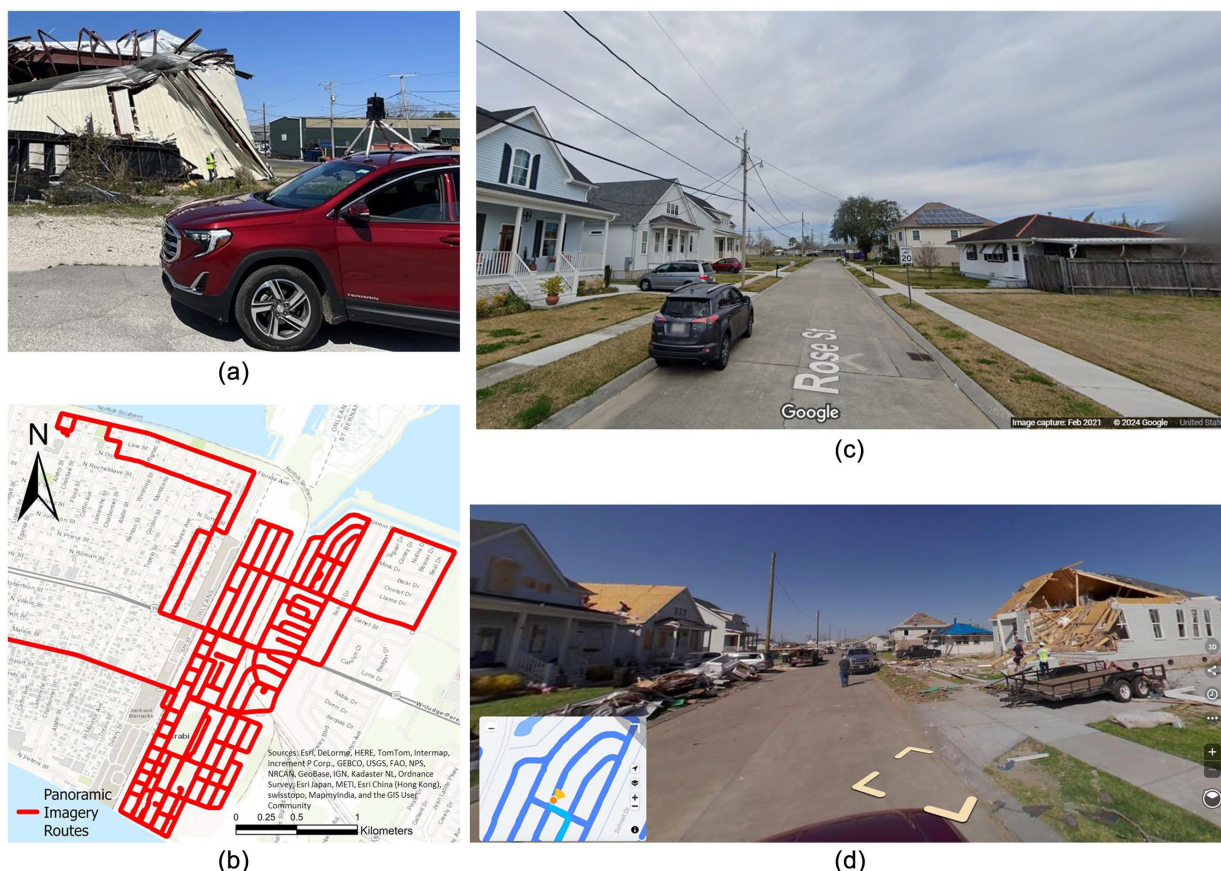
Fig. 1. Surface-level panoramas, including (a) the panoramic camera mounted onto a vehicle (image by Mariantonieta Gutierrez Soto); (b) coverage of the SLP in Arabi (sources: Esri, DeLorme, HERE, TomTom, Intermap, increment P Corp., GEBCO, USGS, FAO, NPS, NRCAN, GeoBase, IGN, Kadaster NL, Ordnance Survey, Esri Japan, METI, Esri China (Hong Kong), Swisstopop, MapmyIndia, and the GIS User Community); (c) before view of a street with heavy damage. Before imagery was sourced from the Google Streetview platform (captured in February 2021) (map data © 2024 Google); and (d) after views of a street with heavy damage, as captured by the SLP. The home with heavy damage visible in (d) was constructed after February 2021 and is therefore not present in the before imagery (image by authors).

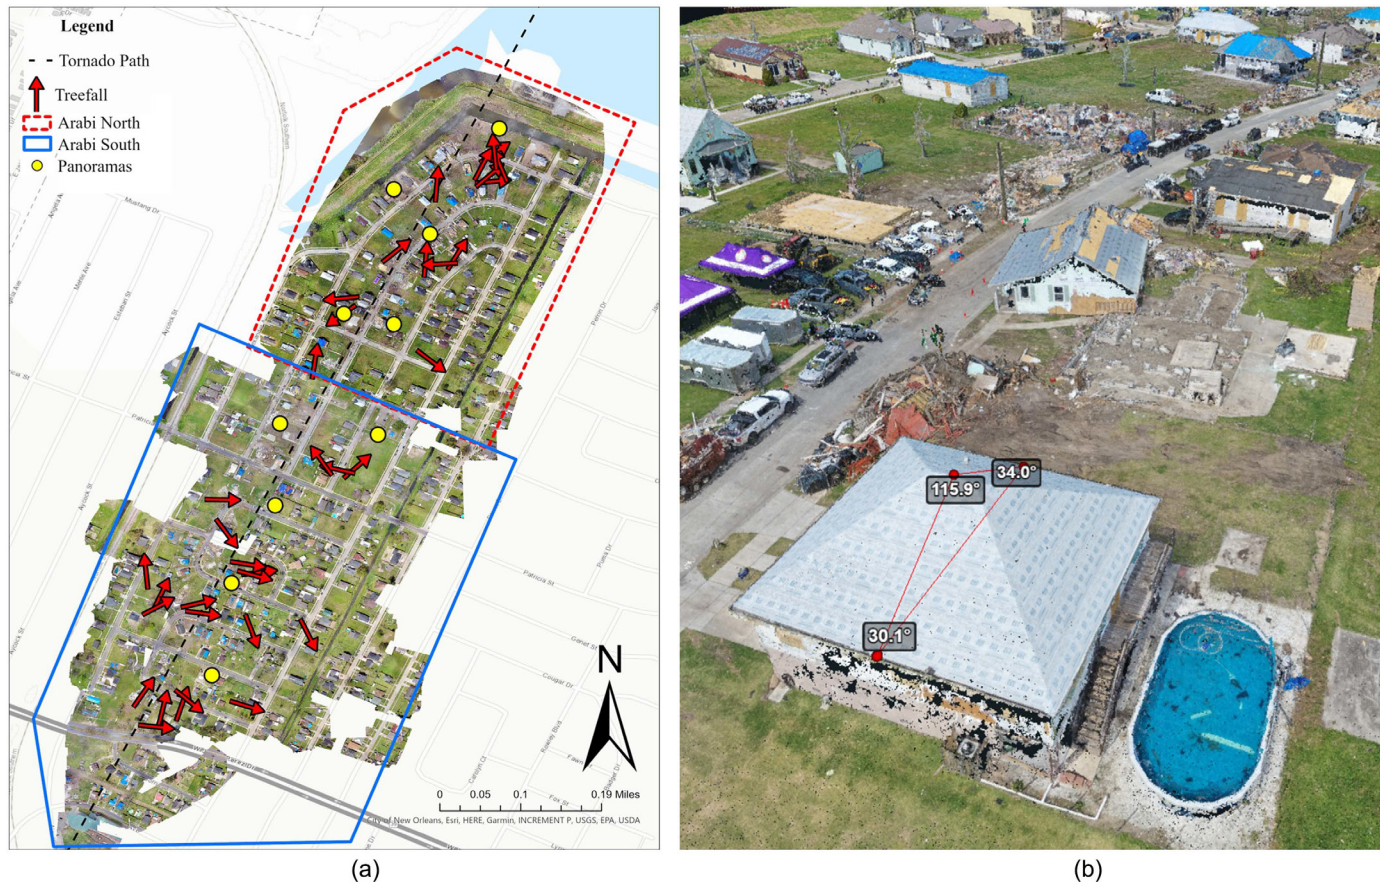
Fig. 3. UAS flights (a) preplanned flight area of the north (dashed line) and south (solid line) Arabi and locations of the additional panoramas (filled circles) (sources: Esri, City of New Orleans, HERE, Garmin, INCREMENT P, USGS, EPA, USDA); and (b) processed point cloud from the Arabi North flight with the ability to measure dimensions and other physical parameters (image by authors).

north (1,734 photographs) and south (1,321 photographs) sections (Fig. 3). Imagery was captured with two DJI Mavic Pro 2 at altitudes of 45 and 50 m, respectively. Panoramas (N ¼ 17) were also captured throughout the impacted area (Fig. 3). The high-resolution photographs captured by the UAS were suitable for the generation of orthomosaics in both the North and South sections with ground sample distances of 1.28 and 1.16 cm, respectively. The higher density of photographs in the North Arabi section, taken in a double-grid flight pattern, was also sufficient for the generation of a 3D point cloud using structure from motion techniques

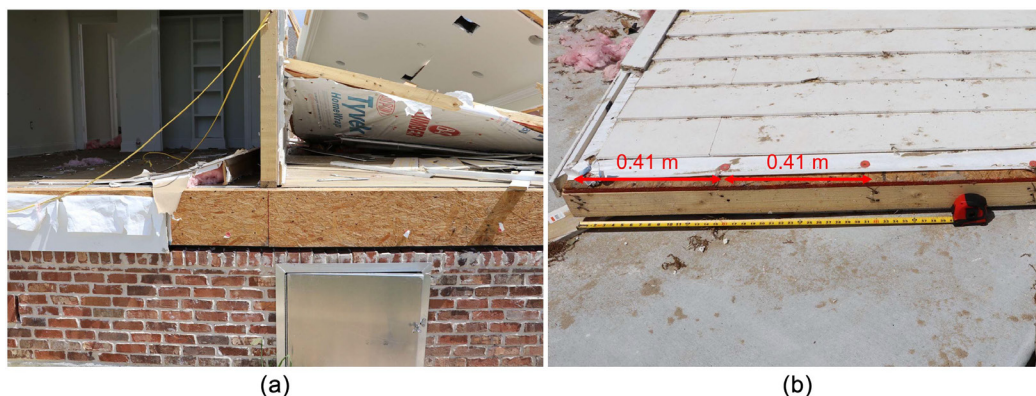
Outside of these foundation-specific failures, one of the prominent failure mechanisms was the failure of the wall structure at the bottom plate due to out-of-plane suction pressures acting on the wall surface (Fig. 9). The connection between the bottom plate and floor joists was observed to use (2) 12d nails (76 mm long by 3.25 mm diameter) spaced 0.3 m or 0.4 m apart depending on the floor joist spacing. In several homes, the weakness of this nailed connection was mitigated by continuously overlapping the wall sheathing across the exterior studs, bottom plate, and rim joist. However, in most cases, the sheathing was discontinuous across this joint, creating a structural fuse in the load path at this connection and contributing to premature failure.

Fig. 9. Local wall structure failures due to a discontinuity in the structural load path at the wall's bottom plate to floor connection caused by (a) wall sheathing not overlapping the join, and thus (b) sole reliance on the limited lateral capacity of the nailed connection between the bottom plate and floor structure. (Images by David B. Roueche.)
