# Structural performance and fragility assessment of elevated residential buildings during 2017–2018 hurricanes in Texas and Florida

Haitham A. Ibrahim<sup>a</sup>, Amal Elawady<sup>a,b,\*</sup>, David O. Prevatt<sup>c</sup>

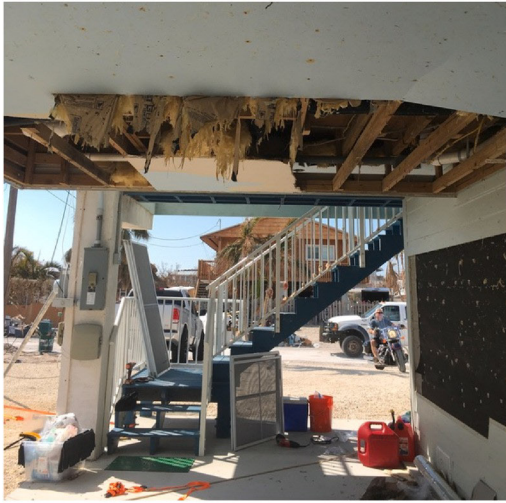
(a) Hurricane Irma

**Record ID:** 7acb1c1a-13ec-4308-a926-e5132ce6954b

**Damage mode:** Wind

**Estimated 3-sec WS:** 115.5 mph (51.6 m/s)

**Storm surge:** 1.2-2.4 m

**Fig. 7.** Cladding damage of the underside of elevated structures [22,24] (Source: NSF StEER on Fulcrum).

The difference between slab-on-grade and elevated structures is the existence of the underneath floor and the airgap between the floor surface and the ground. Fig. 7 shows typical damage observed on the underside of some of the surveyed structures during Hurricane Irma and Hurricane Michael. For each building, a record ID is provided to enable readers to access the source data and further investigate that specific case. According to the assessment teams, buildings in Fig. 7(a–b) were affected by wind damage only while buildings shown in Fig. 7(c–e) were subjected to combined wind and surge hazards. Damage to the underneath floor varies from a few panels at the edges [Fig. 7(a–b)] to damage concentrated around the corner column [Fig. 7(c–d)], then to complete loss of the underside panels, as shown in Fig. 7(e). The wind-induced damage to the underneath floor can be attributed to the high wind suction developed around the corners and edges of the floor of elevated structures as reported by Ref. [14]. Wind-induced damage to the floor is complex and progressive in nature because the failure of one cladding element leads to excessive changes in the net pressure on the remaining floor claddings and supporting structure. Damage can be even amplified if combined wind and surge hazards exist. Unfortunately, assessment teams did not report the number of elevated houses with damaged undersides which limited the authors of the current study from quantifying their wind performance. However, Kim et al. [16] reported that 28 out of 50 surveyed elevated structures (i.e., 56 %), impacted by Hurricane Michael, experienced floor cladding damage. To better assess the structural performance of underneath floors and facilitate evaluating their vulnerability, future reconnaissance efforts should consider documenting the floor damage of coastal elevated houses. Additionally, conducting computational fluid dynamic simulations for the combined impact of wind and surge hazards could be crucial for a comprehensive understanding of floor damage. The next sections provide more insights on the damage observations based on several controlling factors.

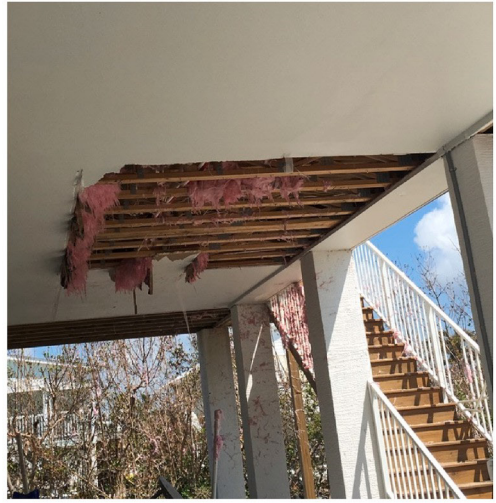
(b) Hurricane Irma

**Record ID:** 4a69021f-6544-44c1-96a6-682b2e7ef296

**Damage mode:** Wind

**Estimated 3-sec WS:** 112.3 mph (50.2 m/s)

**Storm surge:** 1.2-2.4 m

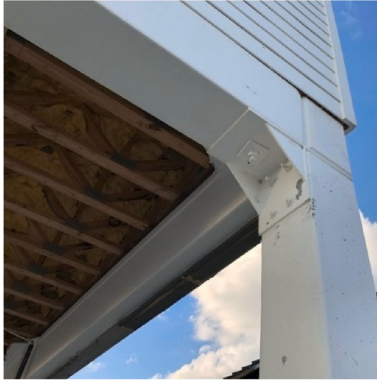
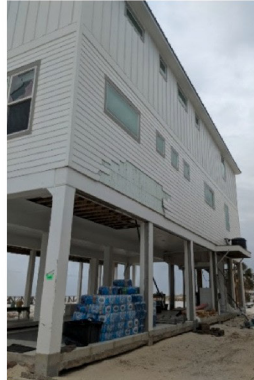
(c-d) Hurricane Michael

**Record ID:** 5707c2e0-471e-4a27-9e9e-4600fd6ade30

**Damage mode:** Surge, Wind, Wind-borne debris

**Elevation Height:** 3.2 m

**Estimated 3-sec WS:** 149.7 mph (66.9 m/s)

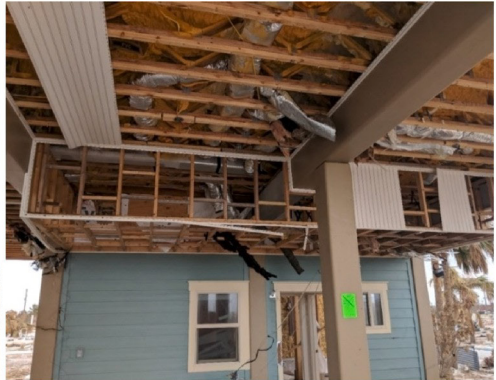
(e) Hurricane Michael

**Record ID:** 25261fab-e23f-4f19-b672-cbc7044c5868

**Damage mode:** Surge, Wind

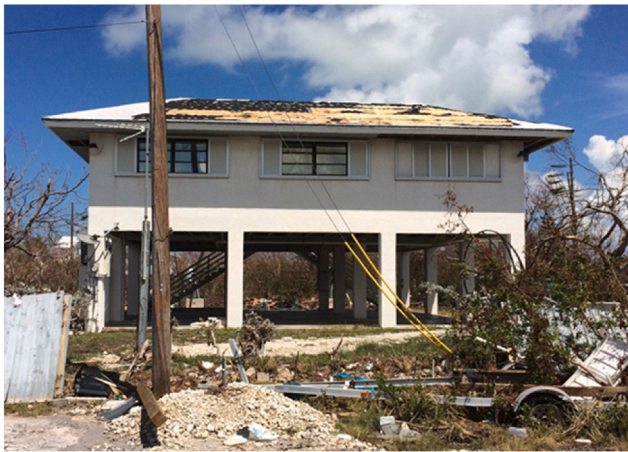
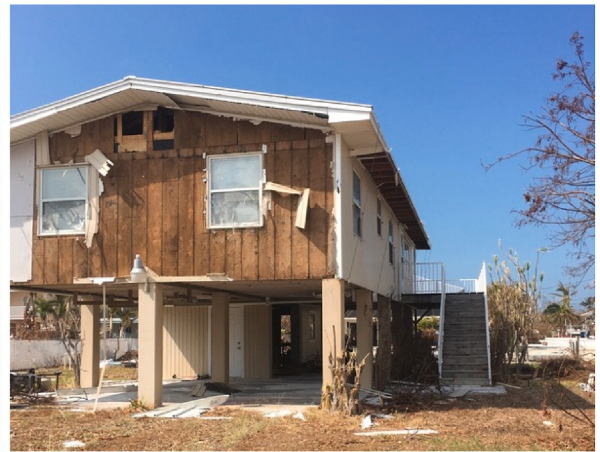
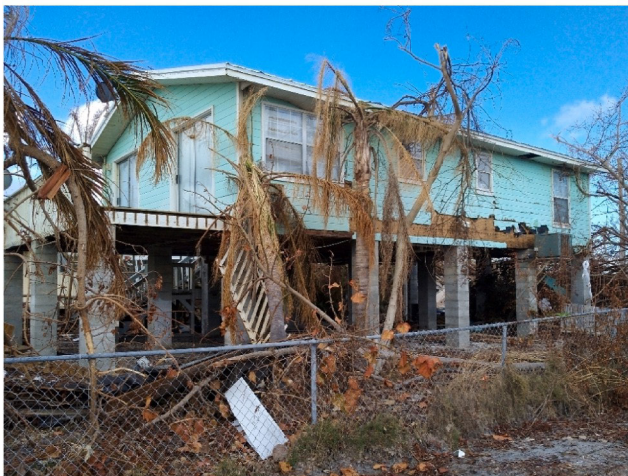
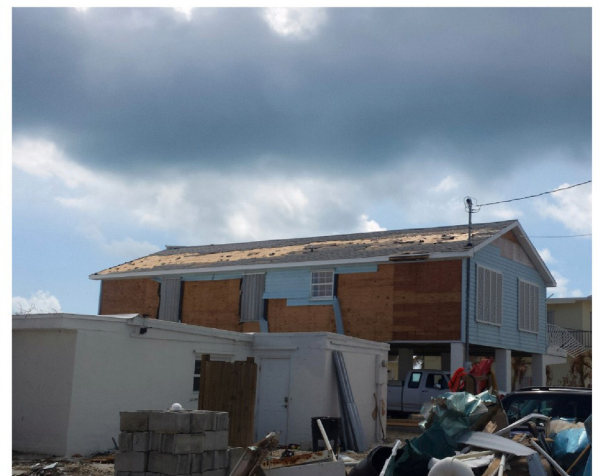
**Fig. 11.** Observed damage to walls with (a) Stucco claddings (estimated wind speed = 55 m/s), (b) Wood panel siding (estimated wind speed = 49.17 m/s), (c) Wood plank siding (estimated wind speed = 55 m/s), and (d) Vinyl siding (estimated wind speed: 45.6 m/s) [22].

Several types of wall cladding, such as vinyl siding, stucco, wood panel, and wood plank siding, have been used on the surveyed houses. Fig. 11 shows representative samples of the induced damage for walls with different cladding materials. At estimated wind speed of 123 mph (55 m/s), the elevated house with stucco claddings shown in Fig. 11(a) experienced minimal wall damage. On the other hand, two houses with wood panels and plank siding experienced more damage at estimated wind speed of 110 mph (49.17 m/s) and 123 mph (55 m/s) [see Fig. 11(b-c)], respectively. The elevated house shown in Fig. 11(b) lost almost 50 % of its wall claddings. Fig. 11(d) shows an elevated house with vinyl siding that lost almost 80 % of its wall cladding at an estimated wind speed of 102 mph (45.6 m/s). The distribution of wall cladding failures by cladding type is shown in Fig. 12 for both elevated and slab-on-grade houses. 63.0 % of elevated houses with vinyl siding experienced cladding failures. This percentage decreased to about 56 % for elevated houses with wood panels and plank siding. As can be seen in Fig. 12(a), the best performance for wall cladding is observed for elevated houses

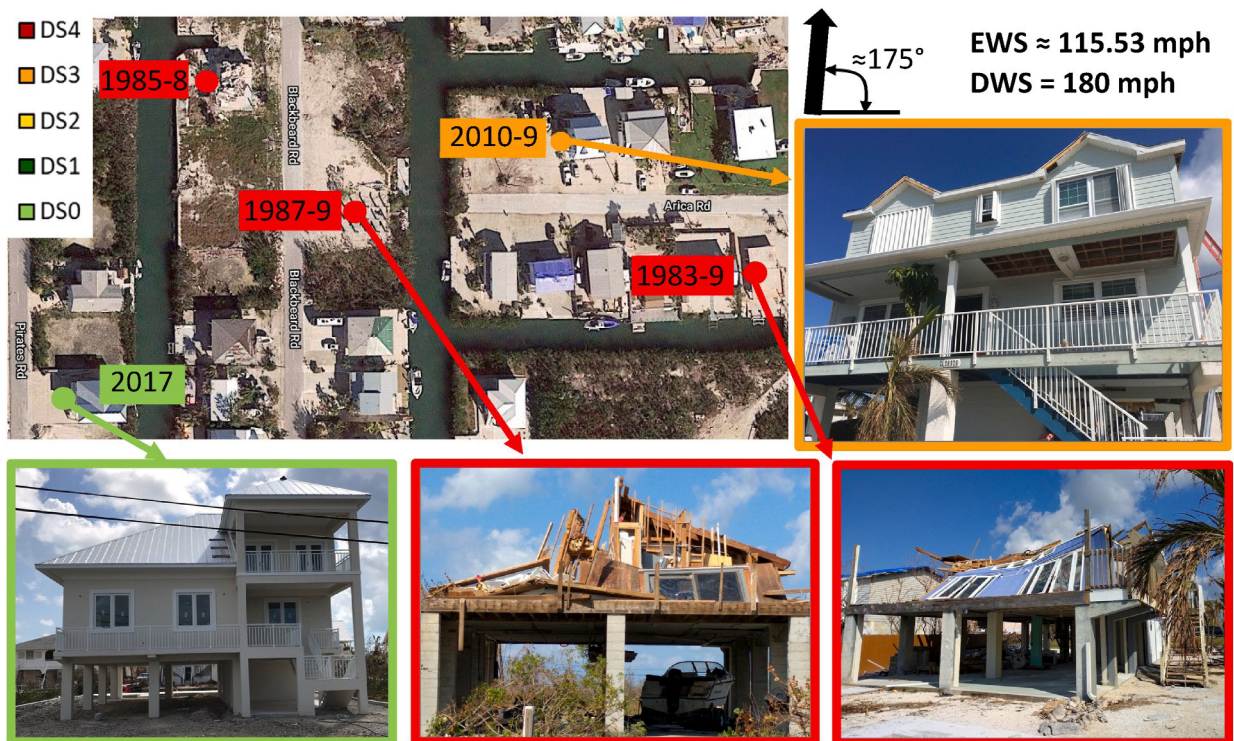
Fig. 14. Levels of wind-induced damage to construction in Little Torch Key, Florida, during Hurricane Irma with estimated wind speed (EWS)  $\approx 115$  mph (51.4 m/s) and current design wind speed (DWS) = 180 mph (80.46 m/s) [22] (Source: NSF STEER on Fulcrum).

By scrutinizing the data, it was found that the level of damage may vary significantly for houses in the same area that are exposed almost to the same wind speed with the same exposure and elevation height. For example, Fig. 14 shows an aerial image of the damage in Little Torch Key, Florida, during Hurricane Irma for five houses with the same elevation height. It should be noted that Fig. 14 is provided with the estimated wind speed from Hurricane Irma and the current design wind speed for this region, in addition to a black arrow indicating the wind direction. Moreover, for each house, a colored box is provided to show in which year the house was built, the first-floor elevation in ft, and the damage state based on the color. It should be noted that the year of re-roofing, whenever available, was used instead of the built year of the house. The houses in Fig. 14 experienced an estimated wind speed of 115 mph (51.4 m/s) which is lower than the current design wind speed for this region (i.e., 180 mph or 80.46 m/s). However, since these buildings were built in different years, such comparison may not be valid except for the house built in 2017. The design wind speed according to the South Florida Building Code [35] was at least 120 mph (53.64 m/s). Furthermore, the 3-sec design wind speed for the same region according to the (ASCE 7-05) is 150 mph (67.0 m/s). That is, these houses experienced estimated wind speed less than the design level corresponding to the construction year. While no damage was observed for the 2017 house, the 1987 and 1983 houses experienced complete structural failure for both roofs and walls. On the other hand, the 2010 house experienced mainly roof cover damage with limited sheathing damage, soffit damage, and no structural failure.
