Operation and Performance of CMS Pixel Detector

Grace Haza on behalf of the CMS Collaboration*

The 32nd International Workshop on Vertex Detectors (VERTEX2023)
16-20 October 2023
Sestri Levante, Genova, Italy

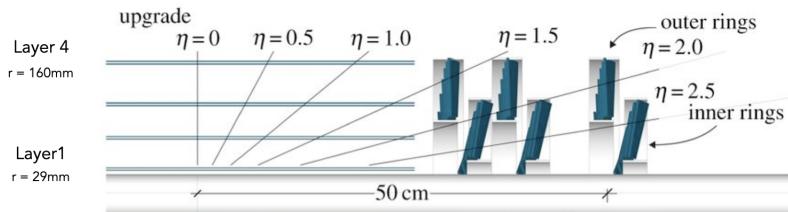
Figure 1: A view of the layout of a quarter of the pixel detector showing the four layers of BPix and three disks of FPix.

The pixel detector [1] is the innermost component of the silicon tracking system of CMS [2] and provides four-hit coverage within $|\eta| < 3$. The barrel pixels (BPix) are made of four cylindrical layers that wrap around the beampipe at radii of 29, 68, 109, and 160 mm. The forward pixels (FPix) are made of three disks on each end of CMS, located between 309 and 508 mm in the longitudinal z coordinate from the interaction point. Each disk has an inner ring beginning at a radius of 45 mm and an outer ring beginning at a radius of 96 mm. The Phase-I pixel detector was installed in the winter of 2016 and 2017. The detector geometry is shown in Fig. 1.

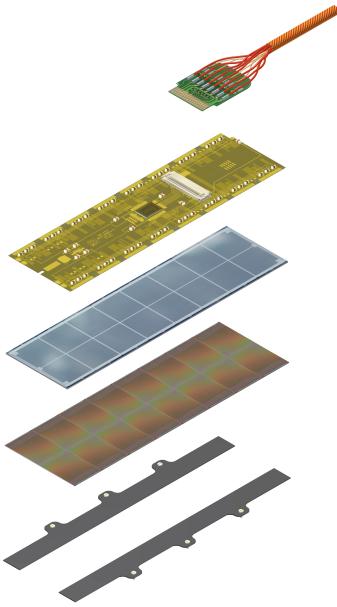
Figure 2: An exploded view of a pixel module with power and signal cables, HDI including TBM, silicon sensors, ROCs, and base strip.

The detector is built from modules. Each module contains 66 560 n^+ -in- n silicon pixels that are 100 μm by 150 μm with 280 μm active thickness, 16 readout chips (ROCs), a high density interconnect (HDI), and a base strip [3]. Each module has a token bit manager chip (TBM) glued and wirebonded to the HDI. BPix Layer 1 exceptionally has 2 TBMs per module to cope with higher hit rates. The different components of a pixel module are depicted in Fig. 2. There are 1 184 modules in BPix and 672 modules in FPix.

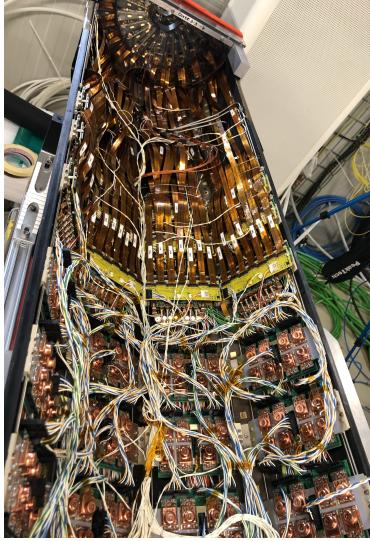
Figure 3: A half cylinder of FPix in the clean room during refurbishment and commissioning. The modules are visible at the top of the photo, and the DCDC converters are seen at the bottom of the photo.

The pixel detector was extracted at the beginning of Long Shutdown 2 and then kept cold and dry in a clean room to prevent reverse annealing. It was refurbished in preparation for Run 3. New DCDC converters robust against radiation damage were installed in the entire detector, and the pipes used for evaporative CO₂ cooling were reinforced for FPix. BPix Layer 1 was completely replaced with new modules. Besides being free of any radiation damage, the new Layer 1 has several improvements. The new version of the TBM has an additional delay setting, allowing Layers 1 and 2 to have different timing delays despite sharing a portcard. The ROCs have reduced dynamic inefficiency and crosstalk, and the HDIs were given a larger border that prevents high voltage shorts. A photo of an FPix half cylinder is shown in Fig. 3.

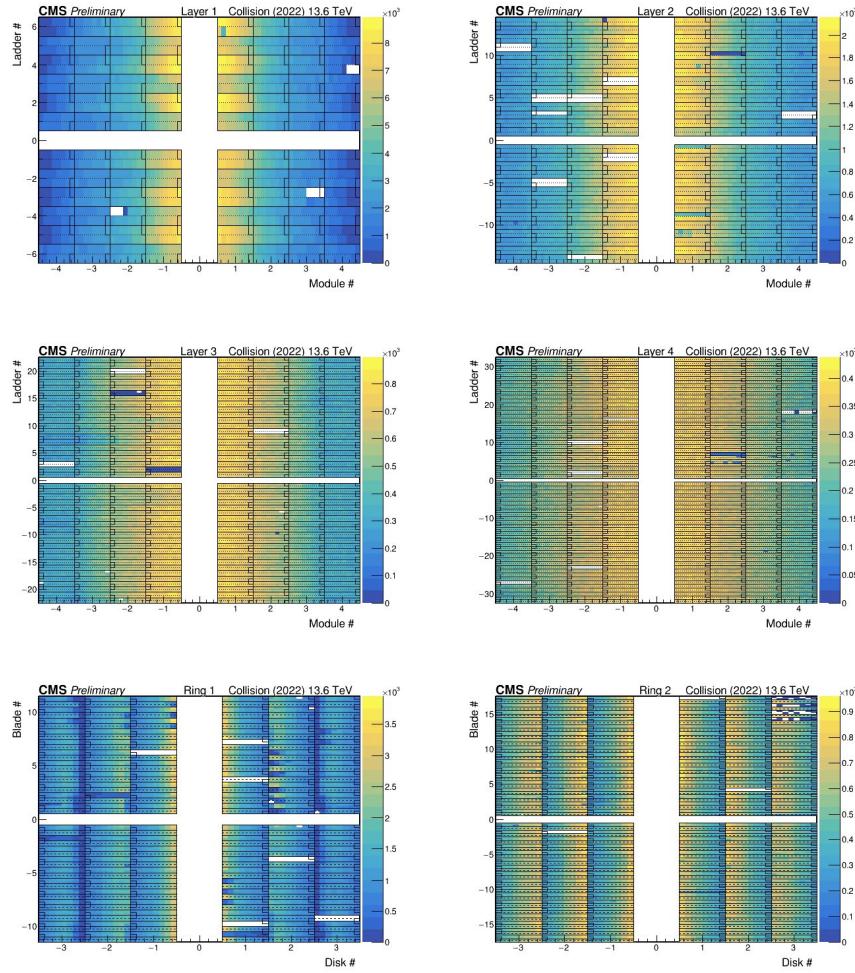
Figure 4: Occupancy plots of BPix Layer 1 (top left), Layer 2 (top right), Layer 3 (middle left), Layer 4 (middle right), FPix Ring 1 (bottom left), Ring 2 (bottom right).

Throughout Run 3, the active detector fraction, hit efficiency, and cluster charge are monitored. Figure 4 shows the active detector fraction at the beginning of June 2023, with 98.4% of BPix and 97.9% of FPix used in data-taking. The hit efficiency is consistently high so far in Run 3, with the largest change seen in Layer 1, as shown in Fig. 5. The hit efficiency is affected by radiation damage, changes of bias voltage, updated settings obtained through gain calibrations, and annealing during time without beam. The resolution for hits in the pixel detector for 2022 and 2023 is listed in Table 1. The resolution has slightly degraded, which is expected for an aging detector.

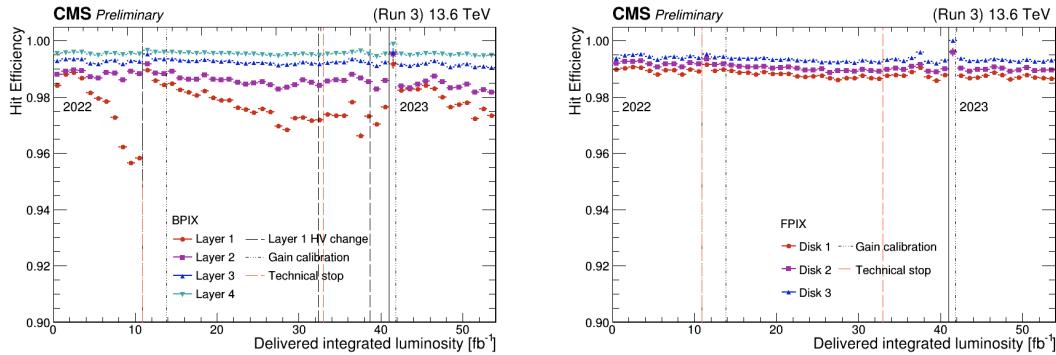
Figure 5: Hit efficiencies of different BPix layers and FPix rings over Run 3. The dip in BPix Layer 1 hit efficiency and subsequent recovery is a result of the bias voltage being adjusted[5].

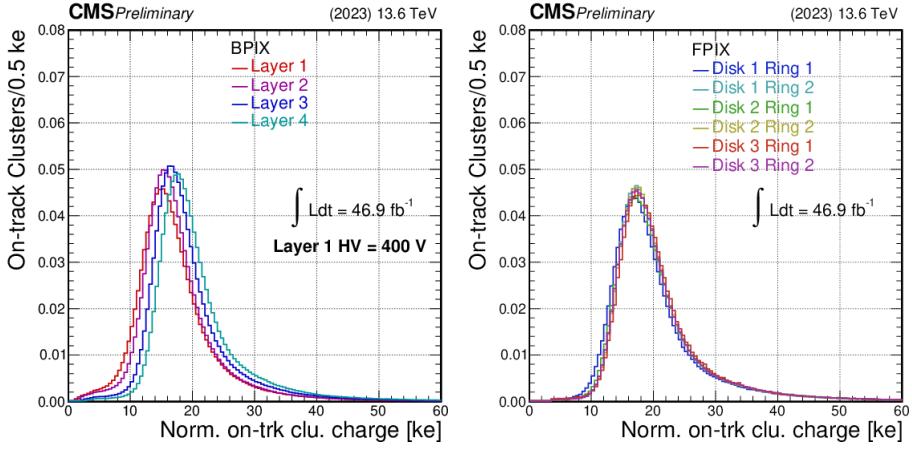
Figure 6: Cluster charge distributions of different BPix layers and FPix rings[5].

Bias voltage scans are taken weekly during proton-proton collisions to check the optimal settings. The cluster charge is measured as a function of bias voltage, and the settings are updated accordingly. The cluster charge distributions are shown in Fig. 6. BPix Layer 1 receives the most radiation and its depletion voltage setting changes rapidly, as shown in Fig. 7.

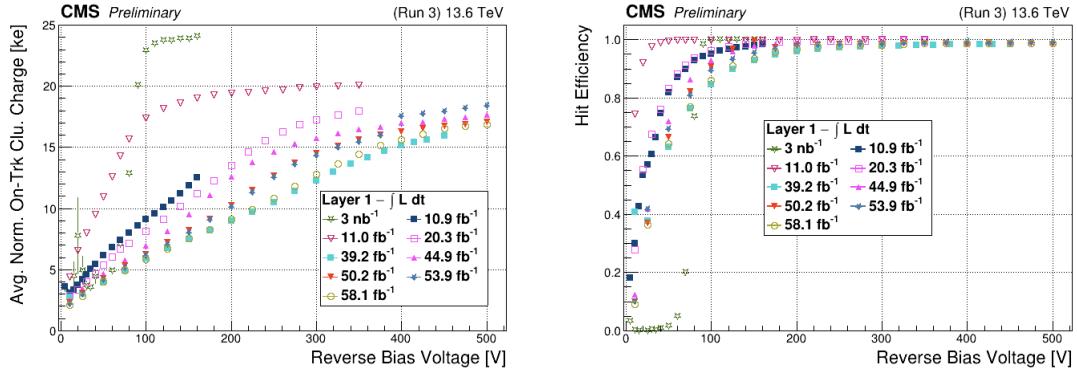
Figure 7: The cluster charge (left) and hit efficiency (right) of BPix Layer as a function of bias voltage. The different curves correspond to scans performed at various times in Run 3, denoted by the amount luminosity[5].

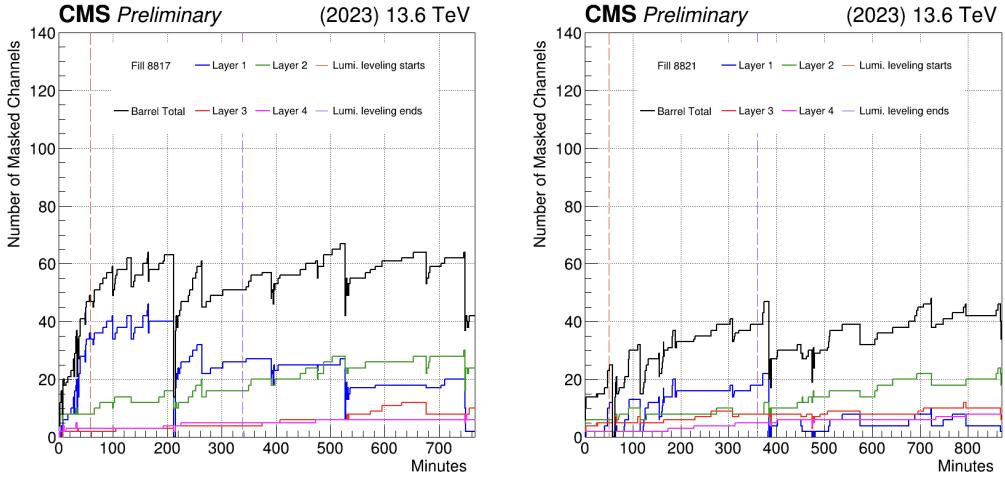
Figure 8: A comparison of the number of automasked channels between Fill 8817 (left) and Fill 8821 (right). The fills have comparable conditions: Fill 8817 had a peak luminosity of $2.05 \times 10^{34} \text{ cm}^{-2} \text{ s}^{-1}$ and a peak pileup of 62.3, and Fill 8821 had a peak luminosity of $2.12 \times 10^{34} \text{ cm}^{-2} \text{ s}^{-1}$ and a peak pileup of 64.3. Adjusting the 400 MHz data transmission phase greatly reduced the number of automasked channels in BPix Layer 1 [6].

During data-taking, if a channel fails to reliably transmit data, its readout will be stopped through a procedure called automasking. A channel in Layer 1 corresponds to 2 ROCs, a channel in Layer 2 corresponds to 4 ROCs, and a channel in Layers 3 and 4 and FPix corresponds to 8 ROCs. If a reconfiguration fails to recover the corresponding modules, they are blacklisted and will be DCDC powercycled at the next interfill. An anticipated and unavoidable cause of automasking occurs when a TBM is stuck as a result of an SEU. The BPix Layer 1 should be robust against this type of problem, yet it still had a relatively high number of automasked channels, as shown in Fig. 8. In this case, the channels were being automasked due to an unacceptably high number of out-of-sync errors from the FEDs. The high rate of automasking was diminished by adjusting a timing setting on the TBM which corresponds to the relative phase of the ROC and TBM and the phase of the 400 MHz data transmission. Once this adjustment was made, the level of automasking greatly reduced, as seen in the right plot of Fig. 8.
