Assessing the behavior of historic masonry buildings to tornadic events: A comparative study of code-based analysis and point cloud based simulation

Saanchi S. Kaushal^a, Mariantonietta Gutierrez Soto^b, Rebecca Napolitano^{a,*}

1.2. Case Study: US Post Office

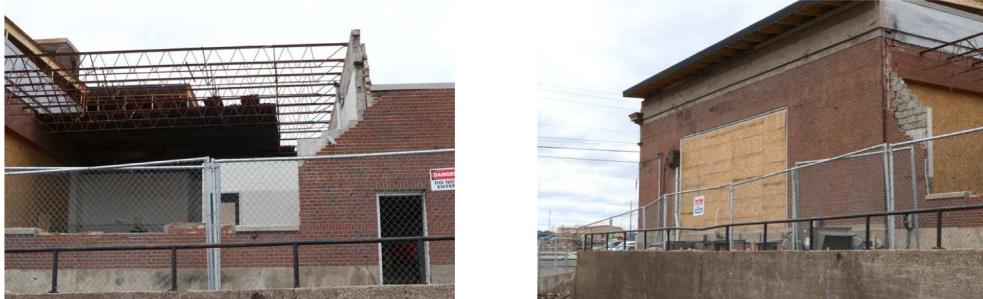
Fig. 2. Some of the damages seen on the US Post Office.

(a) Wall and Roof Damage

(b) Broken Windows

In December 2021, the Midwest Tornado passed close to the US Post Office, according to the estimated path (Fig. 3). This resulted in significant damage to the Post Office, while its adjacent structures were razed to the ground. The damages observed for the Post Office included roof damages, broken windows and wall collapse (Fig. 2).

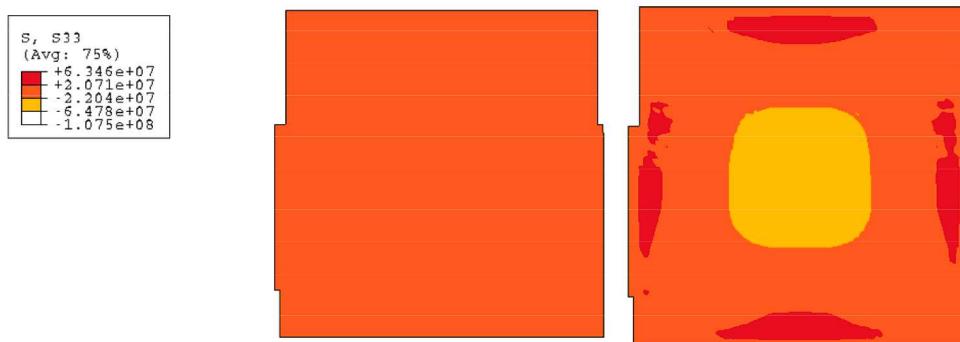
Fig. 11. The different stress variations when subjected to ASCE (L1) and On-site (L2) loading conditions.

(a) The different principal stresses generated by the two loading conditions on the roof

(b) The different uplift forces generated by the two loading conditions on the roof

(c) Compressive stresses generated by the two loading conditions on the windward wall

Fig. 11 provides a visual representation of the comparative analysis between the stresses produced by the two loading conditions. An examination of the ASCE 7 (L1) loading conditions in comparison to the documented on-site damage reveals that the stress generated were insufficient to induce the uplift or wall damage observed in the field. In contrast, the on-site (L2) loading condition

resulted in significantly elevated stress levels within the primary wind force-resisting system, aligning qualitatively with the areas of impact on the structure. It is noteworthy that, irrespective of the evaluation direction, the on-site (L2) loading condition consistently yielded higher stress values. The analysis revealed notable differences in the stresses experienced by the building under on-site speeds compared to those under ASCE 7-22 standard wind speeds.

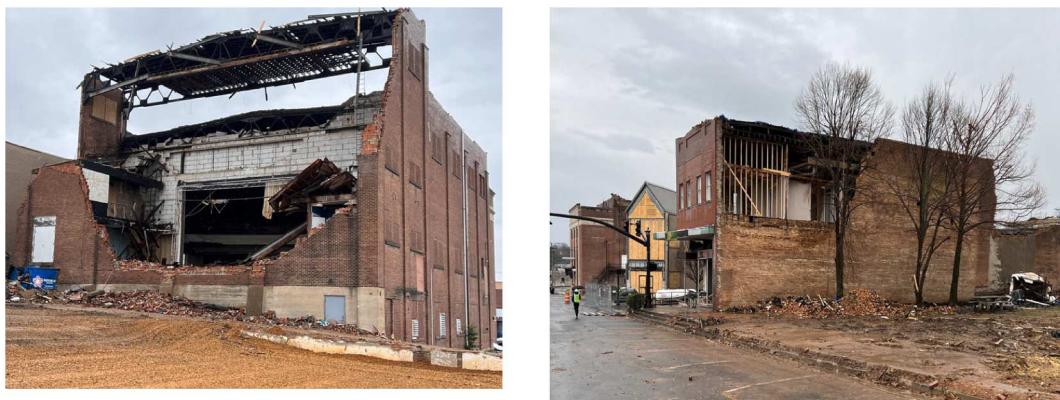
Fig. 12. Masonry buildings in Mayfield showcasing similar damages.

(a) American Legion

(b) Urban Outfitters

Furthermore, while this study primarily focuses on the US Post Office, the observed behavior of other masonry structures in Mayfield reinforces the necessity for targeted preservation strategies addressing common damage patterns and vulnerabilities across historic districts. In conclusion, this research opens avenues of discussion pertaining to the decision-making and proactive measures to safeguard cultural heritage in the face of tornado events.
