Three-Dimensional Digital Documentation of Tornado-Damaged Heritage Buildings

Abstract: In December 2021, an EF-4 tornado swept through several Midwest states in the United States, with Kentucky being the worst hit. Among the impacted towns was Mayfield, KY, where the historic buildings in downtown suffered significant damage. In response to this disaster, the authors conducted a reconnaissance mission to digitally document the affected historic structures. This involved capturing a series of three-dimensional (3D) point clouds, providing detailed spatial data about the impacted buildings. The resulting data set includes both the original raw data and processed information, now accessible via the DesignSafe open-access repository. This paper outlines the data collection process for the impacted buildings, and the steps undertaken to process it. The final product of this endeavor are the point clouds generated for the historic building typology, which included 10 historic buildings and 2 comparable religious buildings. These point clouds serve as invaluable resources for further analysis, aiding in understanding a disaster's impact, and guiding restoration endeavors.

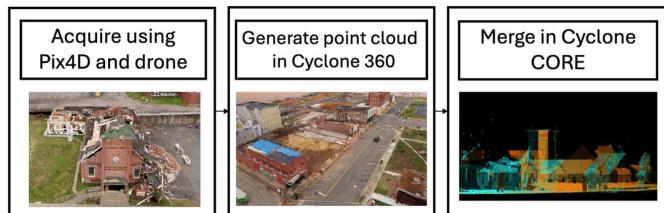
Fig. 1. An overview of the data collection and processing methodology.

Following the collection of data, a three-step methodology was utilized to process the gathered information, where the images and scans were transformed into point clouds, as shown in Fig. 1. The first two steps involved individual processing of the UAV images and LiDAR scans to generate the point clouds, and the third step combined the two point clouds. This process entailed the independent management of data acquired from diverse sources, as detailed in the subsequent sections.

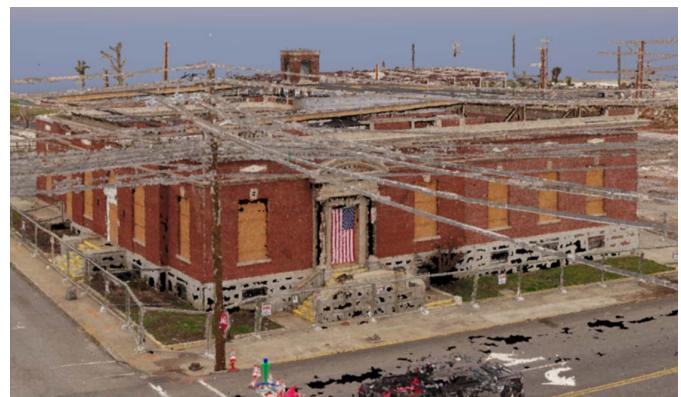
Fig. 2. The point cloud for the Post Office (USPS) generated by Pix4D (USPS).

The primary reason to combine the point clouds for digital documentation is to build more comprehensive point clouds, which can be more precise than using a single point cloud. One of the approaches to merge UAV and LiDAR data is by implementing the registration technique, which iteratively aligns corresponding points to build the complete 3D model (Besl and McKay 1992). Once the point clouds were processed individually in the abovementioned software, Cyclone (Leica Geosystems 2022a), was used to merge the individual point clouds. This helped process the data, register the two point clouds to each other, and then fuse it into a full 3-D model. Figs. 2 and 3 are representative of the individually processed point clouds, while Fig. 4 was the final point cloud.

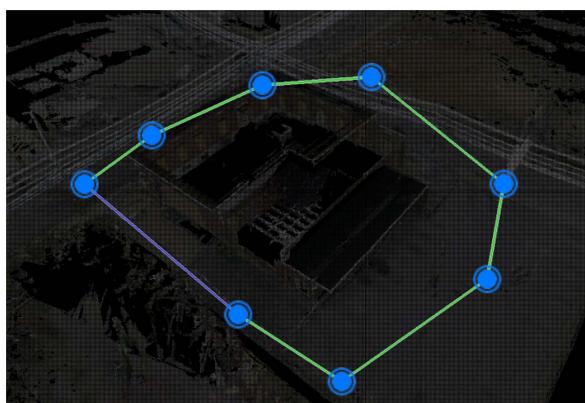
Fig. 3. The LiDAR scans aligned in Register360 for the Post Office (USPS).

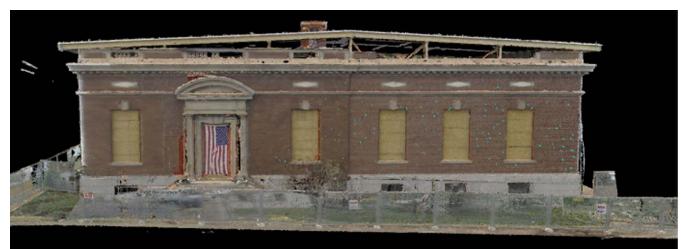
Fig. 4. The final point cloud for the Post Office (USPS).

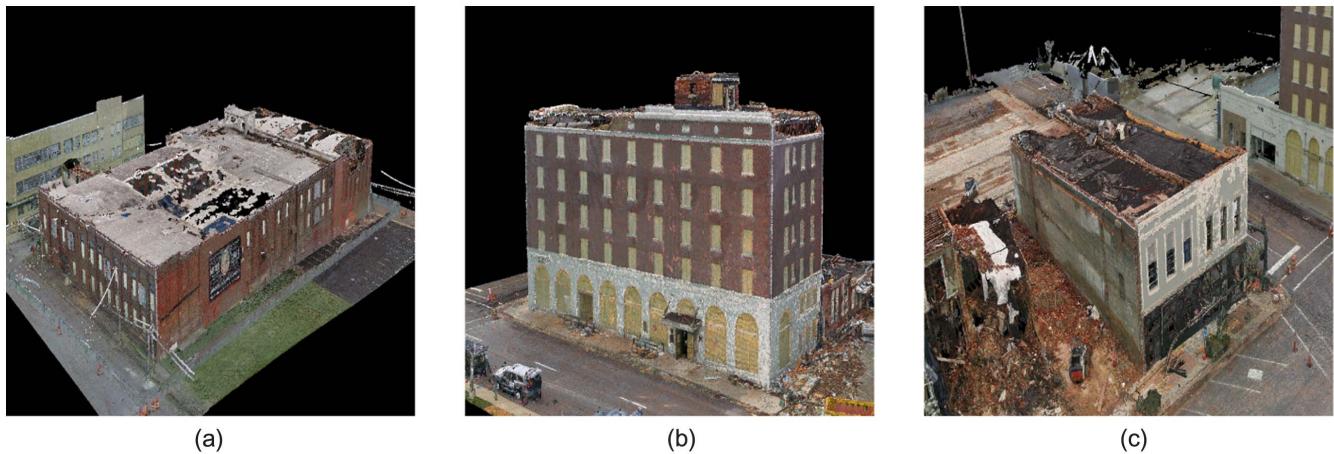
Fig. 5. Examples of the point clouds available in the data set: (a) Clothing Mill; (b) Hall Hotel; and (c) Mayfield Mural Building.

The most significant directory within the data set is the *deliverables* folder, particularly valuable for those seeking to leverage the point clouds further. This folder encompasses point clouds generated by each software in their most reusable formats, identified by the *.pts* and *.las* extensions. These point clouds, exported from their respective software, represent incomplete data sets and are present under *Pix4D*, *Register360*, and *Cyclone* folders. For comprehensive usability, the *final PC* folder stores the fully merged point clouds, complete with *.las* and *.pts* extensions, offering a reusable resource if needed. These final point clouds are easily editable and accessible using all photogrammetry software that supports these extensions such as *CloudCompare* (Girardeau-Montaut 2016) or *Metashape* (Over et al. 2021). Fig. 5 displays a few of the point clouds available in the data set.
