# Shake-Table Testing of a Full-Scale 10-Story Resilient Mass Timber Building

**Abstract:** As part of a collaborative research effort (The NHERI TallWood Project), an extensive shake table test program was undertaken on a full-scale 10-story mass timber building with a resilient posttensioned mass timber rocking wall lateral system. Over a three-year period, academic and industry partners collaborated on the design, construction, and testing of a 34 m (113 ft) tall, 10-story mass timber building at the world's largest outdoor shake table facility (NHERI@UC San Diego). The test building incorporated a resilient mass timber rocking wall lateral system, gravity connection details designed to remain damage-free under design level earthquakes as well as innovative nonstructural systems detailed to tolerate moderate building drifts without significant damage. A total of 88 earthquake tests at different intensity levels were conducted, including several at the risk targeted maximum considered earthquake intensity for the building's design location. Experimental results indicate that a tall wood building with the systems and details employed in this study can withstand design basis and m

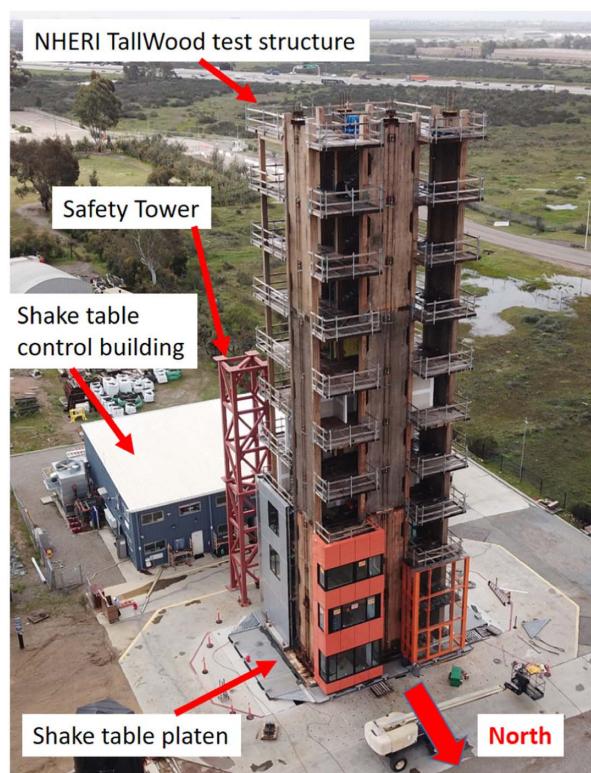
**Fig. 1.** Full-scale 10-story NHERI TallWood test structure with rocking wall lateral system. (Image by authors.)

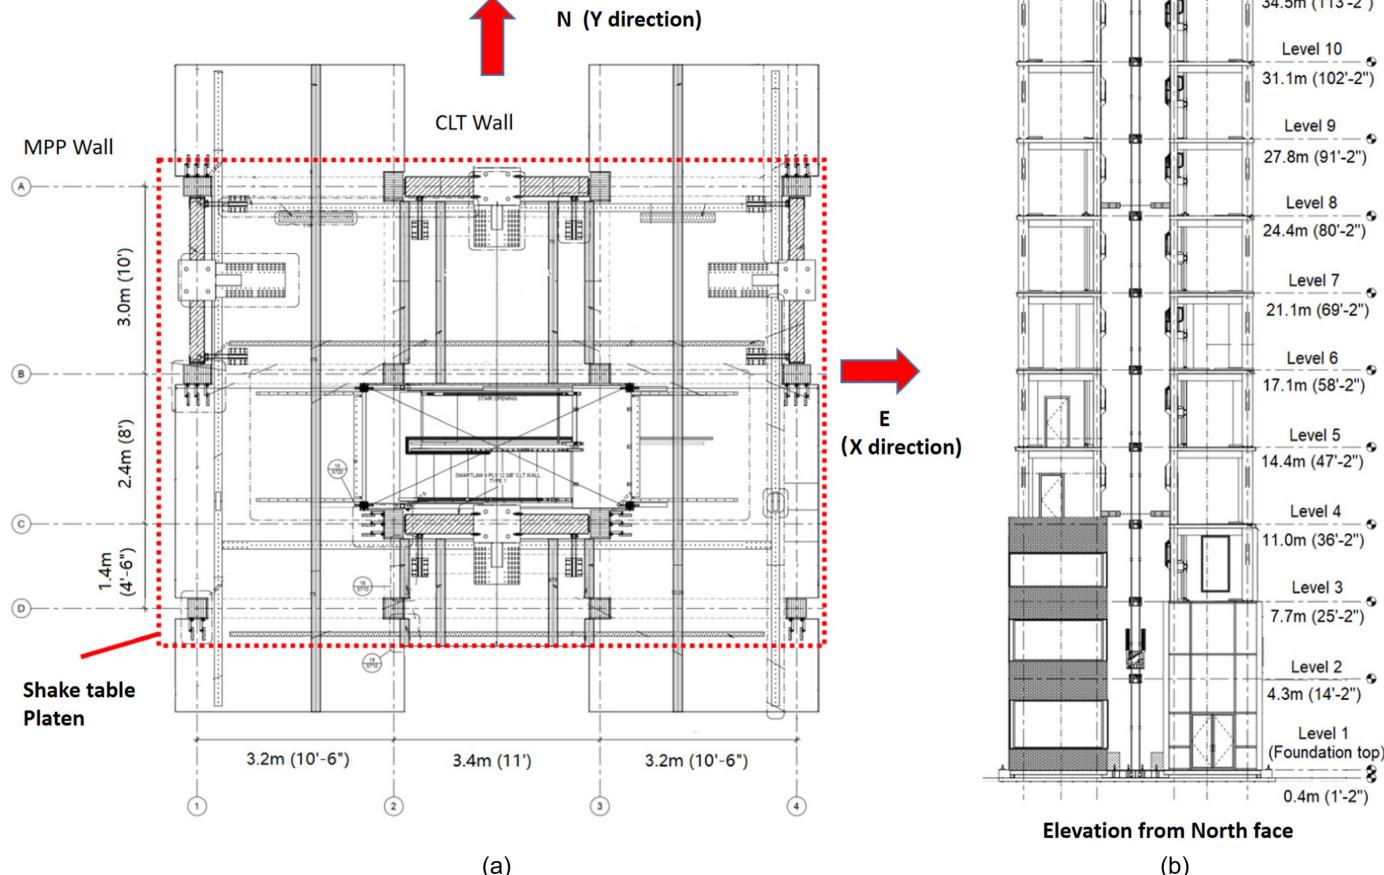
Fig. 2. Test specimen schematic: (a) plan view of typical floor; and (b) elevation view.

constrained to be within a reasonable proportion to the floor plan dimensions. Based on these physical constraints, the test building floor plan and elevation were sized as shown in Fig. 2 (the X-Y axis of the shake table facility is also shown). A single floor area was  $84 \text{ m}^2$  (900 ft $^2$ ) and was uniform over the building's height. The total building height was 34.4 m (113 ft). The column grid consisted of 14 gravity columns arranged within the space limitations of the shake table surface. Cantilevered precast concrete foundation blocks were used to expand the surface of the shake table so that the building's first floor plan included cantilevered patio portions toward the north and south directions beyond gridlines A and D, which supported four different types of exterior nonstructural façades.

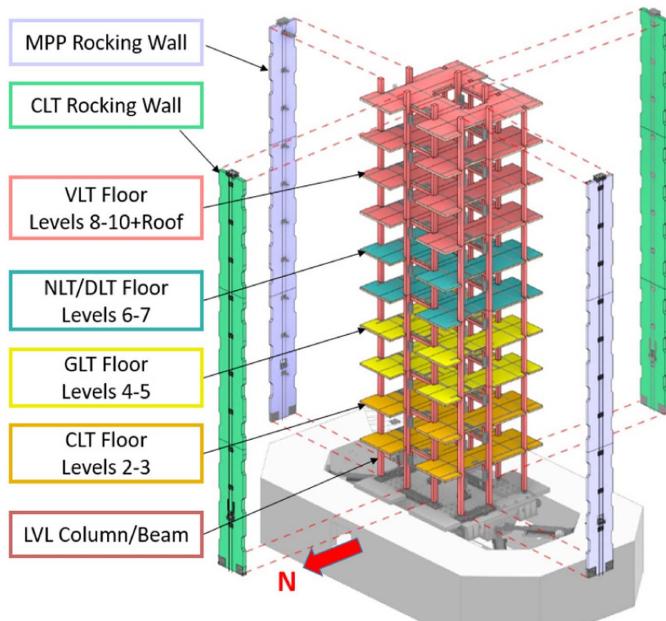
**Fig. 3.** Mass timber structural elements (graphic courtesy of LEVER Architecture; see Table 1 for material acronyms).

was not the controlling criteria for the selection of the floor panel thickness in this study. As shown in Fig. 3, multiple types of mass timber products were used for the floor diaphragms to test the feasibility of different products. Five-ply CLT panels were selected for Floors 2 and 3 to provide adequate fire resistance of a diaphragm with an exposed ceiling. On the remaining floors, other mass timber floor systems were selected to have similar thicknesses as the CLT floors for similar fire resistance and detailing. The bounding columns, located on each side of the rocking walls, had larger cross-sections than typical columns to resist axial forces generated from the steel yielding energy dissipation devices [U-shaped flexure plates or UFPs were used in this test for its cost-effectiveness and reliability, but other type of energy dissipation devices could also be used (Skinner et al. 1974)]. The gravity and lateral system materials and dimensions are summarized in Table 1 and illustrated in Fig. 3, including the four mass timber rocking walls shown in exploded view for clarity.

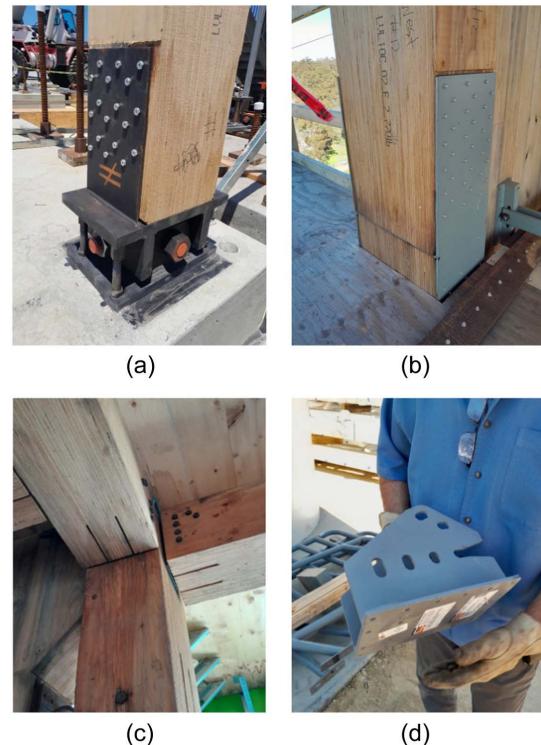
**Fig. 4.** Gravity frame connection details: (a) column base connection; (b) column splice connection; (c) beam and column joint; and (d) special beam hanger. (Images by authors.)

To achieve damage-free performance under repetitive earthquake tests, connections for the gravity system in the test building were specially designed by an industry partner to allow free rotation up to 5% interstory drift while providing adequate axial stiffness and strength for column bracing (Pryor et al. 2024). Examples of these connection details can be found in Fig. 4(d), with detailed structural drawings available in Busch (2023). The column base was detailed as a true pin to allow biaxial rotation [see Fig. 4(a)]. While

such a column base would not be required even in a resilient mass timber building, it was necessary for this study to ensure the columns were not damaged for many phases of testing by multiple research teams. The column splices were located at the floor levels and were designed for axial loads from gravity. Bounding column splices were also designed for a net tension force demand generated from a subsequent project to NHERI Tallwood, which reused the 10-story specimen. The beam-to-column connection used a beam hanger with slotted holes that transferred shear but permitted rotation about a top bolt to minimize moment transfer. The beam hanger was embedded within the wood for fire protection of the steel components.

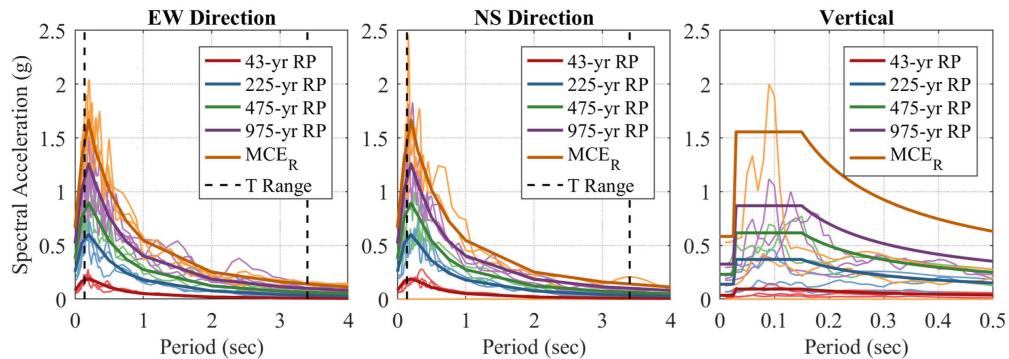
**Fig. 5.** Response spectrum at the different hazard levels considered for design and implemented in testing. (Data from [Wichman 2023](#).)

The building was designed for a location in Seattle, Washington, on Site Class C soil. The ATC hazards by location tool ([ATC 2021](#)) was used to generate short period ( $S_{MS}$ ) and 1 s ( $S_{M1}$ ) risk targeted maximum considered earthquake (MCE<sub>R</sub>) spectral acceleration values of 1.65 and 0.72 g, respectively. Uniform hazard spectra (UHS) were also generated for several different hazard levels (i.e., return periods [RP]), as shown in Fig. 5. The seismic hazard in Seattle is unique in that there are significant contributions from crustal faults and the Cascadia Subduction Zone (producing interplate and intra-plate earthquakes). The UHS were developed using the USGS 2014 US earthquake source model ([USGS 2017a](#)) and generated for a site with a time-averaged shear-wave velocity to 30 m depth ( $V_{S30}$ ) equal to 500 m/s (using [USGS 2017b](#)). The site-specific MCE<sub>R</sub> spectrum was also developed per ASCE/SEI 7-16 Section 21.2.1.1 ([ASCE 2016](#)) and is as shown in Fig. 5. The target vertical acceleration spectra were developed in accordance with Section 11.9 of ASCE/SEI 7-16, which is typically used for defining the MCE<sub>R</sub> vertical spectra. For other hazard levels, that same procedure was used but with  $S_{MS}$  replaced by the 0.1 s horizontal spectral acceleration from the various UHS given in Fig. 5.

the design (Wichman 2023). The test plan incorporated motions from the five different hazard levels with the target spectra as shown in Fig. 5. A total of 88 dynamic tests using the selected ground motions were conducted over a three-week period. The target test intensities (shown as maximum horizontal peak ground acceleration

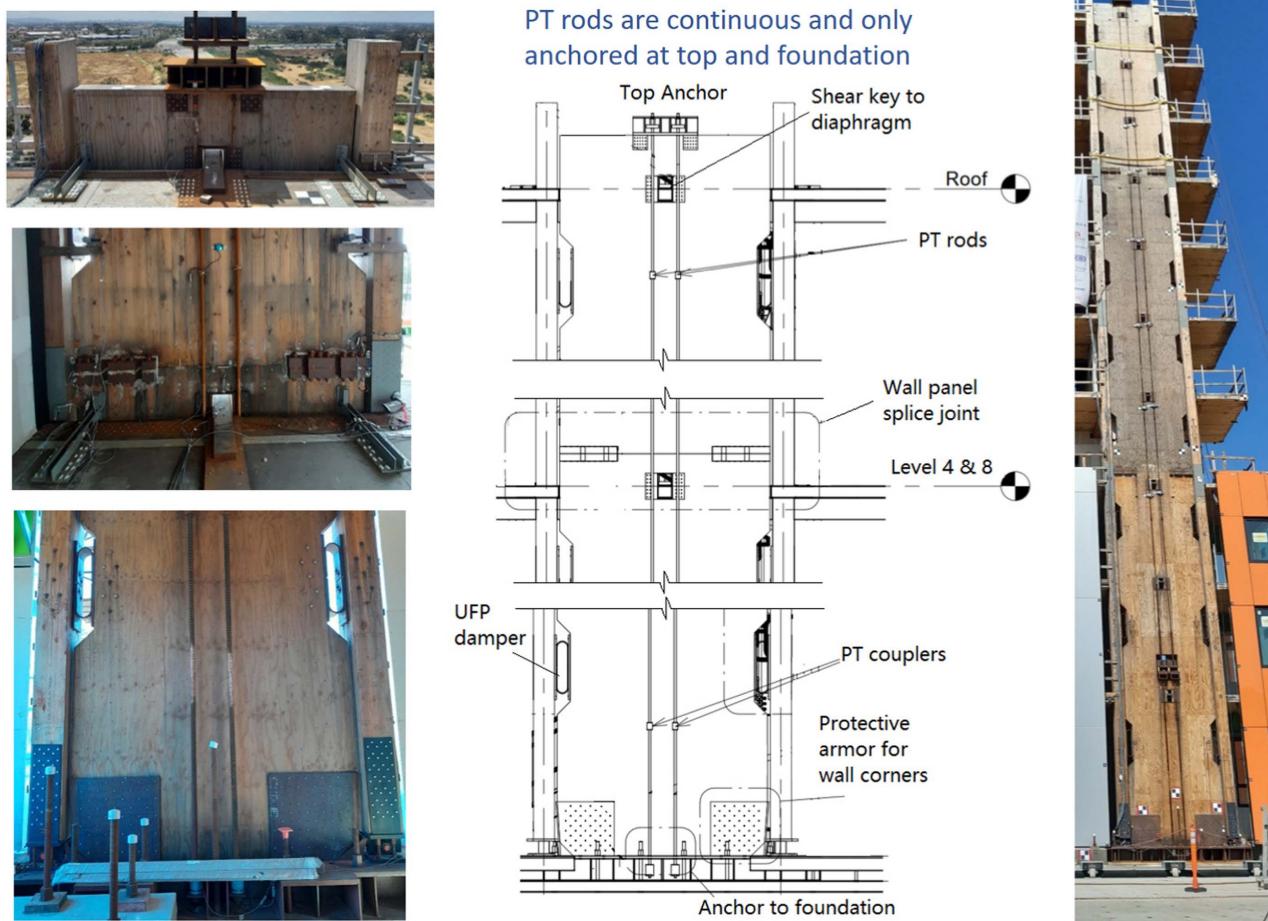
**Fig. 6.** Key components and sections of rocking wall system. (Images by authors.)

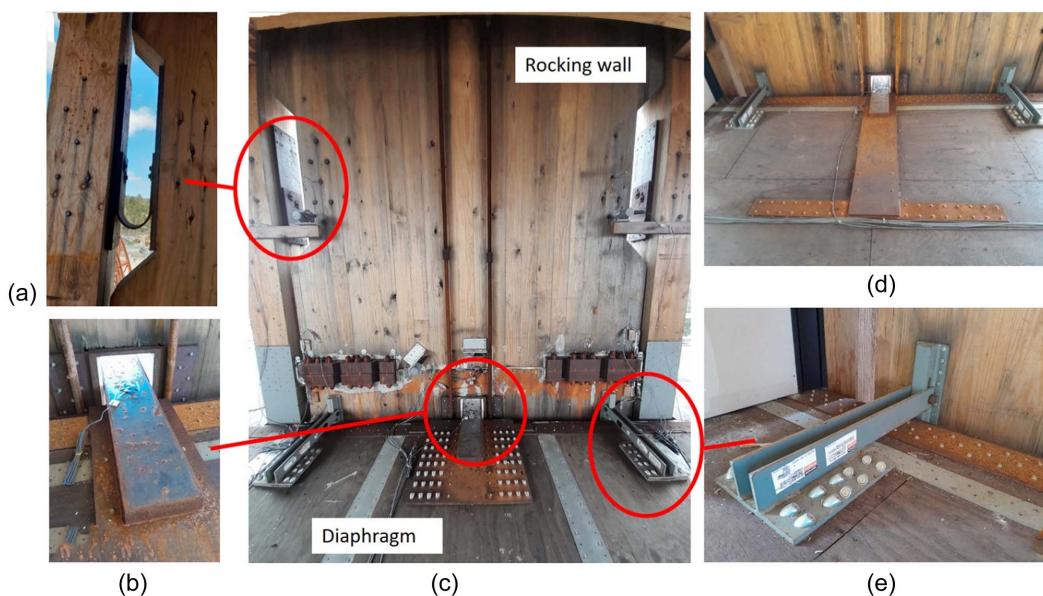
**Fig. 7.** Connections for the lateral force resisting system: (a) UFP between wall and bounding column; (b) shear key wall-to-diaphragm connection; (c) typical wall-to-diaphragm connection interface showing nonsheathed floor wing plate; (d) alternative wing plate connection detail for sheathed floors; and (e) out-of-plane brace for rocking wall. (Images by authors.)

performance with no damage to the diaphragm, walls, or steel components. The vertically slotted connection in the rocking wall panel allowed the wall to move independently from the diaphragm in the vertical direction, decoupling the rocking walls from the gravity load-bearing system. The connection between the shear key and the floor diaphragms varied depending on how diaphragm shear was developed for the different mass timber panel materials used. For diaphragms without plywood sheathing (CLT and VLT), a concentrated wing-plate with 45-deg screw connections was used. For floors with plywood sheathing (glulaminated timber, nail laminated timber, and dowel laminated timber floors), a different connection detail was adopted so that the shear would be effectively transferred into the sheathing layer. The rocking walls were braced out-of-plane to the diaphragm at all floor levels using a connection designed to resist tension and compression forces while still allowing vertical wall movement relative to the floor. The demand for the wall lateral braces was estimated using the lateral bracing requirements for point bracing of members in combined bending and axial compression from AISC 360-16 (AISC 2016). Photos for these connection details are presented in Fig. 7.

The lateral demands for the design of the floor diaphragms were obtained from nonlinear response history analysis with the intention of keeping them damage-free even during the MCE<sub>R</sub> level ground motions. Given the small footprint of the test building, the diaphragms acted rigidly and remained elastic during all testing. From damage inspections, there was no detectable deformation or damage to the floor systems through the entirety of the test program. For all tests, the lateral forces were effectively transferred to the rocking walls through the shear key detail shown in Fig. 7 with no damage or deterioration detected.

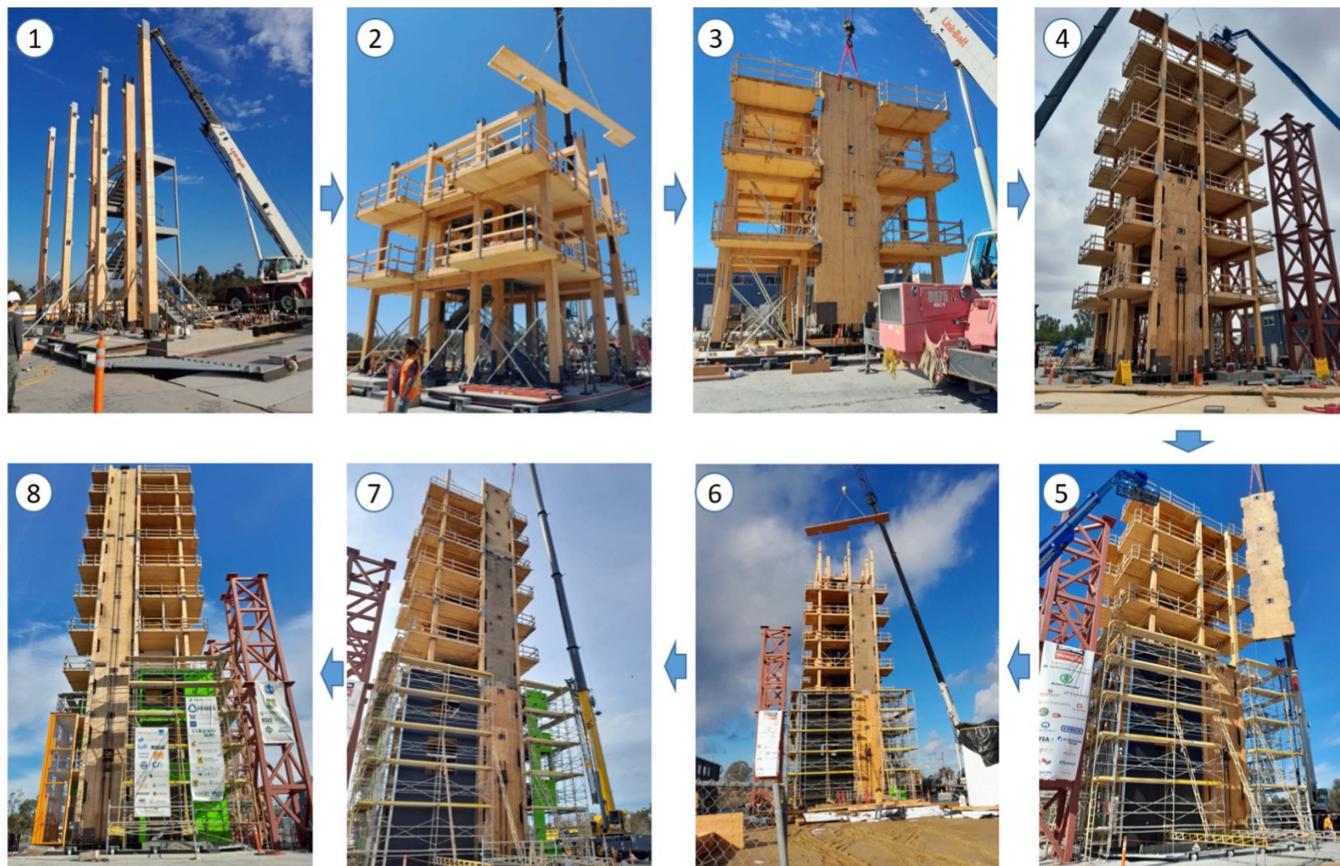
**Fig. 8.** Structural construction sequence of the test building. (Images by authors.)

rigid part of the steel shake table platen. After the foundation was ready, the structural construction of the building was completed with a relatively small crew (four to six carpenters depending on the labor demand each day) in approximately 2.5 months. The actual structural construction spanned more than four months due to a 1.5-month inactive waiting period for needed parts. The installation of nonstructural wall assemblies lasted for about four months, including some time-overlap with structural construction. The stair tower was assembled in parallel with the structural construction. Overall, construction started in mid-July 2022 and concluded in February 2023.

The first three levels of the stair system and gravity columns were installed on the foundation blocks, followed by the installation of beams, floor panels, and the first segments of rocking wall panels. As shown in Fig. 8, the first gravity column segments and rocking wall panel segments were both three stories tall. After the first segments of wall panels were in place, temporary posttensioning anchors were installed at the second story of each wall panel to provide temporary lateral support for stability and wind loading resistance during construction. This detail would not be necessary for full-sized building projects where the floor diaphragms are large enough to accommodate temporary braces for construction stability. After reaching Level 4 and completing the posttensioning of the first wall segments, a similar sequence was repeated for the next two segments (stories four to seven and stories eight to ten). Wall segments were spliced together vertically at their interfaces above levels 4 and 8. After topping out the building, posttensioning rods were installed for the full height of each rocking wall with the design PT forces. The temporary construction posttensioning at the middle of the first panel segment was released at the same time.

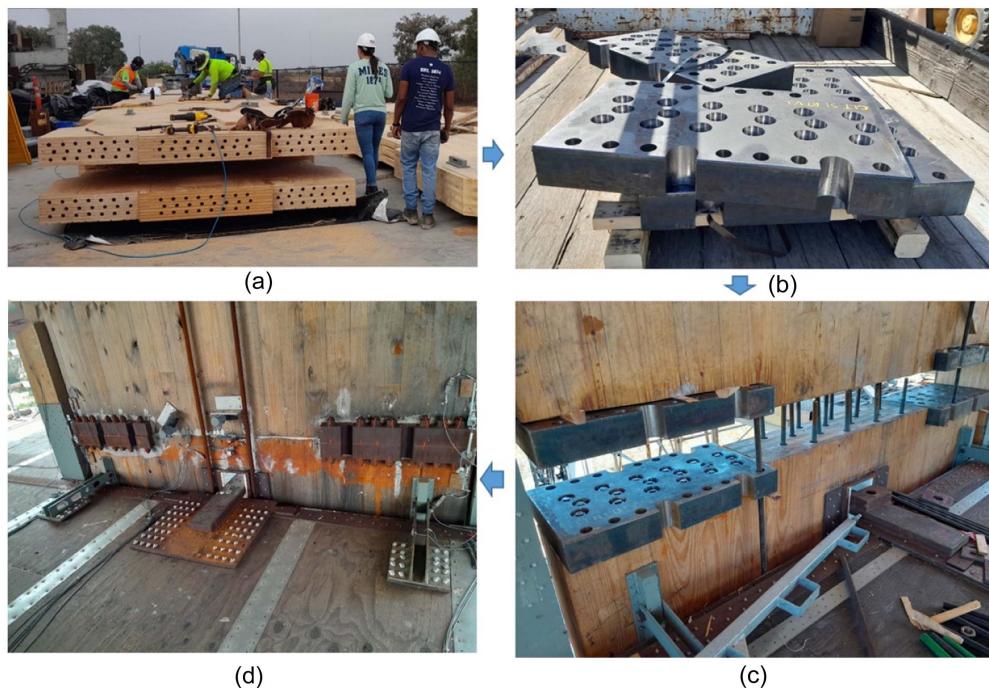
**Fig. 9.** Wall panel splice joint detail: (a) notched panel interface with epoxy holes; (b) coupler plates; (c) installation of a panel splice onsite; and (d) completed panel splice. (Images by authors.)

One of the major challenges in structural erection was splicing the rocking wall panels on site. With the increasing span and height of mass timber structures, efficient and reliable splicing details for mass timber panels are critical for construction efficiency and economy of mass timber projects. Specifically, the rocking wall panel splices in this project needed to remain stiff and elastic throughout the entire test program, with the capability to fully transfer all flexural and shear demands from the seismic loading across the splices. A glued-in rod detail (i.e., threaded steel rods epoxied into long holes drilled into the end of each wall segment) was designed for this connection similar to a connection that had been used successfully on past projects (Zimmerman et al. 2021). The glued-in rod connections used development lengths for the flexural rods and shear capacities for the shear rods determined from independent testing at Oregon State University (Field et al. 2023). However, a hand-fabrication method used by the fabricator to predrill the splice rod holes resulted in errors in location of the holes that prevented alignment of the wall segments onsite. The research team developed an alternative design for the tensile region of the splice and enlarged the holes in the shear region to enable the splicing of the wall panels. Customized steel coupler plates were installed at each corner of each wall panel such that the epoxied rods from each wall segment were connected to a steel plate coupler; then, the coupler plates were bolted together from the outside of the panel. Despite this fabrication error, the adjusted splice design successfully transferred the large tension forces from flexure across the wall segments using long glued-in threaded rods as intended. Fig. 9 shows the component details from the final wall splice and its assembly. A detailed description of the construction challenges associated with the wall splice can be found in Busch (2023); detailed calculations for the original and modified splice designs can be found in Wichman (2023).

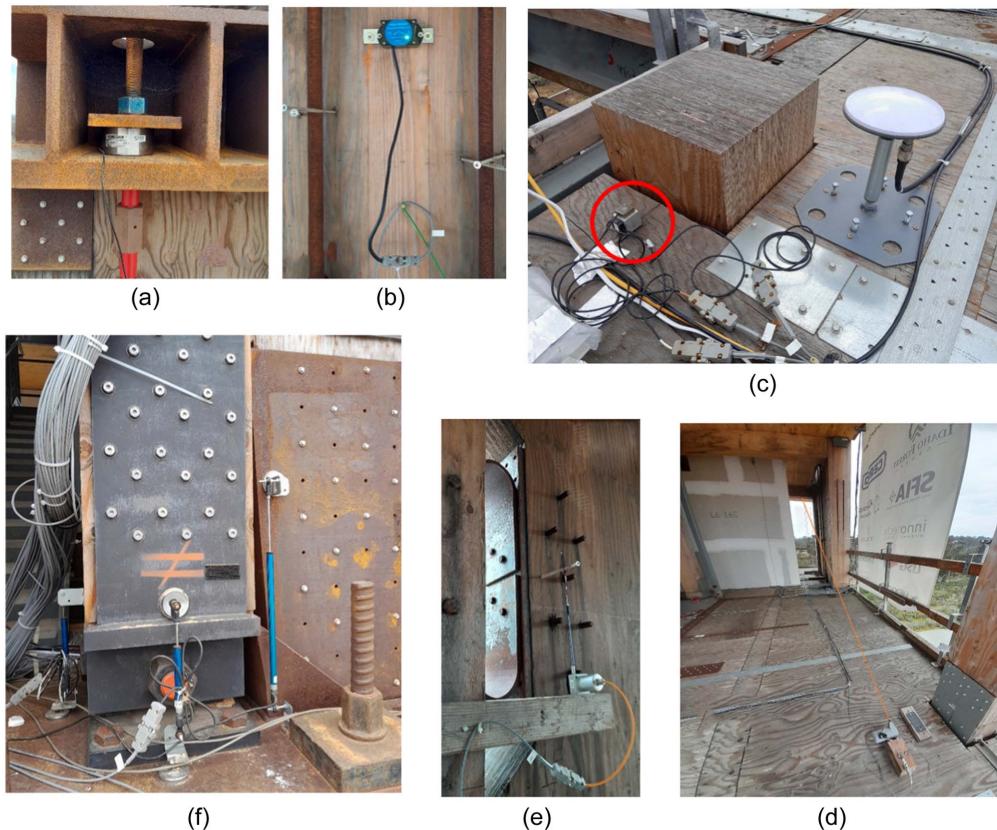
**Fig. 10.** Example sensors installed on the building: (a) load cell for PT force; (b) tiltmeter on rocking wall; (c) accelerometer (circled) and high precision GPS; (d) diagonal string-pot for interstory displacement; (e) string-pot for UFP displacement; and (f) linear potentiometers for column rotation and rocking wall uplift. (Images by authors.)

A summary list of the sensors is presented in Table 5. Fig. 10 shows typical sensor types installed in the building as discussed here. Detailed drawings and a comprehensive list of sensors on the building can be found in Busch (2023). A summary of the plan and rational for installed structural sensors on different building components is also presented here.

**Rocking wall system:** The posttensioned rocking wall system was also heavily instrumented. Accelerometers and tilt-meters [Fig. 10(b)] were attached at selected floors on the CLT and MPP rocking walls. Linear potentiometers were placed at wall panel splice joints to monitor deformation at the splice and near the rocking interface at the base to monitor uplift and/or compressive deformation [Fig. 10(f)]. String-pots were used to measure UFP deformation [Fig. 10(e)] and the movement of the shear key connection from the floor to the wall. Commercial and custom load cells were installed on PT bars to monitor the force variation during tests [e.g., Fig. 10(a)]. Strain gauges were used to estimate the stress and force level in the shear key components and out-of-plane wall braces.

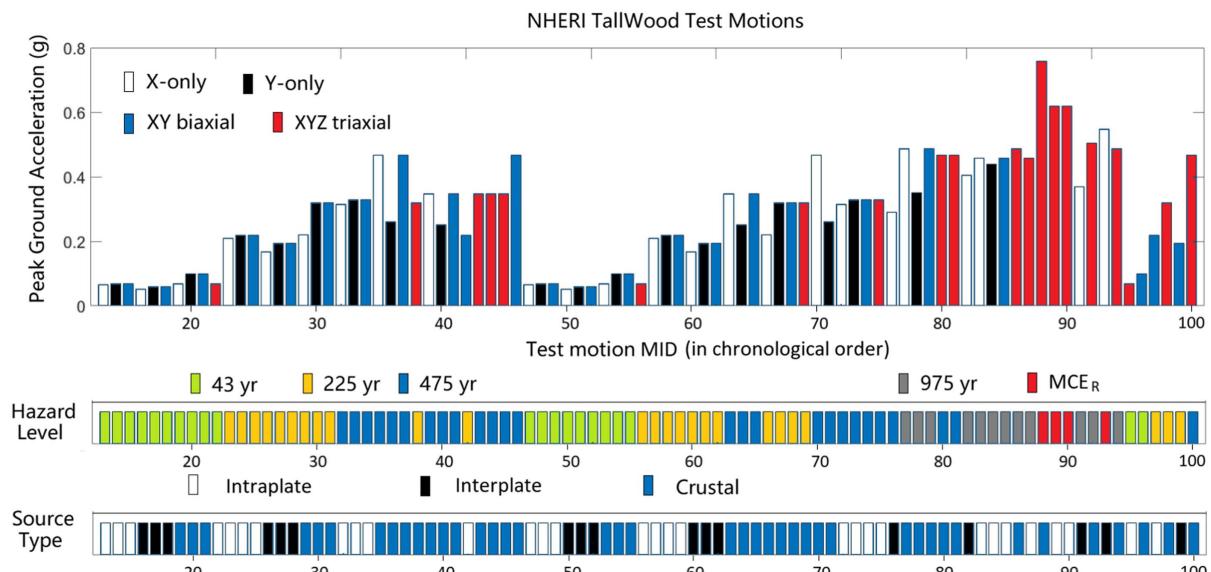
**Fig. 11.** NHERI TallWood test plan (PGAs shown for multidirectional tests were the maximum of the horizontal motions).

[PGA]), hazard levels, source types, and ground motion directions are illustrated in Fig. 11 in chronological order. The ground motion ID (MID) starting with MID13 and ending with MID100 correspond to the numbering scheme used in the original raw data set. White noise tests with a 4% g root mean square (RMS) magnitude and 60 s duration are not shown in this figure but were conducted between major tests in each of the X (EW) and Y (NS) directions separately to monitor the potential change in the building's natural periods.

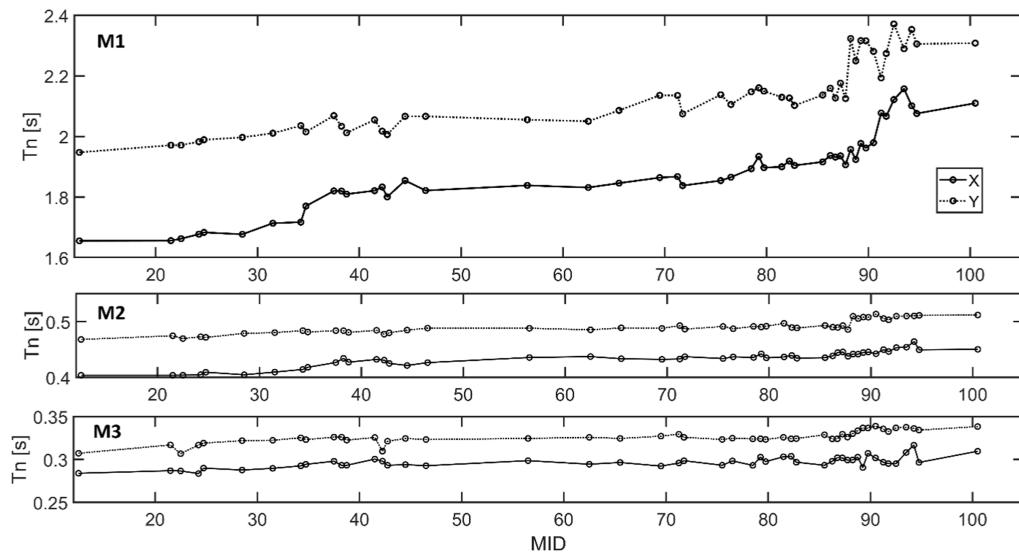
**Fig. 12.** Natural periods of first six modes estimated through white noise results (M1, M2, and M3 correspond to the first, second, and third translational modes).

Fig. 12 illustrates the change in monitored natural periods of the building in X and Y directions estimated based on white noise responses. In order to demonstrate the relationship between the test program progression and change in building dynamic characteristics, natural periods of the first three translational modes were plotted against the same MID numbering system as in Fig. 11 (e.g., period estimated from WN tests after MID-X are plotted at MID-X location). Initially, the observed natural periods agreed relatively well with the numerical model used for the design and analysis of the building [fundamental period estimated from numerical model was 1.74 s; see Wichman (2023)] but was larger than the period estimation from ASCE/SEI 7-16 simplified formula (i.e., 0.69 s). As shown in Fig. 12, repetitive tests at lower and moderate intensity levels did reduce the stiffness of the building gradually. After a few MCE<sub>R</sub> tests (starting from MID 88), more significant deterioration of the building's first mode periods from WN measurements was observed in the X and Y directions. This is likely due to damage and softening in the nonstructural systems attached to the structure as well as localized crushing of the mass timber panel corners at the base (see Fig. 13). Such localized damage did not affect recentering ability or strength of the lateral system but did cause reduction in rocking wall initial stiffness.

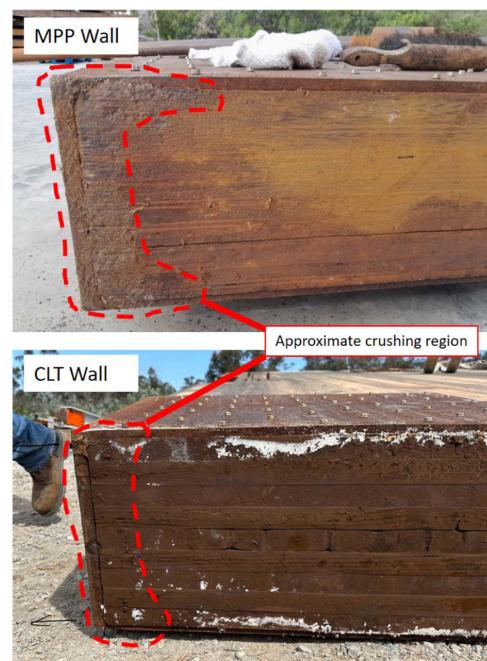
**Fig. 13.** MPP and CLT rocking wall toe area detail observed after deconstruction. (Images by authors.)

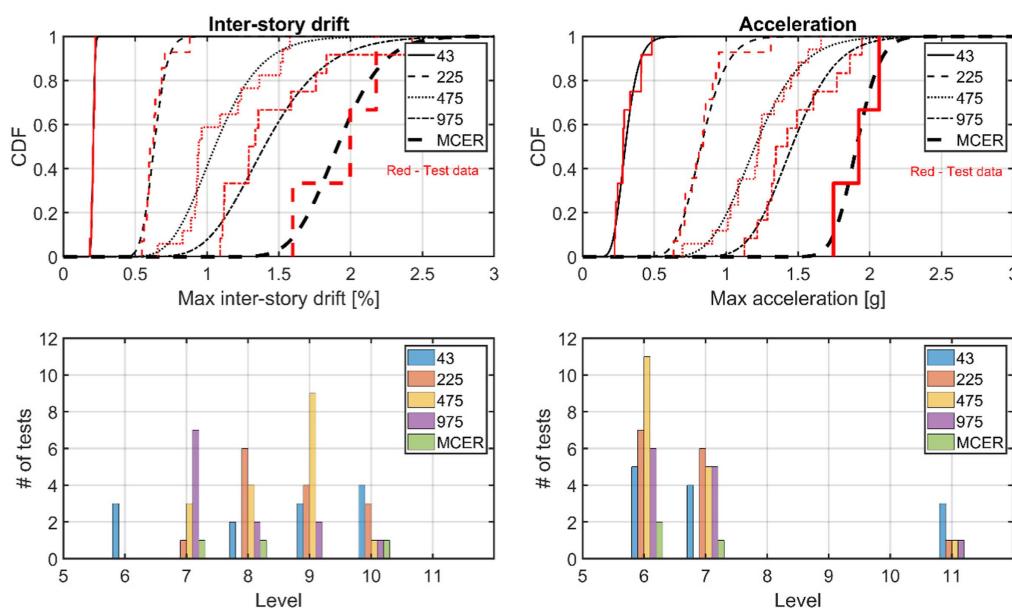
**Fig. 14.** CDF plots of maximum interstory drift and acceleration for each hazard level (bar chart indicates at which level the maximum drift or acceleration values were observed).

The peak interstory drift and floor accelerations from all tests, grouped according to the predefined target hazard levels, are plotted in Fig. 14 as empirical cumulative distribution curves for each hazard level. A fitted lognormal distribution model is also shown. The bar chart at the bottom of Fig. 14 indicates the floor levels at which the peak drifts/accelerations were observed. The data indicate that peak interstory drift of the building at MCER level excitations averaged about 2%, which is in good agreement with the intended design target. The overall peak drift (2.4% at Story 7) occurred during MID 91, which was a uniaxial interplate subduction zone earthquake record from the 2011 Tohoku Earthquake applied in the *X* direction. Across the entire test sequence, the overall maximum floor acceleration of 2.07 g was observed on Floor 7 during

MID 90, which was a MCER-scaled 3D intraplate earthquake motion. In general, the peak interstory drift for a given test tended to be observed within one of the top four floors, while the peak accelerations occurred mostly at midheight or the roof. This is consistent with the behavior of a rocking wall where gap opening due to rocking forms at the base with the elastic wall deformations causing the drifts to increase with height (Acikgoz and DeJong 2012). Peak interstory drift and acceleration distributions along the height of the building are presented in Fig. 15 for representative ground motions at a low hazard level (43-year RP) and high hazard level (MCER) tests, indicating similar behavior.

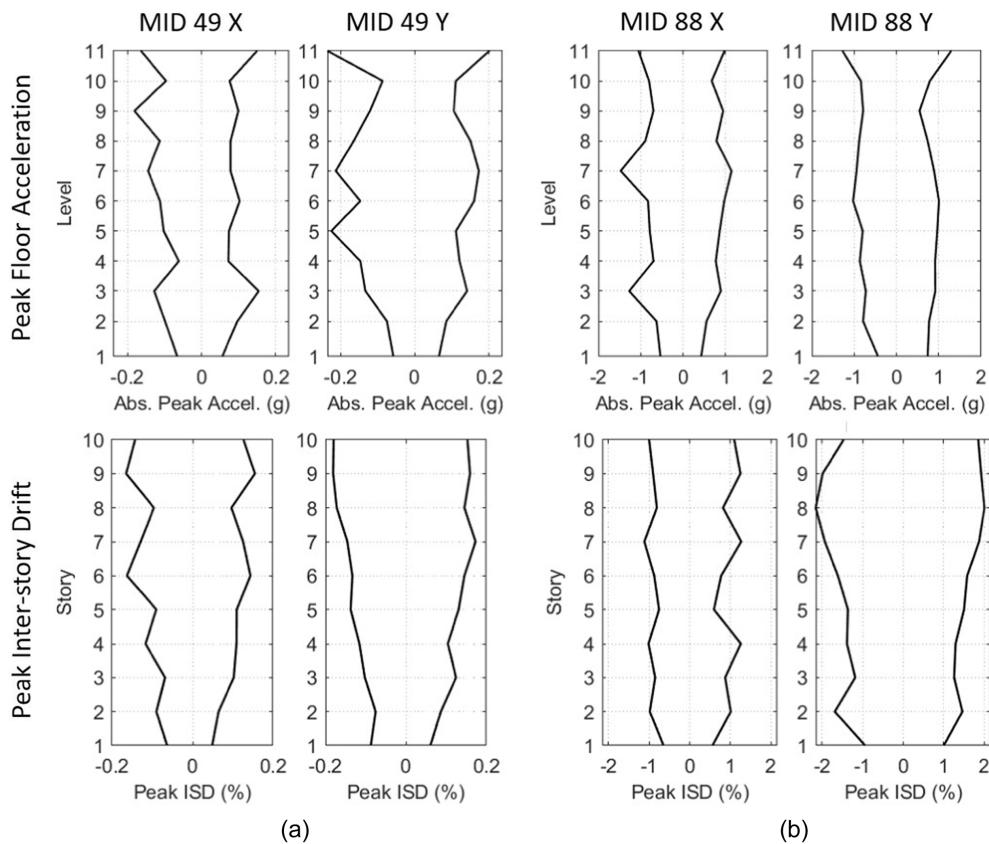
**Fig. 15.** Distribution of peak acceleration and interstory drift along the height of the building for: (a) representative 43-year RP ground motion; and (b) MCE<sub>R</sub> ground motion.

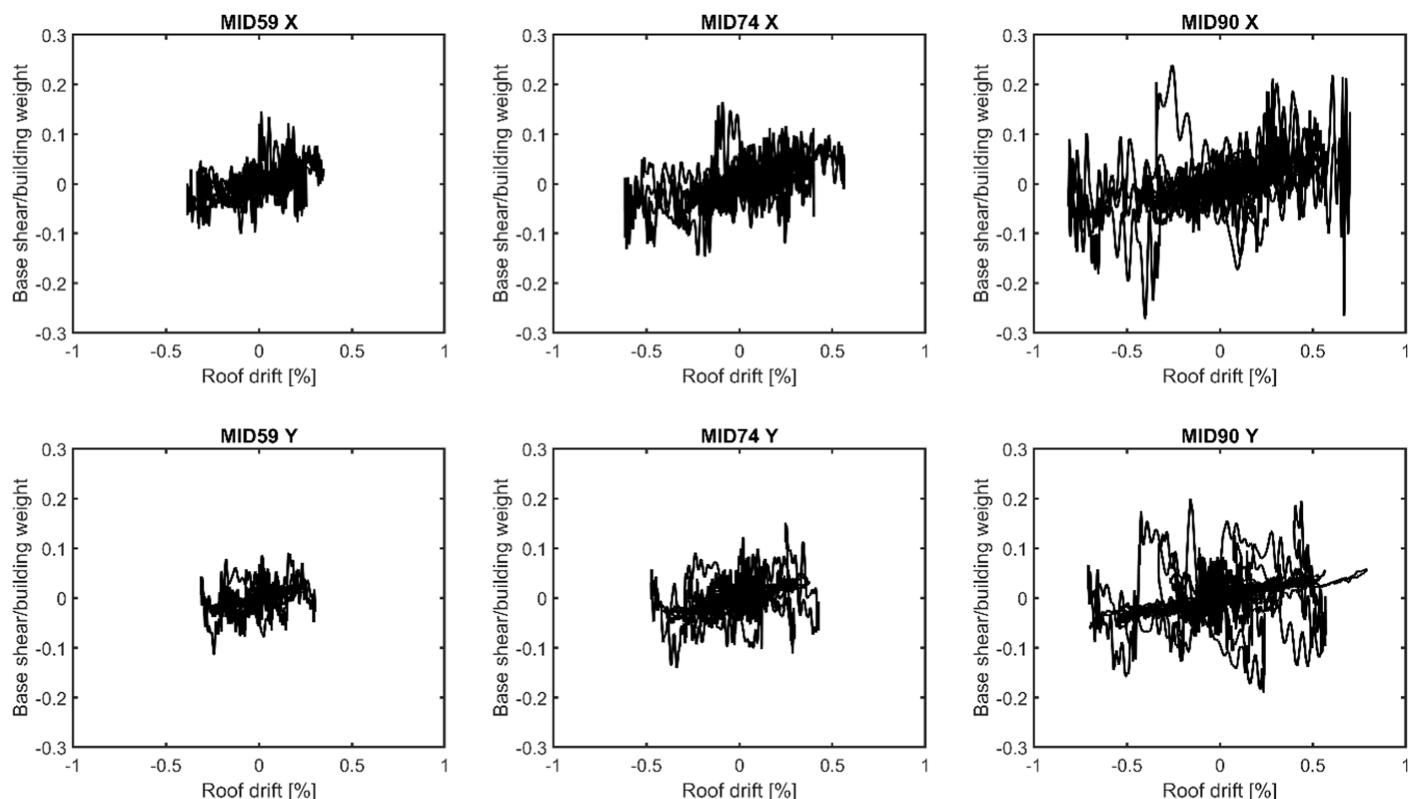
**Fig. 16.** Sample building global hysteresis responses at different hazard levels.

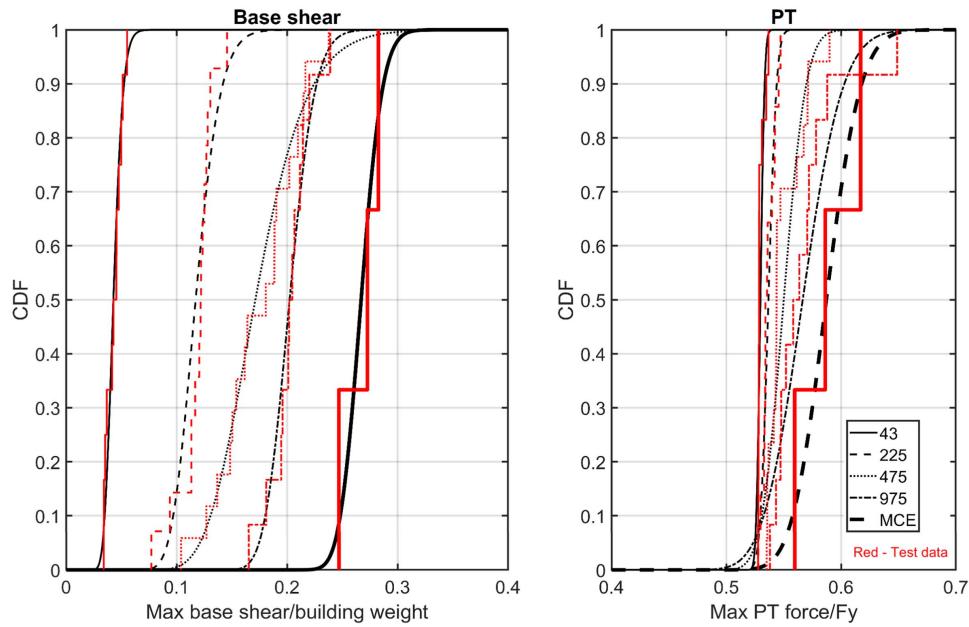
**Fig. 17.** CDF plots of maximum base shear and PT forces for each hazard level.

The distributions of maximum base shear and PT forces from all tests are illustrated in Fig. 17. The PT force during testing did not vary by more than 16% [35.6 kN (8 kips)] from the initial PT force [222 kN (50 kips)]. Even though substantial wall uplift occurred during the tests, that uplift did not result in significant strain in the PT bars owing to their 34.1 m (113 ft) length. Therefore, the PT bars remained well below yield for all tests.

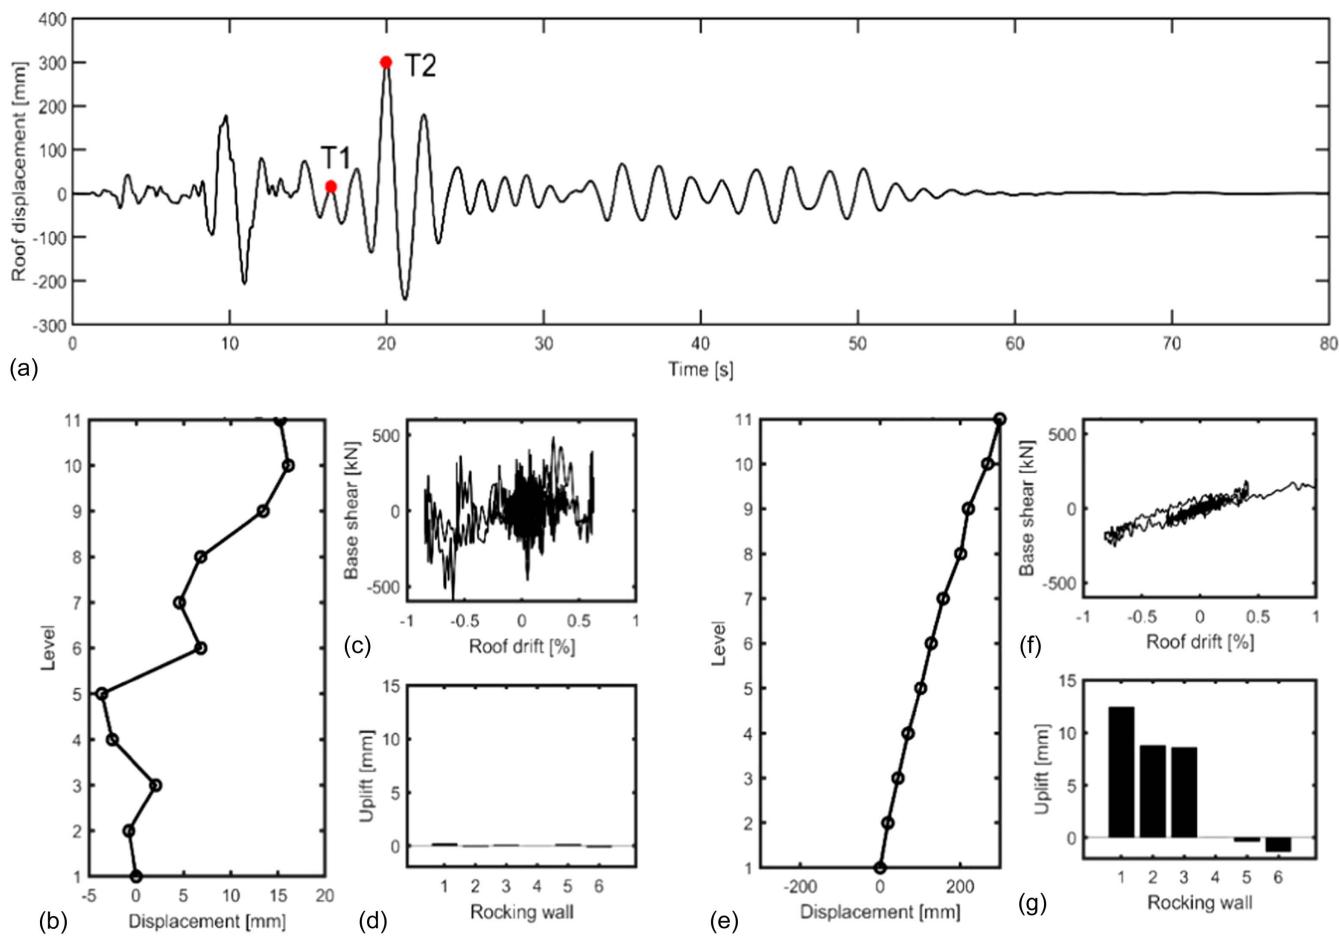
**Fig. 18.** Example response comparison between higher mode and first mode for MID 80: (a) roof time history in  $X$  direction; (b) floor displacement at T1; (c) global hysteresis from time 0 to T1; (d) base uplift profile at T1; (e) floor displacement at T2; (f) global hysteresis from time T2 to end; and (g) base uplift profile at T2.

As briefly discussed, the response of the building included prominent higher-mode contributions that were visible to observers watching the tests. Data collected also reveal this distinct higher-mode participation. For example, the “spikes” observed in Fig. 16 in the hysteresis loops are likely a result of the higher-mode-induced accelerations. For example, responses from a 475-year RP test shown in Fig. 18 (Test MID80) illustrate substantial variation in the deformed shape of the building at different time points during the test (e.g., T1 vs. T2). There were clear higher-mode contributions to the deformed shape of the building at T1 [Fig. 18(b)], while the entire structure was dominated by the first mode response at T2 [Fig. 18(e)]. The global hysteresis from time 0 to T1 reveals many spikes in acceleration-induced base shear, indicating high force demands related to higher-mode effects [Fig. 18(c)]. However, the hysteresis from T2 to the end of the test is much smoother [Fig. 18(f)], which indicates more first mode dominated response correlated with larger rocking deformation (base uplift) measurements. As shown, the amount of wall base uplift (measured by six LVDTs along the base of the North CLT wall) was essentially zero at T1 [Fig. 18(d)] when the response was dominated by higher modes (sensors 1–3 are attached at the rocking toe at 0, 305, and 610 mm from the end of the wall; sensors 6, 5, and 4 were placed in the mirrored positions on the other end of the wall). At T2, the uplift was significant [Fig. 18(g)]. While large force demands and accelerations were observed during higher-mode responses, the maximum wall uplift, story drift, roof displacement, and PT force typically occur when the building is dominated by first mode response, which often happens toward the end of the earthquake excitations. It is also clear from the displacement time history that the building returned to its initial position without residual displacement.

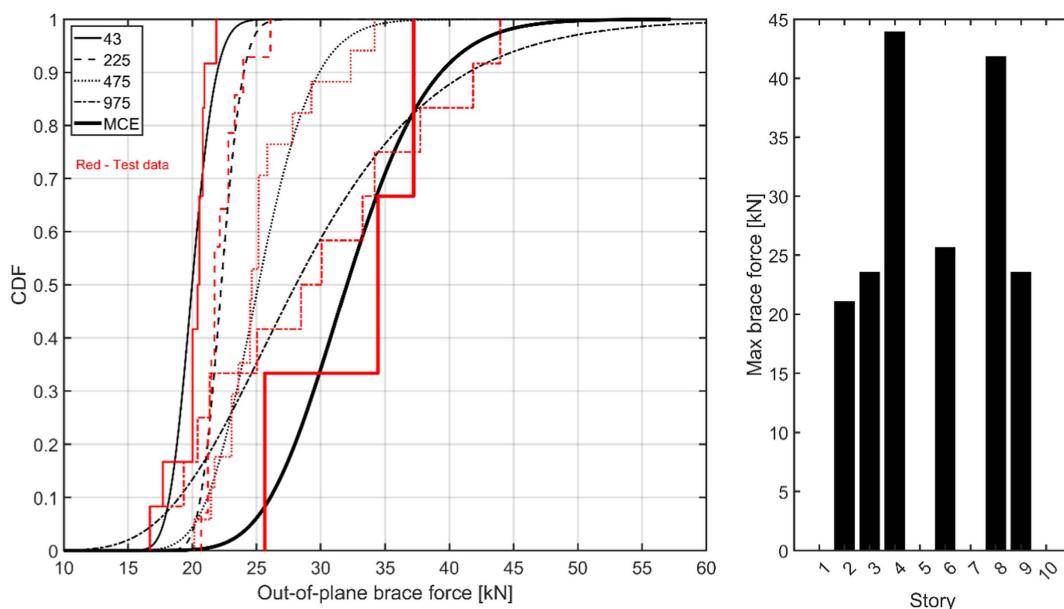
**Fig. 19.** Measured maximum rocking wall out of plane bracing demand and its distribution along building height.

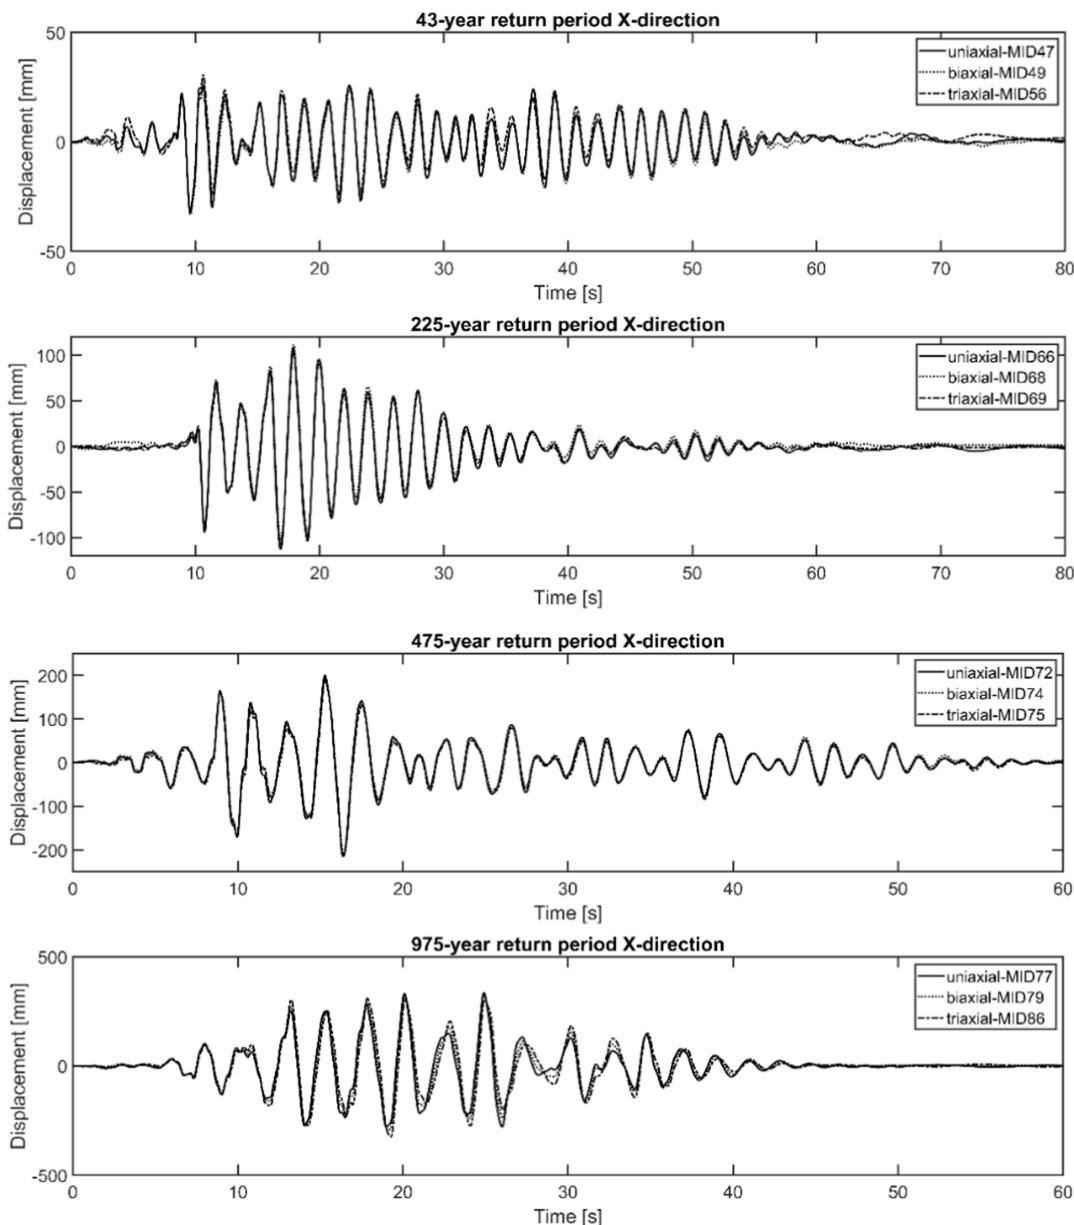
**Fig. 20.** Representative roof displacement time history comparison of multidirectional excitation conditions.

Fig. 20 shows representative roof displacement comparisons among uniaxial, biaxial, and triaxial tests using the same ground motion records at different intensity levels. Multiaxial loading had an insignificant effect on roof displacement up to the 975-year return period hazard. Fig. 21 summarizes the maximum values of key measurements from different excitation types and similarly shows that peak response quantities in one building direction were not significantly impacted by the addition of orthogonal and

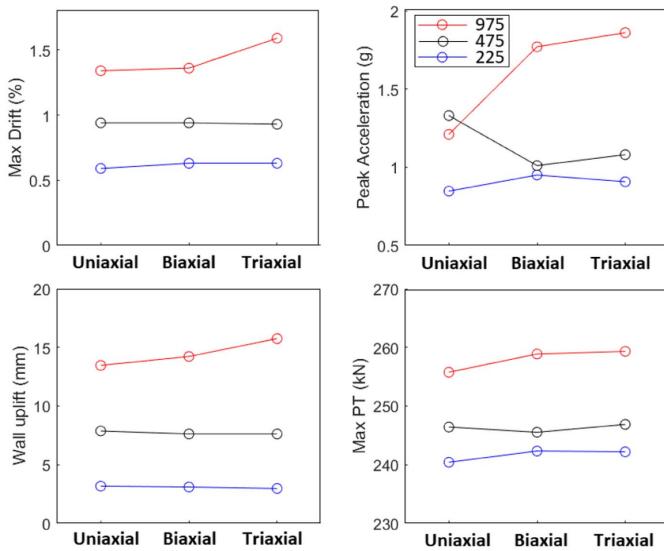
**Fig. 21.** Maximum response from ground motion with different directionality.

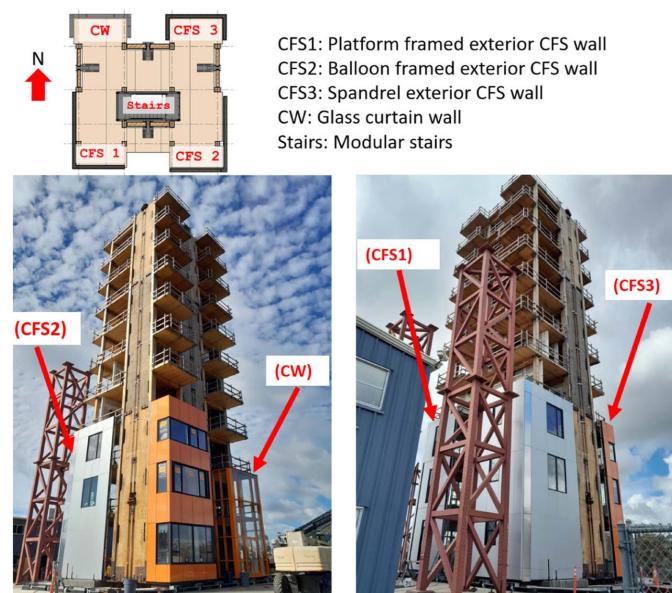
**Fig. 22.** Finished building with different exterior façade components. (Diagram adapted from Busch 2023; images by authors.)

The building included four exterior façade subassemblies supported by the cantilevered concrete foundation blocks, one on each corner of the building (see Fig. 22). Three of the façades utilized cold-formed steel (CFS) framing, with drywall sheathing on the interior side, and fiberglass mat or steel-sheathed drywall sheathing on the exterior side with an aluminum composite panel skin finish outboard of a rainscreen drainage gap; and each were three stories tall. A variety of windows and one door were also included. The first L-shaped subassembly utilized platform framing, meaning the
