# Shake-Table Testing of a Full-Scale 10-Story Resilient Mass Timber Building

**Abstract:** As part of a collaborative research effort (The NHERI TallWood Project), an extensive shake table test program was undertaken on a full-scale 10-story mass timber building with a resilient posttensioned mass timber rocking wall lateral system. Over a three-year period, academic and industry partners collaborated on the design, construction, and testing of a 34 m (113 ft) tall, 10-story mass timber building at the world's largest outdoor shake table facility (NHERI@UC San Diego). The test building incorporated a resilient mass timber rocking wall lateral system, gravity connection details designed to remain damage-free under design level earthquakes as well as innovative nonstructural systems detailed to tolerate moderate building drifts without significant damage. A total of 88 earthquake tests at different intensity levels were conducted, including several at the risk targeted maximum considered earthquake intensity for the building's design location. Experimental results indicate that a tall wood building with the systems and details employed in this study can withstand design basis and m

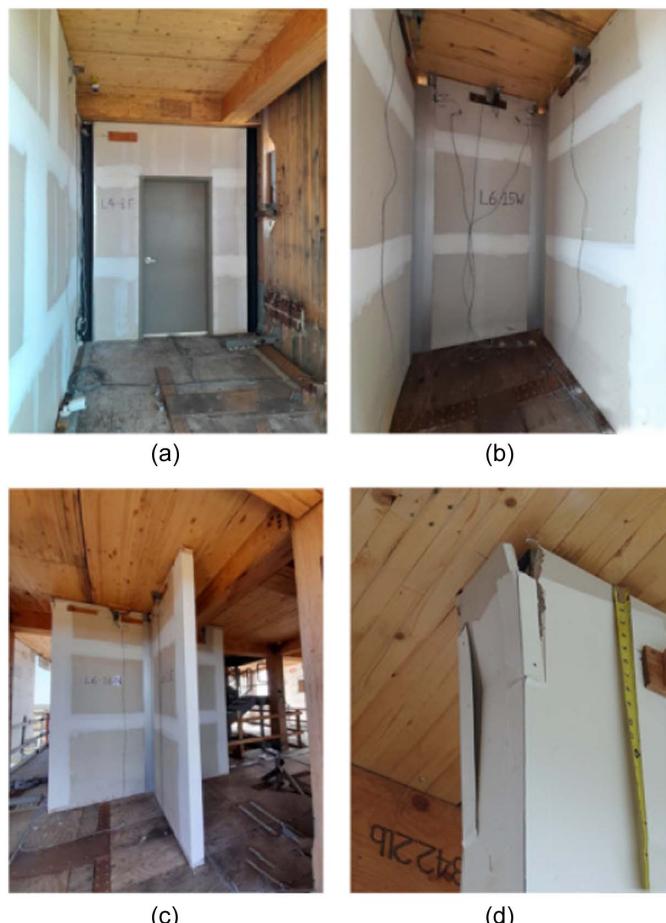
**Fig. 23.** Interior partition walls and typical damage: (a) interior wall with door; (b) C-shaped partition wall; (c) T-shaped partition walls; and (d) typical damage observed on partition walls. (Images by authors.)

adjacent conventional interior to shaft wall connection that allowed for continuous slip across the interface. However, some damage to drywall was observed after the test, as shown in Fig. 23(d), even with the sliding track detail. This type of damage can be avoided by dropping the level of the gypsum board at the end of the wall. The preliminary observations of the interior partition walls response are detailed in Ji et al. (2024).

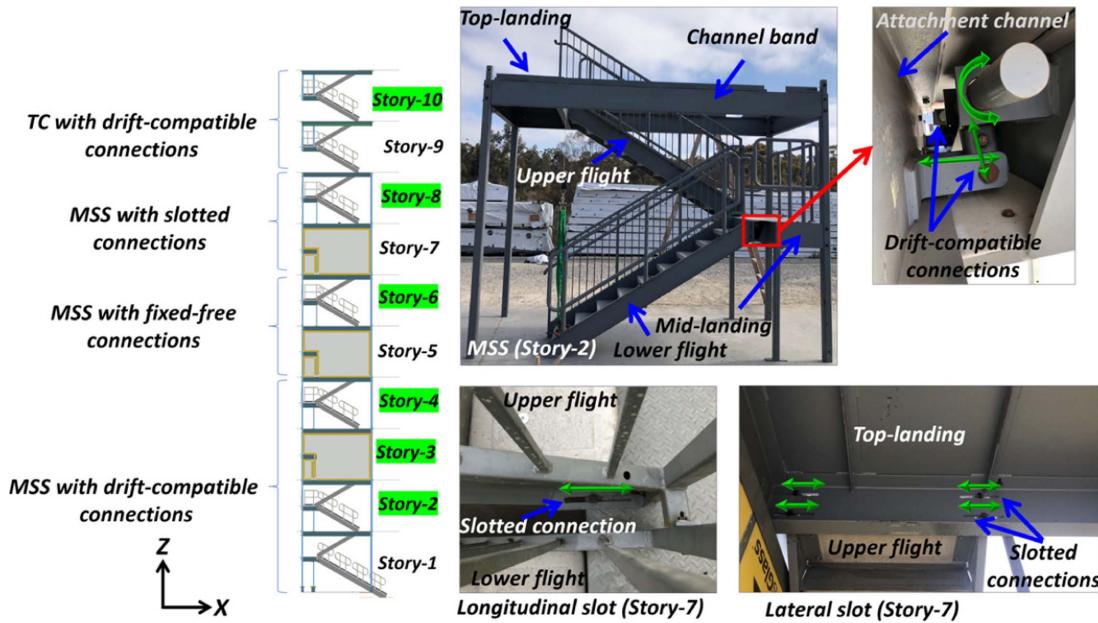
**Fig. 24.** Stair tower with instrumented stories highlighted in green, and a sample of stair connection details with degrees of freedom shown using green arrows. (Images by authors.)
