## Bending induced wrinkling and creasing in axially crushed aluminum tubes

Jake A. Haley, Stelios Kyriakides \*

Research Center for Mechanics of Solids, Structures & Materials, The University of Texas at Austin, ASE 5.230 Austin, TX 78712, USA

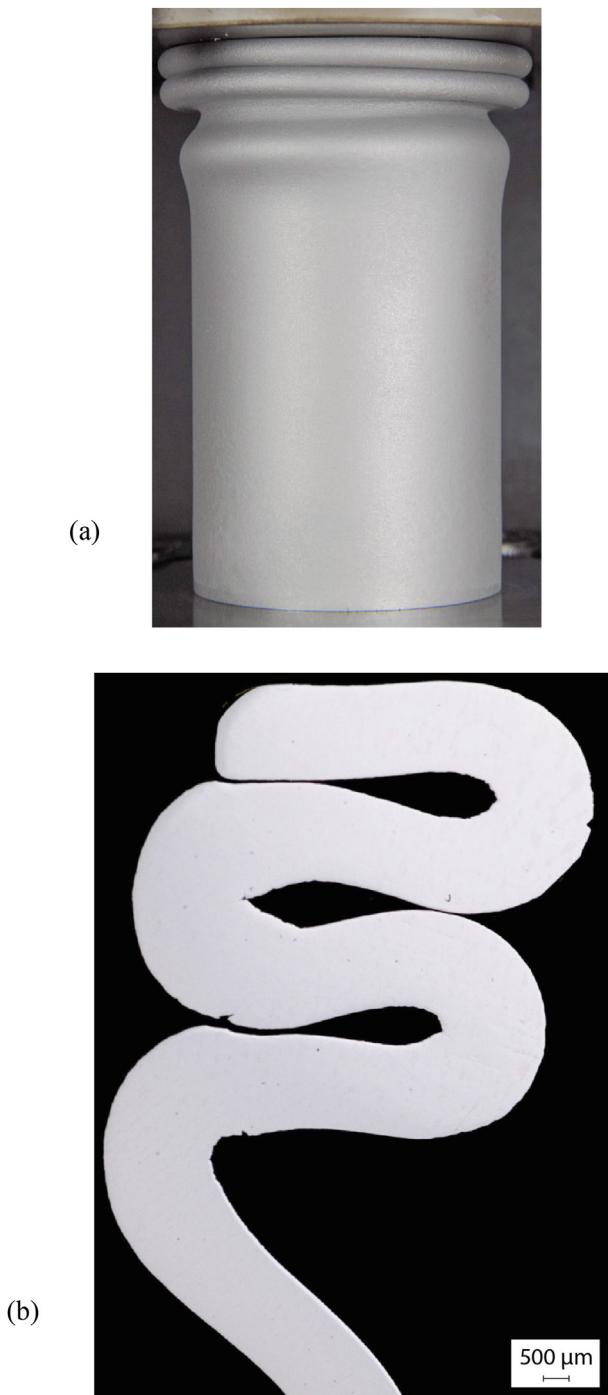
**Fig. 1.** (a) Crushed aluminum alloy tube exhibiting axisymmetric folding (Exp. II,  $D/t = 25.6$ ). (b) Polished cross section of specimen in (a).

The crushed tubes were first examined externally and photographed intact as shown in **Fig. 1a**. This revealed a significant “orange-peel” type surface roughening on the outer surfaces of the folds. The tube was subsequently cut axially in half and the flat surfaces were polished for observation under a microscope. This produced images like the one in **Fig. 1b** in which some cracking on the outer surface is evident. Simultaneously, signs of wrinkles and crease-like features on the compressed side became apparent. This prompted a more detailed microscopic evaluation of specimens at magnifications at which the deformation at the grain level could be detected. To this end, sections were removed from one of the sectioned halves of the crushed tubes and polished followed by etching as described in **Appendix A**.

shown in Fig. 1 (see Table 2). The force–displacement response recorded is included in Fig. 2 where it is seen to nearly replicate the response of Exp. I up to the point that experiment was terminated. The events associated with the crushing were outlined in the introduction. The crushing was terminated just as the second fold came into contact terminating local deformation and a third one started to form. The grain level micrograph of the affected part of the cross section is shown in Fig. 4. We are again mainly concerned with the compressed sides of the folds and have marked three areas for more detailed analysis.

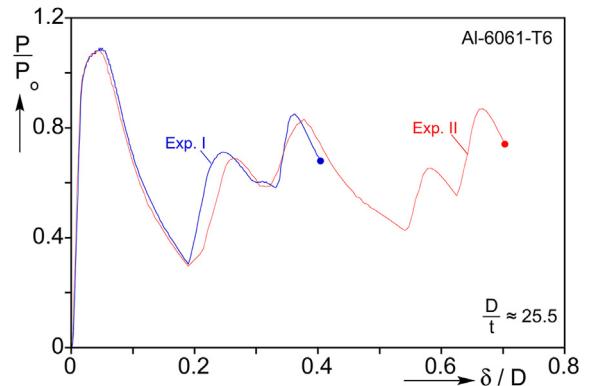
**Fig. 2.** Force-end displacement crushing responses recorded for Exps. I and II ( $P_0 = \pi(D - t)t\sigma_0$ ).

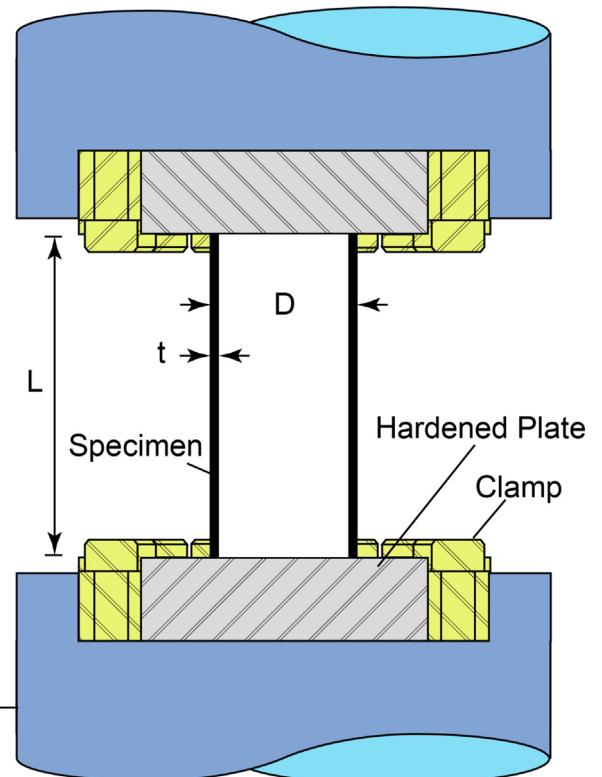
**Fig. 3.** The crushing tests were performed under displacement control using the setup shown schematically.

The tubes were crushed between two rigid plattens in a servo-hydraulic testing machine under displacement control (see **Fig. 3**). The displacement rate was such that during the initial uniform deformation part of the test it resulted in a strain rate of  $\dot{\varepsilon} \approx 2 \times 10^{-4} \text{ s}^{-1}$ . The force and displacement were recorded in a data acquisition system running LabView. The crushing of the specimen was monitored with time-lapse photography using a 12 MP digital camera running on a common time base with the data acquisition system. Typically, images were recorded at 8 s intervals. Post-processing related the images with the force displacement-response (typical such records are reported in Haley, 2020).

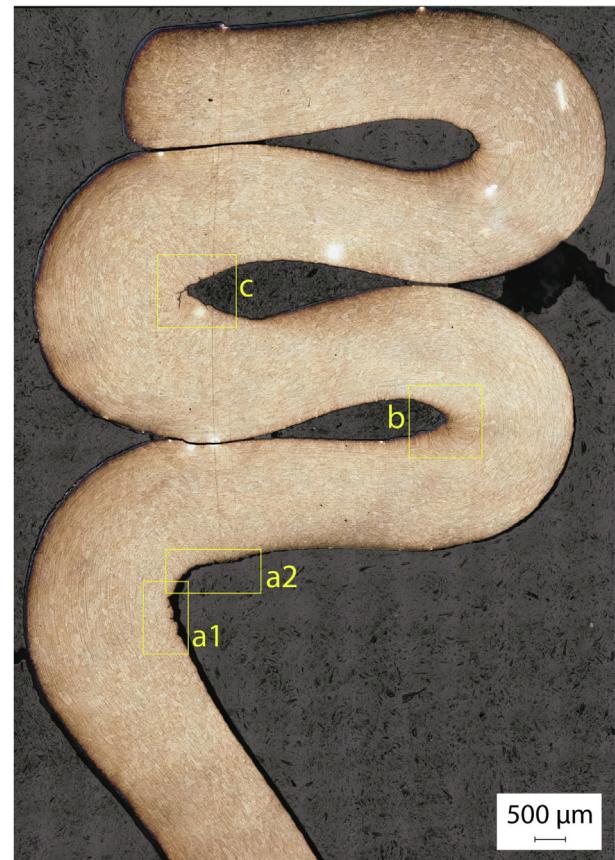
**Fig. 4.** Etched image of part of the cross section of the tube of Exp. II. Boxes identify areas of interest that appear subsequently enlarged.

zoom into parts of the section of interest. Thus for example, in **Fig. 4** three areas of interest in yellow boxes will appear enlarged in subsequent figures.

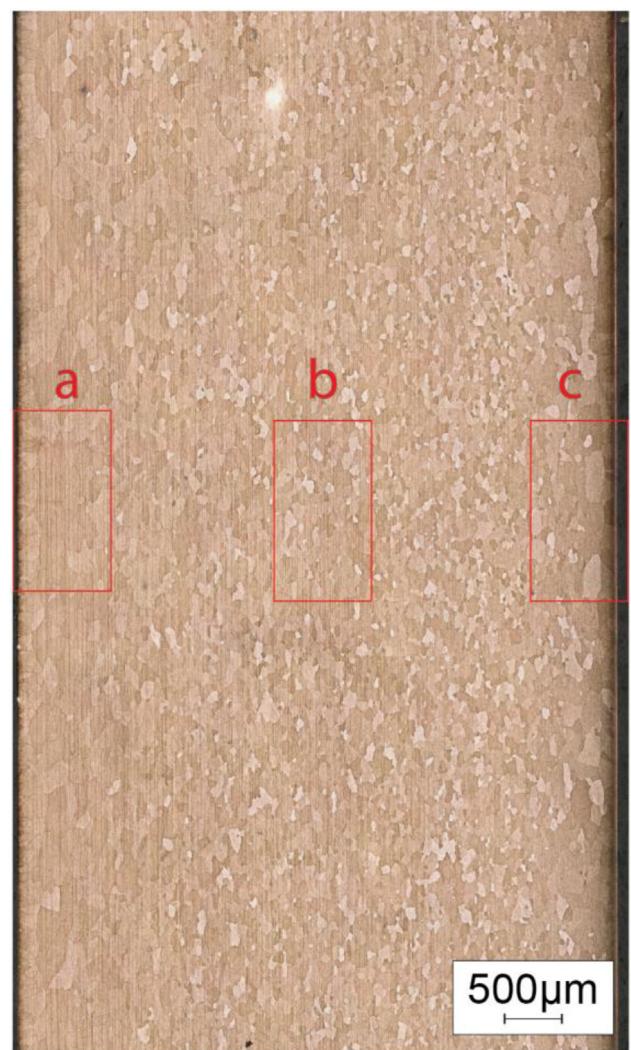
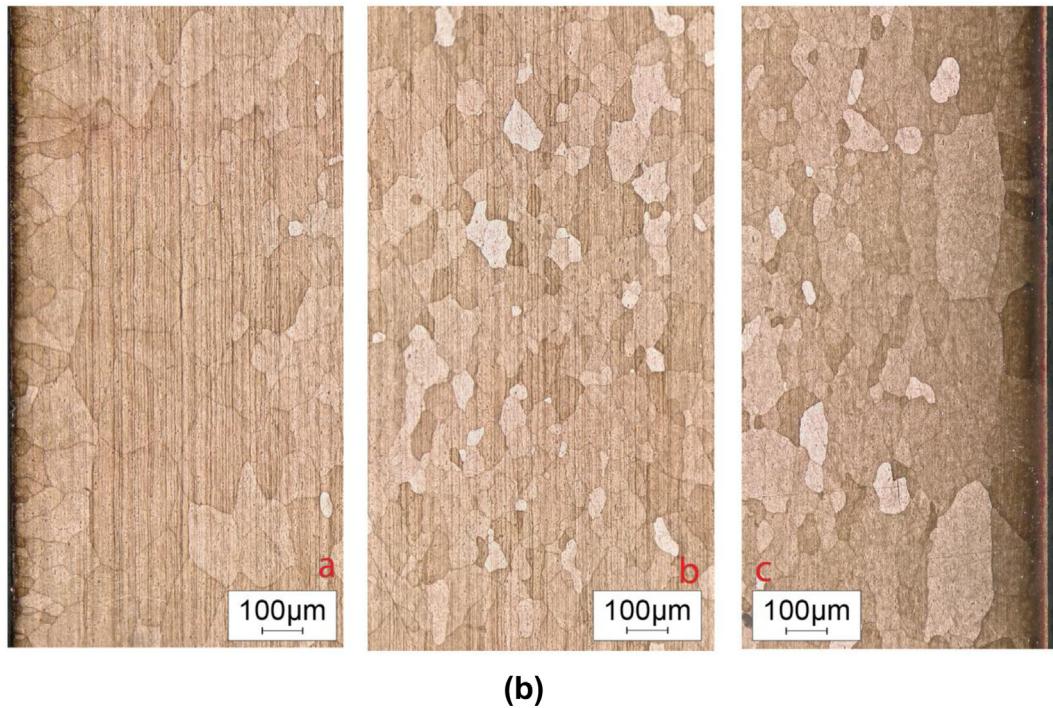
Fig. 5. Etched images showing the grain microstructure across the wall thickness of the undeformed extruded tube. (a) Full thickness – the left represents the inner surface. (b) Enlarged images showing grain distributions close to the inside surface “a,” in the interior “b,” and near the outer surface “c.”

“b” represents the grain distribution away from the edges; and “c” is representative of the outer surface of the tube.

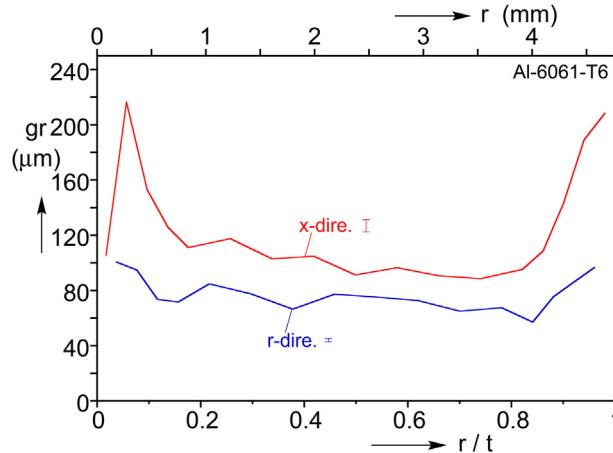
**Fig. 6.** Grain size measured across the tube thickness using a lineal intercept method;  $x$  is along the axis of the tube and  $r$  is a measure across the thickness starting from the inner surface.

The distribution of grain size across the wall thickness ( $r$ -direction) and along the axial direction ( $x$ ) was established using a type of *lineal intercept method* as described in ASTM E112-13, and the results are plotted in Fig. 6. What is apparent is that for the inner 70% of the wall thickness, the grain size is somewhat elongated along the axial direction but nearly uniform with an average size of about  $70 \times 100 \mu\text{m}$ . The grain sizes along the inner and outer surfaces are different. The inner surface starts with a zone about  $200 \mu\text{m}$  wide with grain sizes representative of the interior, followed by a zone about  $500 \mu\text{m}$  wide with grains that are significantly elongated along the axial direction. Similarly, elongated grains populate a zone about  $700 \mu\text{m}$  wide along the outer surface, but here the finer grain zone at the edge is absent. These trends are also confirmed by the grain size plot in Fig. 6. It is worth remembering that the outer surface of all tubes discussed in this study was turned down in order to achieve the desired wall thickness. Consequently, their outer surface had the initial grain distribution representative of the central part of the wall thickness in “b”. In addition, the enlarged images exhibit some fine lines along the axial direction. These are areas that underwent differential etching. They will also show up as deformed “stream lines” in the images of the folds that follow.

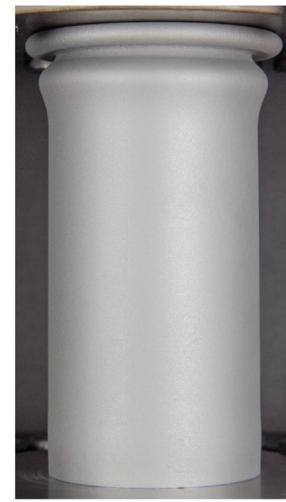
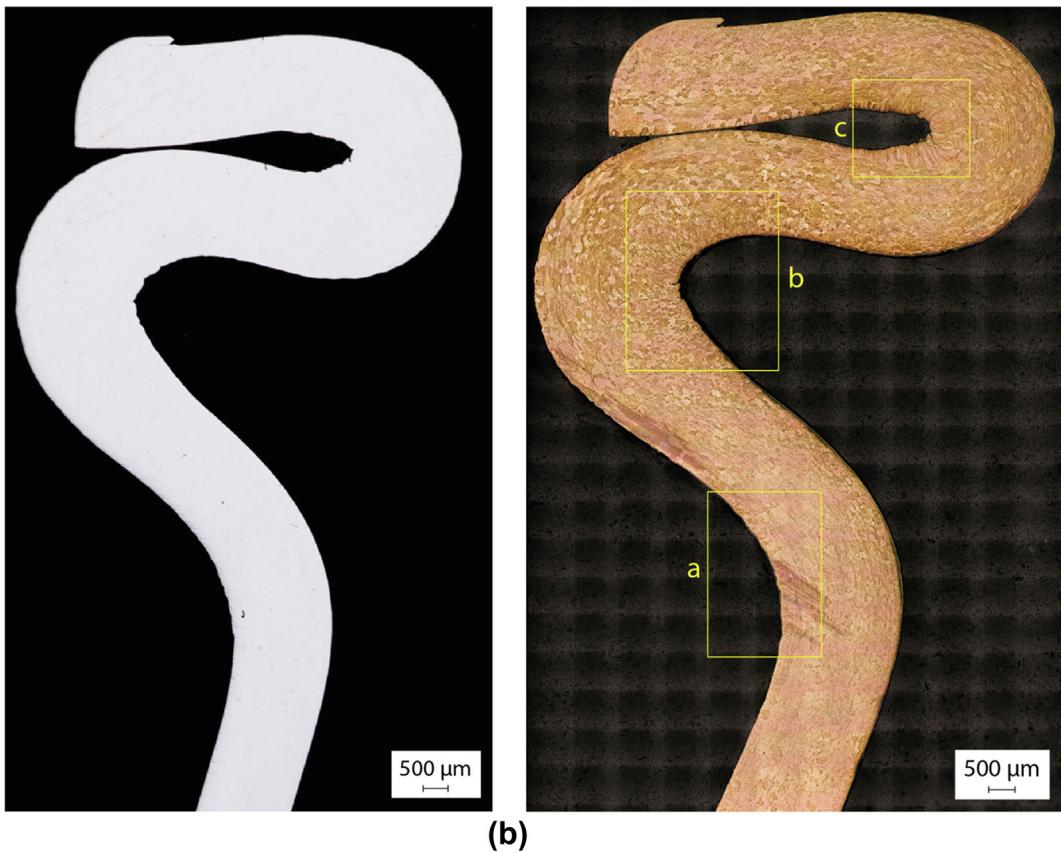
**Fig. 7.** (a) Crushed tube from Exp. I ( $D/t = 25.6$ ). (b) Polished and etched cross sectional images from Exp. I. Boxes identify areas of interest that appear subsequently enlarged.

This involves a tube with a  $D/t$  of 25.4 crushed only to one complete axisymmetric fold as shown in Fig. 7a. The recorded force-displacement ( $P - \delta$ ) response is included in Fig. 2, and images of the deformed cross section are shown in Fig. 7b and c. The experiment was terminated just as an inward fold started collapsing while simultaneously an outward one started forming. This provides three zones of the cross section bent to different degrees marked in Fig. 7c. In zone “a,” the inner surface is only lightly compressed by bending. In zone “b,” the outer surface of the second fold is at a more advanced state of bending induced deformation, and zone “c” encompasses the compressed side of the completed fold. The three zones are shown expanded in Figs. 8a and 8b.

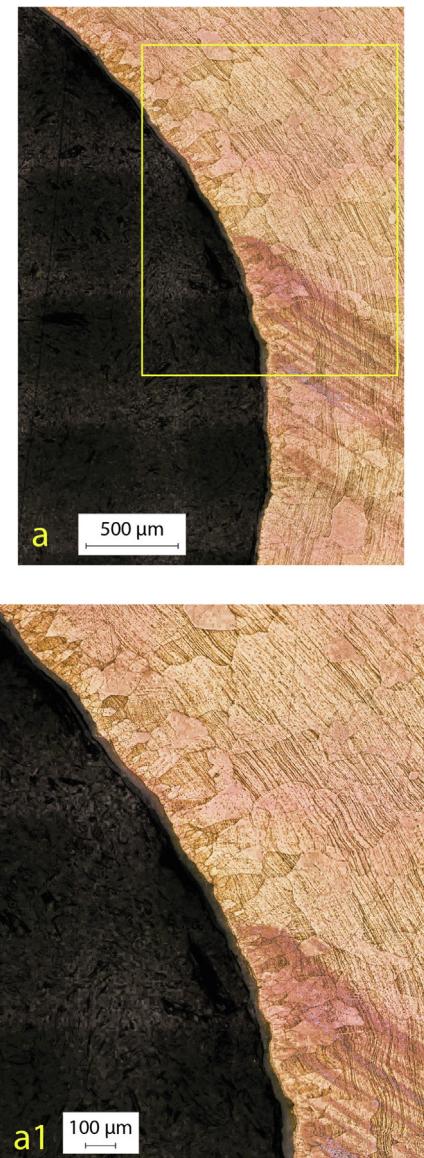
**Fig. 8a.** Expanded images of zones “a” and “a1” from the overall image in Fig. 7b that show surface wrinkles and grain deformation adjacent to it.

In zone “a” shown expanded in Fig. 8a, the microstructure, with the finer grain layer at the free edge and larger elongated grains somewhat further in, has deformed to accommodate the compression induced by the imposed curvature. The etching lines are also seen to follow the curvature of the section. Simultaneously, a significant number of surface undulations have appeared on the free surface. A total of 30 such wrinkles of varying amplitude have been identified with wavelengths ranging from about  $50 \mu\text{m}$  to  $240 \mu\text{m}$  with an average of  $90 \mu\text{m}$ . A sub-zone of this image, designated as “a1,” is shown expanded below image “a”. Here the surface undulations are seen to consist of several grains of varying sizes, an indication that they are independent of the grain microstructure.

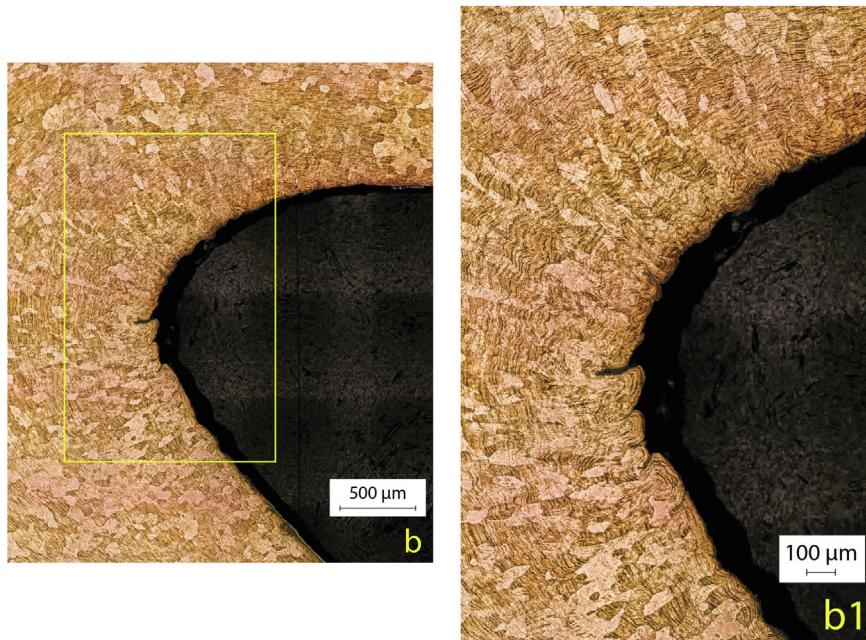
**Fig. 8b.** Expanded images of zones “b” and “b1” from the overall image in Fig. 7b. The larger curvature of this zone caused the amplitudes of surface undulations to grow with several of them separated by creases. Observe also the large distortion of the grains adjacent to the surface.

Fig. 8b shows expanded zone “b” together with subzone “b1” which zooms into the area with the largest curvature. Here because of the larger curvature of this fold, the grains are severely flattened to accommodate the local compression. The surface undulations are in a more advanced deformation state with significantly larger amplitudes. Because of the severity of the compres-

sion, several have morphed into folds, and interfaces of adjoining folds have become crevices or creases. Away from the free surface, the etching lines follow the induced curvature, whereas at the free surface they follow the deformation of the folds. The highly deformed grains inside the folds and the contours of the etching lines inside them indicate again that the formation of these folds and creases may be independent of the local microstructure.

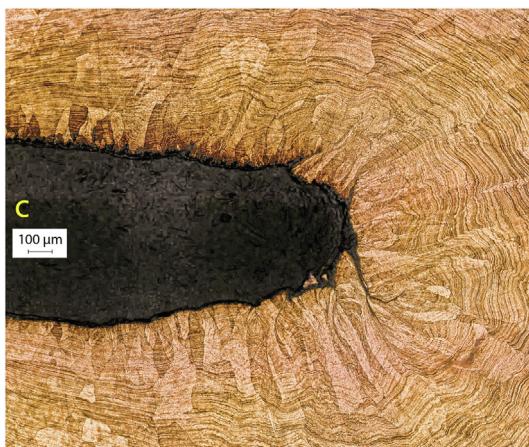
**Fig. 8c.** Expanded image of zone “c” showing the inner surface of the completed fold in Fig. 7b. The very tight local curvature caused several of the undulations to protrude outward with several of them separated by deep crevices. The grains adjacent to the surface are highly flattened along the normal to the surface to accommodate induced compression.

Zone “c” in Fig. 8c shows the most compressed part of the completed structural fold. The large compression has caused the grains to flatten. Thus, the larger grains just inside the surface in Fig. 5b, in this micrograph are very elongated along the normal to the free surface. This elongation tends to decrease moving away from the free edge. The amplitudes of surface undulations at the top and bottom of the bent free surface increased significantly. Closer to the trough with the largest curvature, folds like the ones seen at site “b” in Fig. 8b, are now even more elongated, and adjoining creases are much deeper appearing as cracks. The local compression is so large that some of the folds are protruding out, breaking the continuity of the surface. One of the protruding folds is seen bent over its neighbors from which it is separated by a bifurcated crease.

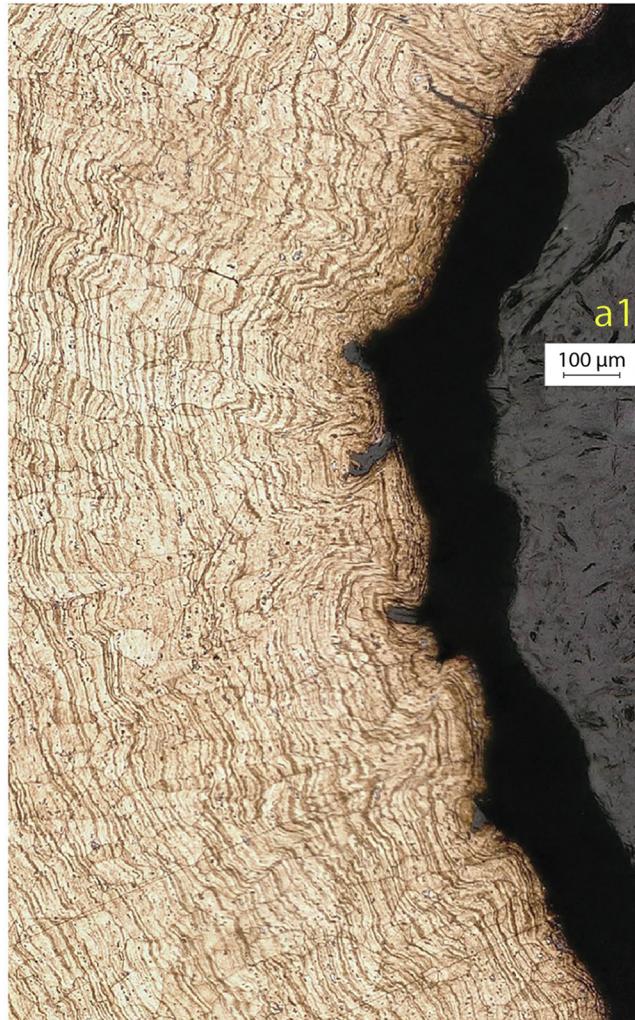
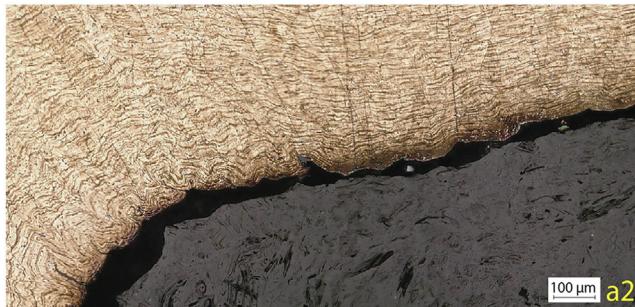
**Fig. 9a.** Expanded images of zones “a1” and “a2” from the overall image of tube from Exp. II in Fig. 4. Part of zone “a2” that is less bent shows surface wrinkles, whereas the more bent left side shows more pronounced wrinkles separated by creases. The higher curvature of zone “a1” has caused more significant protruding undulations and creasing.

Adjacent zones “a1” and “a2,” shown expanded in Fig. 9a, come from the compressed outer surface of the lower partially bent lobe.

The surface of zone “a2” belongs to the end of the second fold and is not as severely bent as zone “a1.” Its surface is covered by well-developed wrinkles with wavelengths ranging from about 85–160  $\mu\text{m}$ . Moving to the left side of the image, the increasing curvature causes the amplitude of the local wrinkles to grow with several of them evolving into protruding folds separated by creases. Close to the free surface the etching lines follow the contours of the wrinkles but further in they follow that of the bent wall. Enlarging the image confirms that the wrinkles encompass several grains as reported earlier.

Zone “a1” is in the more bent part of this lobe and consequently several of the surface undulations have developed into protruding folds separated by crease-like depressions. Once again, these surface features encompass several highly deformed grains and the etch lines follow their surface contours. The grains just inside the free surface are highly elongated in along the normal to the surface. The etch lines exhibit some undulations consistent with differences in deformation in neighboring grains. They become smoother with their trajectories conforming to the imposed curvature further away from the free surface.

Zones “b” and “c” are shown expanded in Fig. 9b. Zone “b” shows the innermost section of the second fold and belongs to the inner surface of the tube. Several of the surface undulations have evolved into protruding folds separated by creases. Since this is an inner tube surface, the wrinkles and folds have finer grains on their surface with highly elongated large grains adjacent to them. These are the large grains close to the inner surface in the undeformed micrograph in Fig. 5b. They were originally longer along the axial direction, but here they are elongated in a direction normal to the free surface. One of the protruding folds has moved further out and is bent over its neighboring folds from which it is separated by a long crease. Overall, the observations are similar

Zone “c” in Fig. 9b shows the most bent part of the trough formed between the first and second folds. The large local curvature has resulted in large amplitude wrinkles separated by creases. Several of the wrinkles are similar to those in image “a1.” They encompass several highly deformed grains elongated along the normal to the free surface. The finer surface grains and the highly deformed inner grains in image “b” have been replaced by a more uniform grain microstructure consisting of highly deformed grains elongated along a direction normal to the free surface. On the surface of the wrinkles, the deformed grains conform to their rounded shapes. In the deepest part of the trough a protruding fold has bent over its neighboring ones, and this has formed a deep crease like feature.

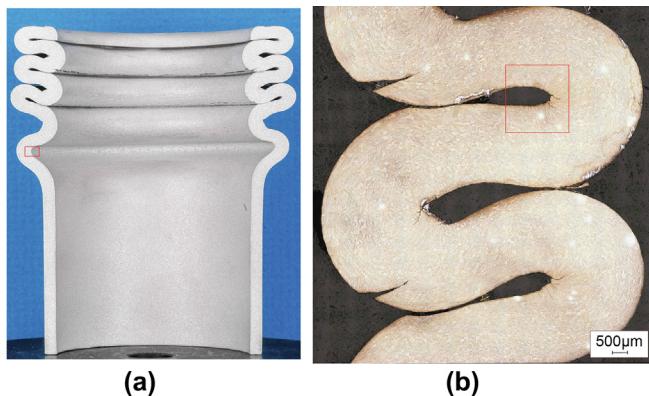
**Fig. 10.** (a) Cross section of crushed tube with  $D/t = 18.5$  from Exp. III. (b) Polished and etched image showing part of the folded cross sectional image. Observe the significant failures on the tensioned side of the inner folds.

new development brought about by the increase in the wall thickness of the tube is that the inner extrados between the second-third and third-fourth folds have developed major ruptures. The global image in Fig. 10a shows the ruptures to affect the whole half circumference. It is interesting to observe that these ruptures occurred at the same locations on the folds as in the higher  $D/t$  tube in Fig. 1b, but those failures had just initiated.

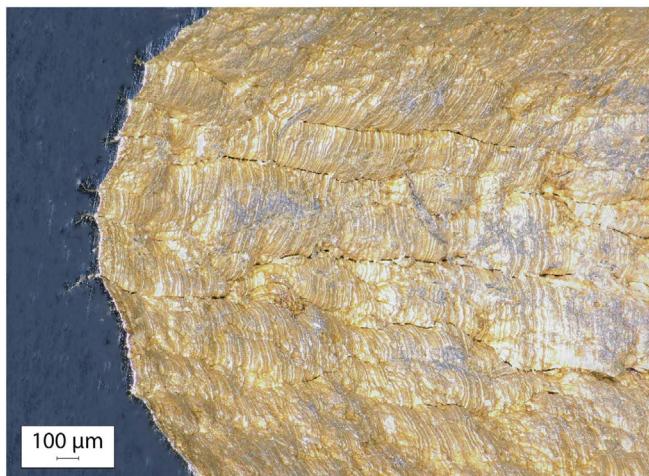
**Fig. 11.** Three-dimensional rendering of the inner surface of the third fold from Exp. III obtained using a confocal microscope (location marked in Fig. 10a). Observed are surface undulations separated by creases on the inner surface of the fold that trace azimuthal directions. The depth of several crease-like features can be seen on the cut surface on the left.

The surface wrinkles are clearly discernible in the trough of the bent section, where they impart an uneven, rough appearance to the bent surface. The wrinkle wavelengths are consistent with the values reported for Exps. I and II. The wrinkles are separated by discontinuities, which can be seen on the cross section to be crease like. They generally follow the circular profile of the circumference of the fold, but some of the wrinkles and creases tend to deviate from the circumferential trajectories presumably because of microstructural or other obstacles. This indicates that the locations of wrinkles, folds and creases observed on any axial section of a crushed tube can differ from those on another axial section. However, overall this three-dimensional view supports the observations made from the 2-D images.

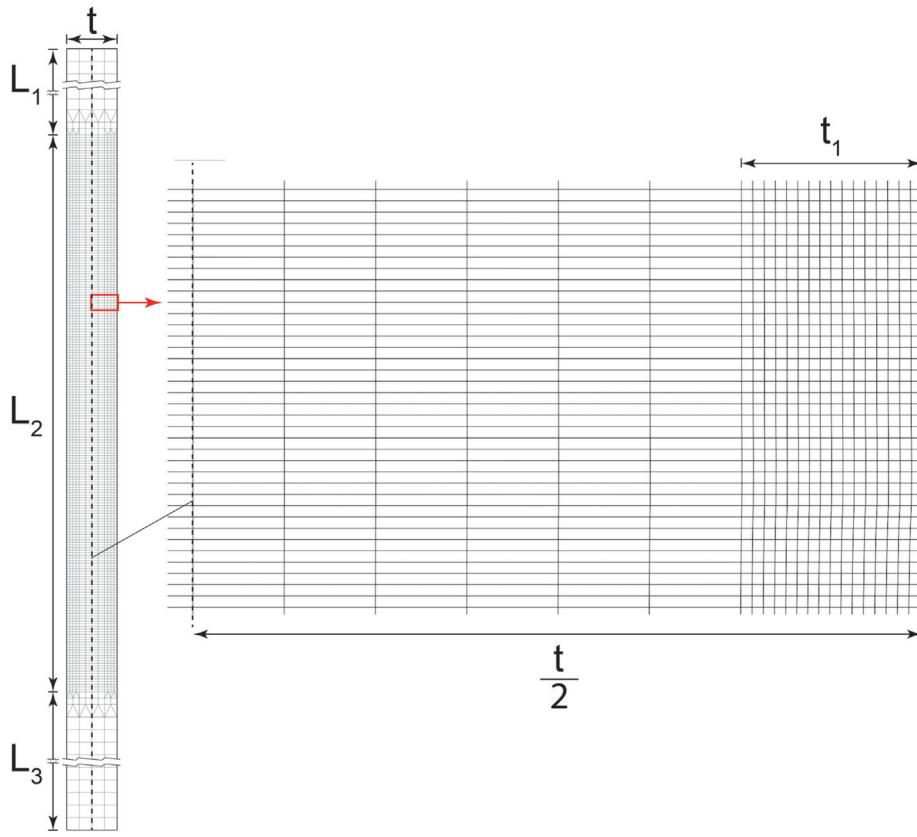
**Fig. 12.** The geometry and mesh of the axisymmetric finite element model used to simulate tube crushing.

mately  $0.54 \times 10^{-3}$  in (13.7 μm). The interior has twelve elements of the same height. The upper section of length  $L_1 = 0.868$  in (22.0 mm) is meshed with four elements across the thickness with a nearly 1:1 aspect ratio, which are sufficient to capture the folding with the required accuracy. The simulation of the inward folding of the top part of the model was particularly challenging because of the significant sliding and large deformation that the contacting surface undergoes. The contact of the top surface with the rigid plane was frictional using a friction coefficient of 0.25 and an exponential pressure-overclosure softening relationship. At the lower end, a length of  $L_1 = 2.859$  in (72.6 mm) is also meshed with four elements across the thickness. The contact with the lower rigid surface is frictionless.

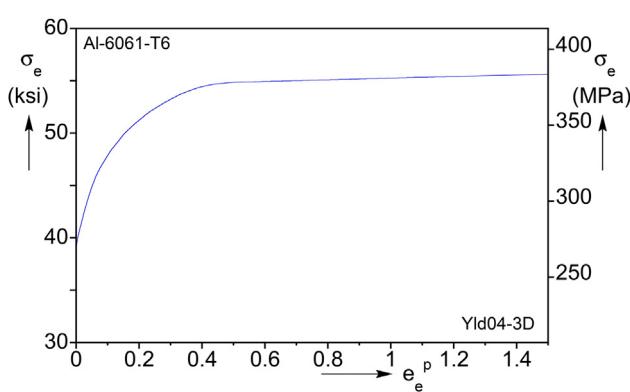
**Fig. 13.** The stress-plastic strain response of Al-6061-T6 used in the analysis.

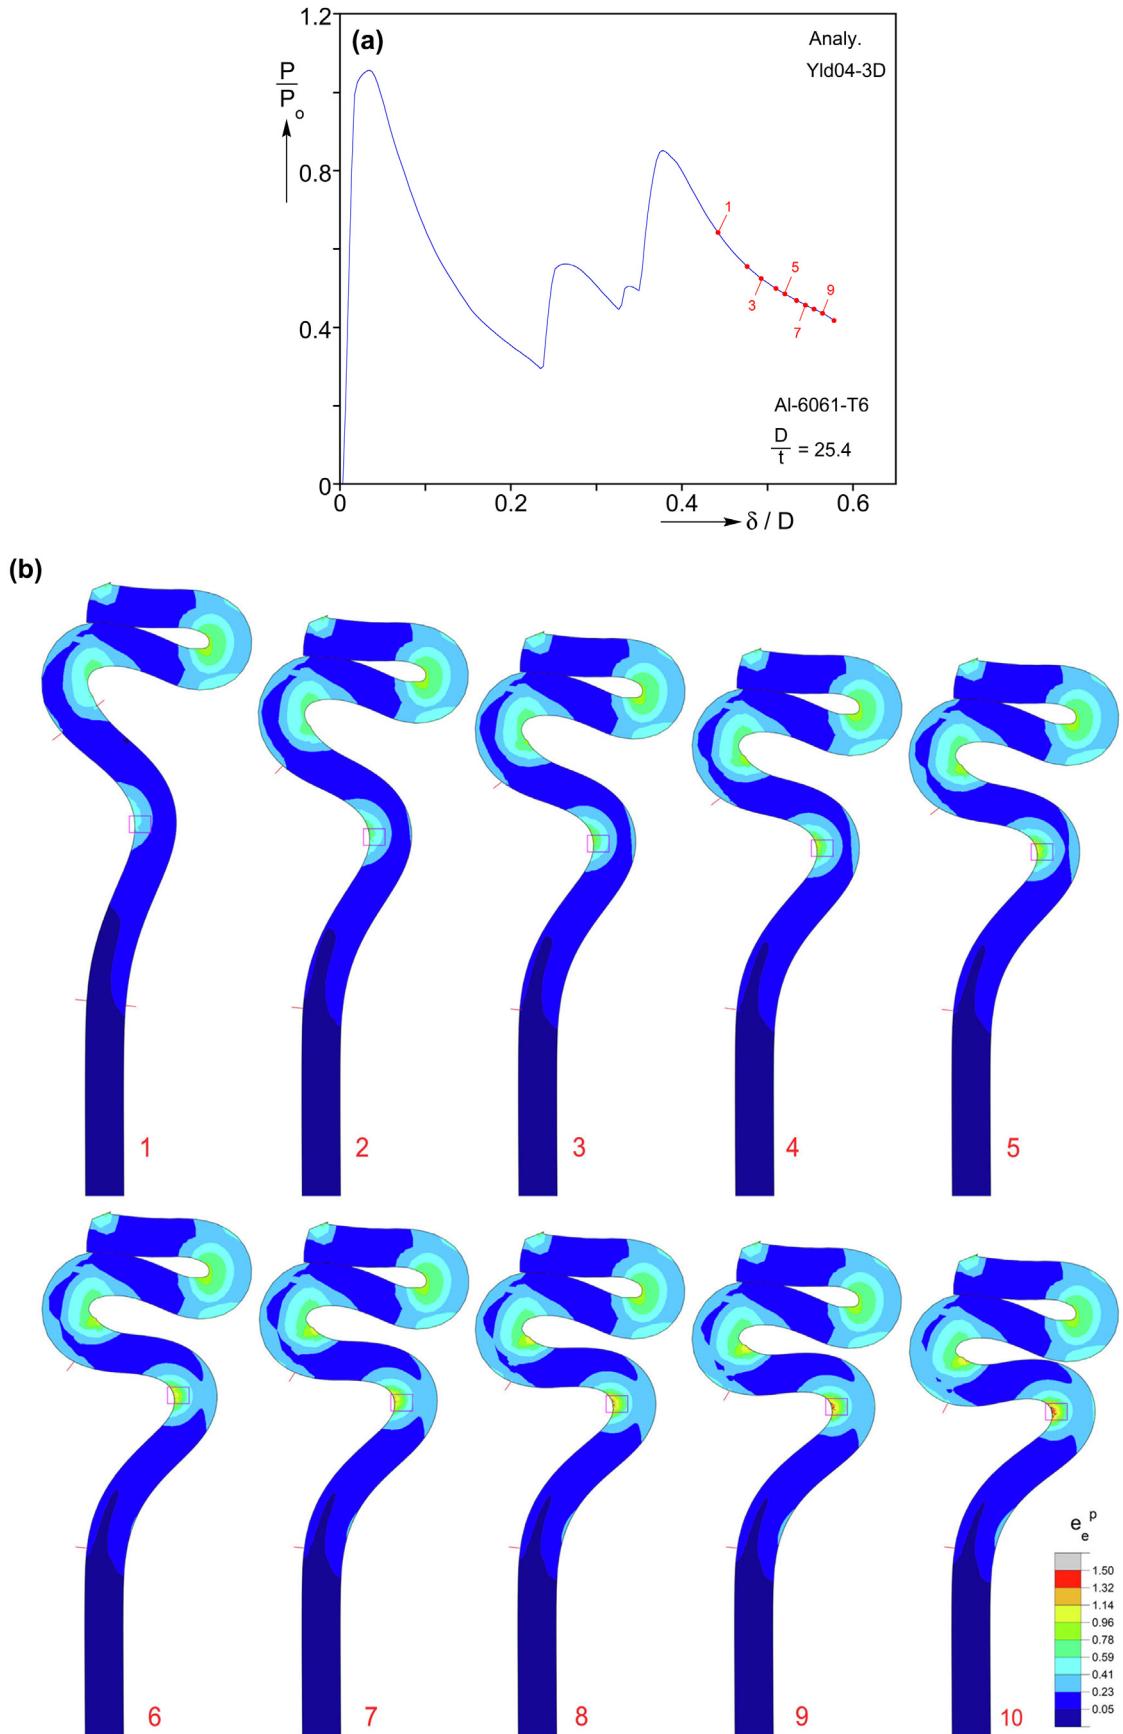
**Fig. 14.** (a) Calculated force-end displacement crushing response. (b) Global configurations corresponding the formation of the second fold corresponding to the stations marked on the response in (a) with numbered bullets.

The calculated force–end shortening response ( $P/P_0 - \delta/D$ ) is plotted in Fig. 14a. The tube crushes in the manner outlined for the experiment in Section 1. Compression causes localization into a protruding lobe at the top; its amplitude grows with the overall load dropping and evolves into a fold with part of the top surface folding inwards. This folding traces the two-peak response that follows the first load valley. A third load peak is reached indicating the formation of a second fold. A more detailed description of the folding is given in Section 2.3.1 and Section 4.2.1 of Haley (2020). Here we pick up the events associated with the formation of the second fold during the last descending part of the response. Fig. 14b shows a set of cross-sectional images of the model with the lower part of  $L_3$  truncated for clarity. The color contours superimposed on the images represent the strain level. The images correspond to the stations marked on the response in Fig. 14a with numbered bullets.

We have chosen to expand the most deformed part of this intrados, contained in the box drawn in red on each image in Fig. 14b. The box has a constant size and is placed at nearly the center of the zone of the most bent section. Fig. 15 shows the evolution of this zone in going from deformed configurations 1–10. For better clarity, the expanded images are presented as follows: Fig. 15a 1–4, Fig. 15b 6–8, and Fig. 15c 9–10. The color represents the strain level.

In configuration 1 in Fig. 14b, the local curvature is relatively small, but the surface strain is still of the order of 0.50. This level of strain is reflected in the elongation of the elements along the normal to the free surface close to it in image 1 in Fig. 15a. The compression is sufficient to excite the imperfections in the zone of interest, resulting in the appearance of small amplitude undulations on the surface. In image 2, the larger local curvature increases the compressive strain to about 0.65 and the amplitude of the surface undulations has increased further with signs of localization of some of the undulations appearing. With further increase in the local curvature in configuration 3, some of the surface undulations in image 3 appear as creases at early stages of development. In image 4, where the surface strain is of the order of 0.85, the amplitude of surface undulations has grown further, and two of the surface depressions have “folded” into creases. In images 5 and 6, the

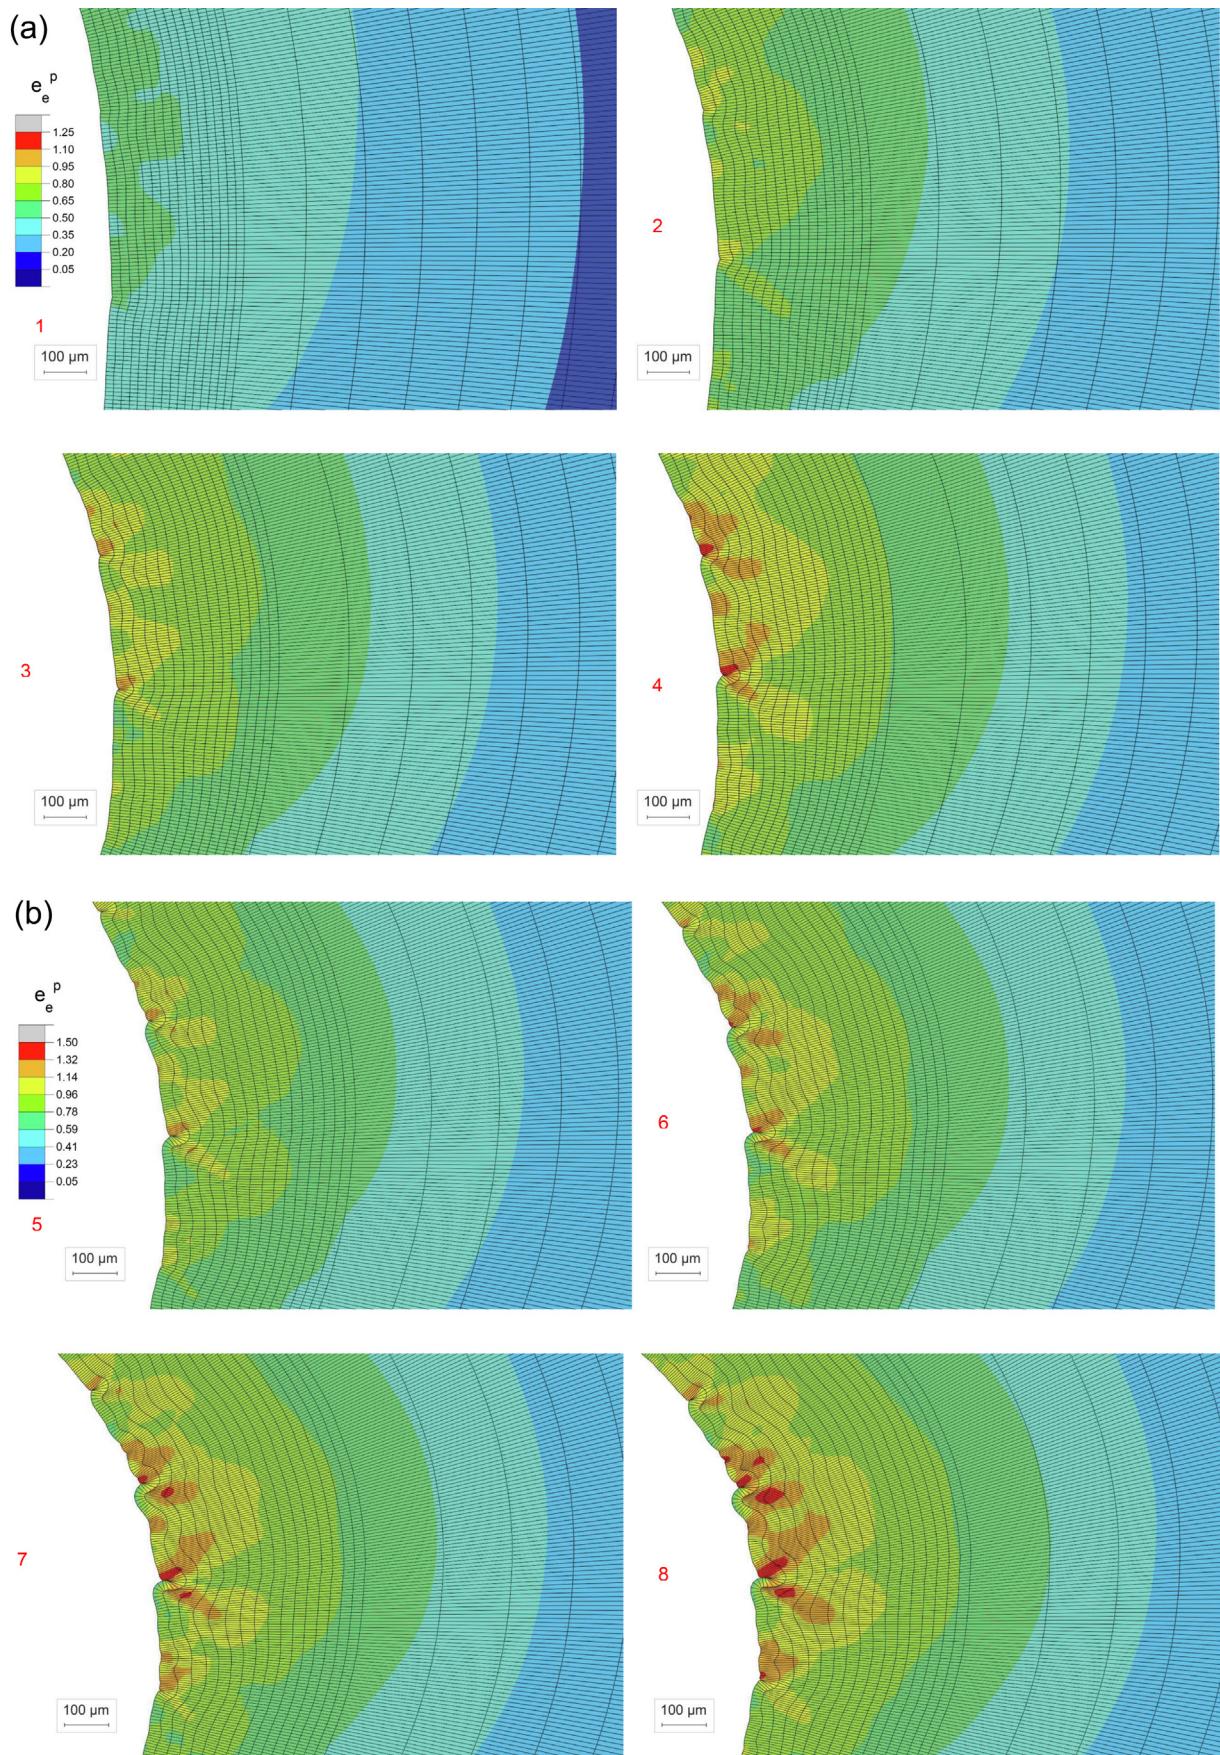
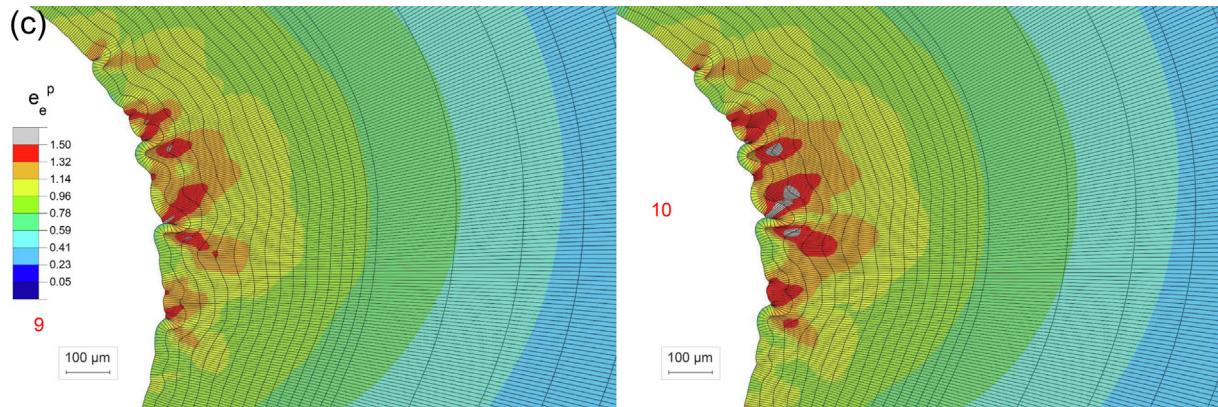
**Fig. 15.** Expanded images of zone is red box in Fig. 14b that show the evolution of surface undulations. (a) Images 1–4, (b) images 5–8 and (c) images 8–10.

additional increase in the local curvature causes the amplitude of surface undulations to grow, leading to local folding and deepening of the creases, and concurrently new crease-like features appear. Note also the additional elongation of elements close to the surface along its normal direction. The growth of surface undulations, the

- The evolution of the observed surface instabilities is influenced by the amplitude of the imperfections imposed to the surface of the tube crushed. Reducing the amplitude to one-half resulted in similar surface patterns, however their growth was delayed; to reach similar levels of deformation as in Fig. 15 required larger curvature.

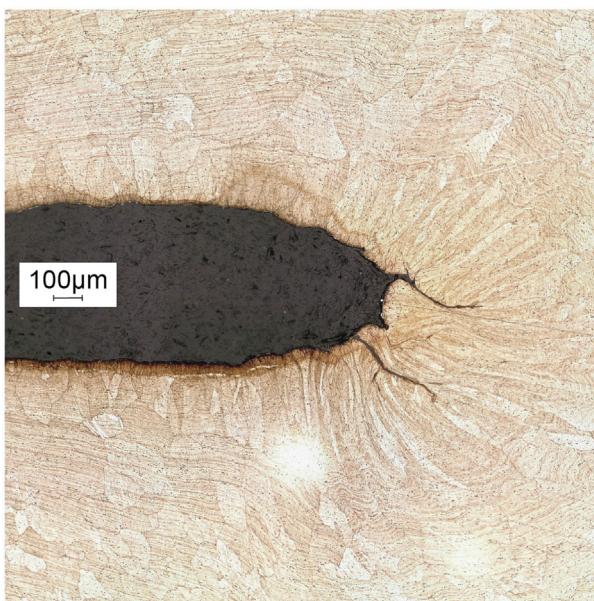
**Fig. B1.** Expanded image of the boxed zone in the larger image of the crushed section of the tube of Exp. III in [Fig. 10b](#).

[Fig. B1](#) shows an expanded image of the most deformed zone of the second fold of the crushed tube of Exp. III, identified with a box in [Fig. 10b](#). The zone shows the trough involving the inner surface of the tube, and it thus exhibits similar surface features to those observed in Figs. 8c and 9b–“b” from the higher  $D/t$  experiments. These included surface wrinkles with highly compressed small grains near the surface, highly elongated larger grains adjacent to them flattened by compression, and several protruding folds separated by creases and crevices.

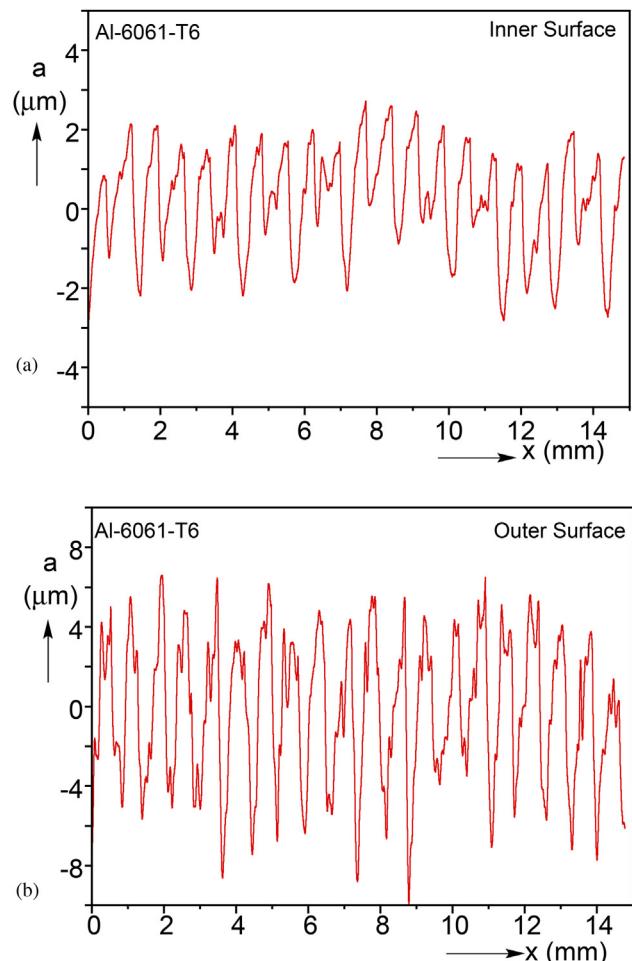
**Fig. C1.** Axial scans of initial surface roughness of tubes used in the experiments. (a) Inner surface, and (b) outer machined surface.
