# Investigation of barrier island highway and marsh vulnerability to bay-side flooding and erosion

**Abstract:** Coastal highways along narrow barrier islands are vulnerable to flooding due to ocean and bay-side events, which create hazardous travel conditions and may restrict access to surrounding communities. This study investigates the vulnerability of a segment of highway passing through the Pea Island National Wildlife Refuge in the Outer Banks, North Carolina, USA. Publicly available data, computational modeling, and field observations of shoreline change are synthesized to develop fragility models for roadway flooding and marsh condition. At 99% significance, peak daily water levels and significant wave heights at nearby monitoring stations are determined as significant predictors of roadway closure due to flooding. Computational investigations of bay-side storms identify peak water levels and buffer distance between the estuarine shoreline and the roadway as significant predictors of roadway transect flooding. To assess the vulnerability of the marsh in the buffer area, a classification scheme is proposed and used to evaluate marsh condition due to long-term and episodic (

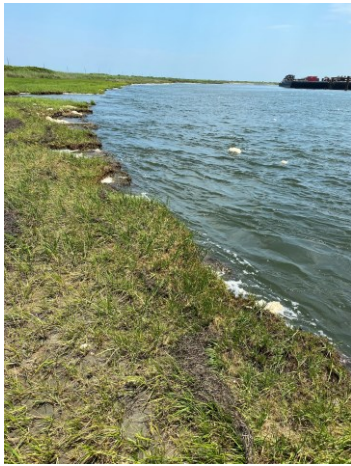
| System Rating | Shoreline Condition | Marsh Condition | Example |
|---|---|---|---|
| <b>Healthy</b> | Gentle slope;<br>Plant growth on or adjacent to shoreline;<br>Minimal to no exposed root mat. | Slope less than 1:30*;<br>All or majority of marsh above 0.61 m (2 ft) elevation;<br>Consistent plant growth throughout marsh, including juvenile plants;<br>Intact root mat. | |

One contribution of this study is the proposed methodology for characterizing the marsh shoreline as “healthy,” “eroded,” or “severely eroded” (Table 2). While guidance exists for shoreline assessment providing criteria for healthy or eroding marshes based on marsh slope or scarp height [58] and other studies have evaluated shoreline condition following extreme events [30,59,71], vulnerability to erosion [72–77], and recovery after storms [71,78], a standardized engineering methodology is required for assessing shoreline condition considering the status of erosion, vegetation persistence, and other landscape factors. Therefore, Table 2 may be refined, expanded, and generalized for evaluation of the condition of marsh shorelines or other nature-based shoreline protection alternatives.

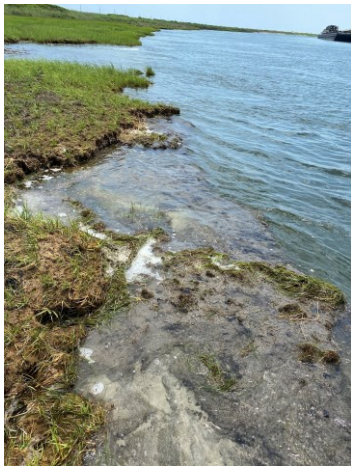
| System Rating | Shoreline Condition | Marsh Condition | Example |
|---|---|---|---|
| <b>Eroded</b> | Scarp less than 0.30 m (1 ft);<br>Evidence of offshore (in-water) plant growth<br><i>May include:</i> Evidence of undercutting or cracks, chunks of marsh breaking off along shoreline | Slope between 1:30 and 1:10*;<br>50% of marsh above 0.61 m (2 ft) elevation;<br>Evidence of dead or otherwise removed plants;<br>Intact or exposed root mat.<br><i>May include:</i> signs of semi-regular flooding, evidence of channel incursion or paleo inlets. | |
