Climate change and infrastructure development drive ice-rich permafrost thaw in Point Lay (Kali), Alaska

Abstract

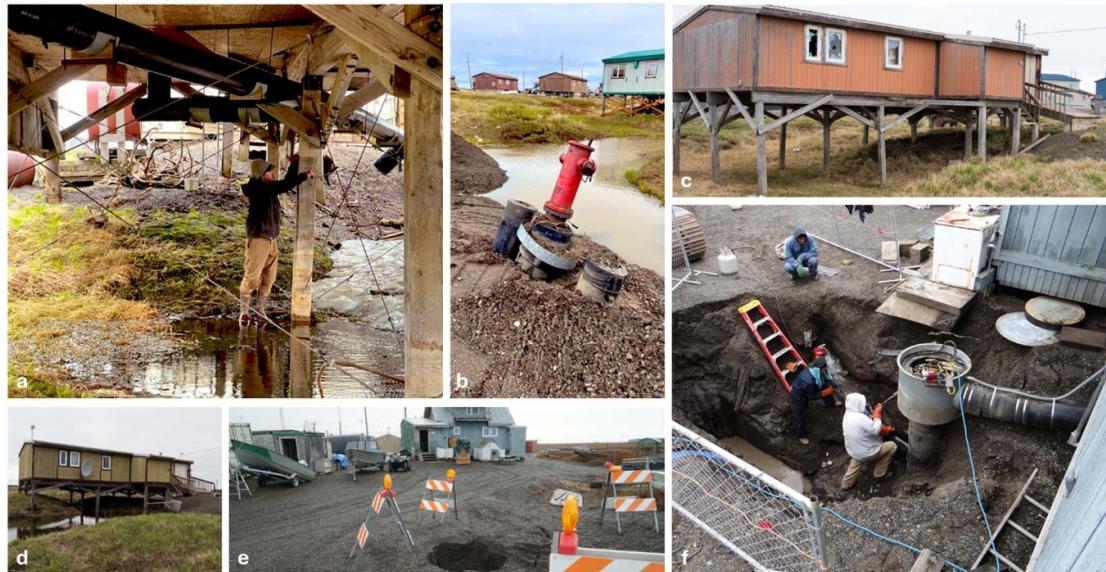
Figure 2. Interactions between degrading permafrost and infrastructure in Point Lay (Kali), Alaska. (a) Where residential pilings were founded in ice wedges, nearly 2 m of thaw subsidence has occurred below some homes leaving less than 1 m of pile embedment (Photo: Peppi Bolz). (b) Thermokarst has disconnected several of the fire hydrants in the northern portion of the community (photo: Benjamin Jones). (c) A North Slope Borough Housing Authority home that has been abandoned due to ice wedge thermokarst (Photo: Billy Connor). (d) A residential home in Point Lay (Kali) showing differential thaw settlement (Photo: Billy Connor). (e) A sinkhole on a residential street associated with underground thermal erosion due to a waterline failure (Photo: Bill Tracey Sr.). (f) Water and sewer utility failure at a home in Point Lay (Kali) (note the exposed ice wedge to the left of the maintenance crew) (Photo: Bill Tracey, Sr.).

Critical infrastructure failures—particularly related to water systems, roads, and buildings—were a key concern among six of eight interviewees, who linked these issues to thaw-induced ground instability and surface water accumulation. In addition, the North Slope Borough and several community members during the 2016 workshop (supplemental material) raised concerns about the increasing frequency of water and sewage line breaks due to differential settlement, leading to service disruptions and forcing many homes to revert to using ‘honey buckets’ and water truck haul services. The village’s one-million-gallon water storage tank suffered a bottom failure due to the loss of foundation support, underscoring the severity of thaw-related impacts. Power infrastructure has also been compromised, with newly installed utility poles leaning due to installation in thawing permafrost. Residents expressed concern over the loss of fire hydrants due to subsidence, which has reduced emergency response capabilities (figure 2(b)).
