Field characterization of areas in İskenderun affected by liquefaction during the 2023 Kahramanmaraş earthquake

Earthquake Spectra

2025, Vol. 41 (5) 3949–3976

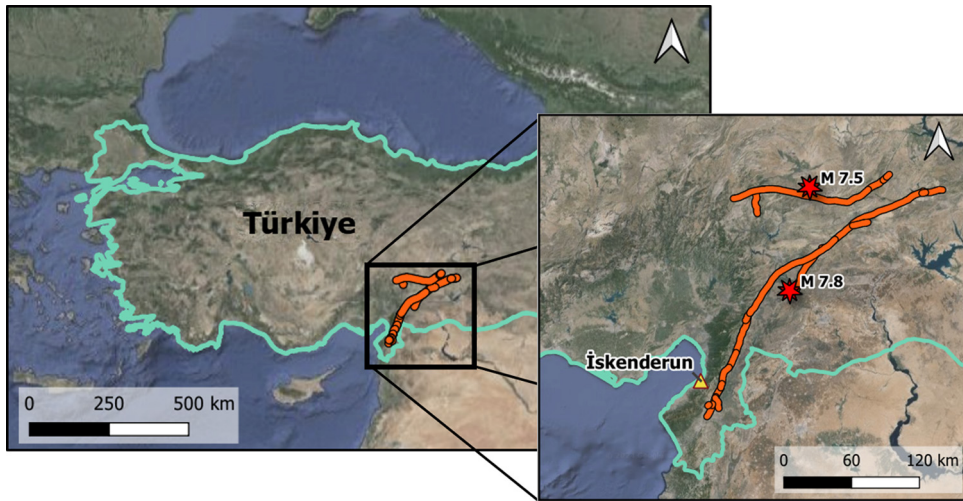
Figure 1. Location of event epicenters in relation to EAFZ and İskenderun.

Türkiye is located at the junction of the Eurasian, African, Anatolian, and Arabian tectonic plates. The East Anatolian Fault Zone (EAFZ) surrounds a roughly 700 km long strike-slip fault that runs southwest to northeast in southeastern Türkiye. On February 6, 2023, Türkiye experienced two major left-lateral earthquake events along the EAFZ followed by numerous aftershocks, which is referred to as the Kahramanmaraş earthquake sequence. The first event had an M_w of 7.8 and occurred in the Pazarcık section of the EAFZ. This rupture included surrounding fault segments (e.g. Amanos and Erkenek faults). The second event had an M_w of 7.5 and occurred 9 hours after the initial event along the Çardak and Doğanşehir faults within the EAFZ. As shown in Figure 1, the first event occurred along a northeast-southwest alignment, and the second event along a west-northeast alignment. The M_w 7.8 and M_w 7.5 earthquakes had focal depths of 8.6 and 7.0 km, respectively. Figure 1 also shows the relative locations of these fault ruptures to İskenderun.

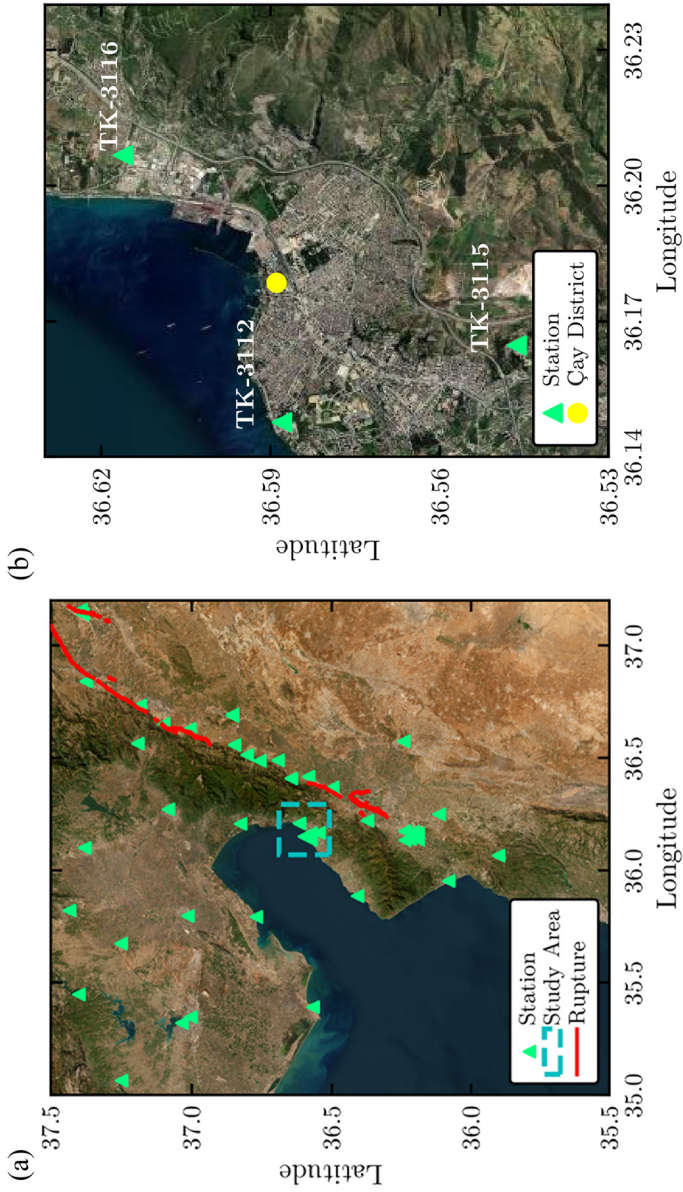
Figure 2. Locations of seismic stations and fault ruptures for the M_w 7.8 Kahramanmaraş earthquake in the Iskenderun region: (a) stations within 100 km of Iskenderun, and (b) stations close to the study areas. Fault rupture geometry is from Karabacak et al. (2023).

Figure 2a shows the seismic strong motion stations in the vicinity of İskenderun and the 2023 rupture of the East Anatolian Fault provided by Wang et al. (2023). The closest stations to İskenderun are TK-3112; TK-3115 and TK-3116, as labeled in Figure 2b. Figure 3a presents the shear wave velocity (V_s) profiles for these stations, with time-averaged shear wave velocity values over the top 30 m (V_{s30}) reported as 233, 424, and 870 m/s, respectively (METU Earthquake Engineering Research Center).

Seismic station TK-3112 is located 2 km west of the Çay District of İskenderun (Figure 2b). Of the nearby seismic stations, TK-3112 is at a site most representative of the subsurface conditions in the study areas. A SCPT was advanced at TK-3112 to measure V_s ; its data are shown in comparison to those from METU EERC in Figure 3a. Figure 3b illustrates the 5%-damped acceleration response spectra of the East-West horizontal component of the recorded motions from the M_w 7.8 mainshock at these stations. Acceleration, velocity, and displacement time histories are also shown. The recording at TK-3112 stopped early during the M_w 7.8 event, likely before the strongest shaking, so response spectra are not provided for this station.

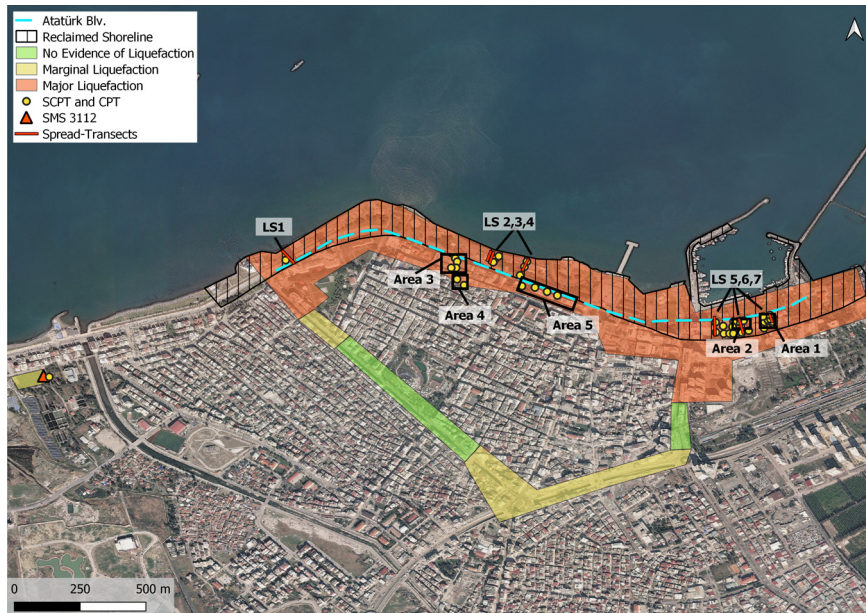
Figure 6. Overview of liquefaction observations and demarcation of key study areas within İskenderun.

Post-earthquake reconnaissance (e.g. Cetin et al., 2023; Moug et al., 2023) found most of the liquefaction-induced damage was located within the reclaimed areas along the current shoreline (Figure 6). Significant volumes of ejecta were observed covering Atatürk Boulevard (Figure 7a), which is the main roadway near the shoreline and generally aligns

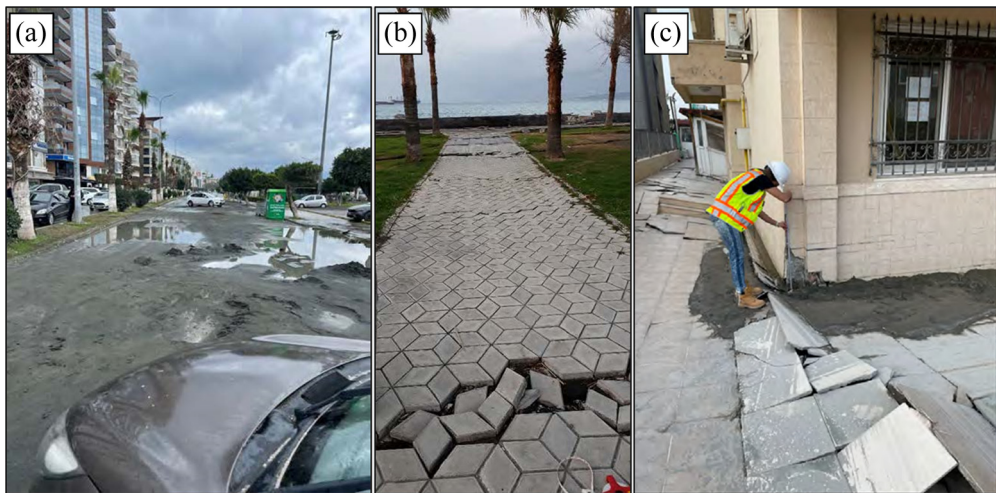
Figure 7. Examples of (a) ejecta along Atatürk Boulevard (delineated in Figure 6) after the M_w 7.8 earthquake, (b) lateral spreading toward seawall at LS4 site, and (c) liquefaction-induced building settlement near Area 1 (from Cetin et al., 2023).

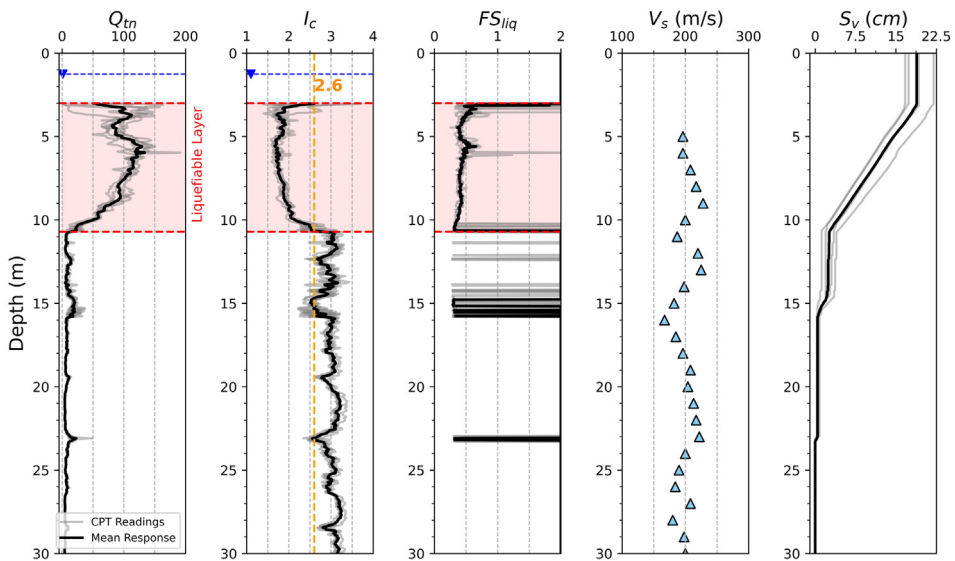
Figure 13. Range of normalized CPT readings (Q_{tn}) at Area 2 with calculated I_c , FS_{liq} , and S_v profiles, and V_s measurements. Soil unit with $FS_{liq} < 1.0$ is denoted as the liquefiable layer.

The range of estimated S_v values depicted in Figure 13 are between 16 and 22 cm. LBS, LSN, and L_D have 16% to 84% ranges of 23 to 31, 27 to 30, and 55 to 110, respectively. These values are consistent with those estimated for these indices in Area 1. The observed settlements of 38 cm and 51 cm of the taller buildings K and M, respectively, in Area 2 (Moug et al., 2024a) are lower than those observed in Area 1 (i.e. 47 to 71 cm). The lower building settlement could be due in part to the underlying interbedded sandy silt and silty

clay unit that exhibits a more fine-grained response (higher average I_c) as compared to the same unit in Area 1.

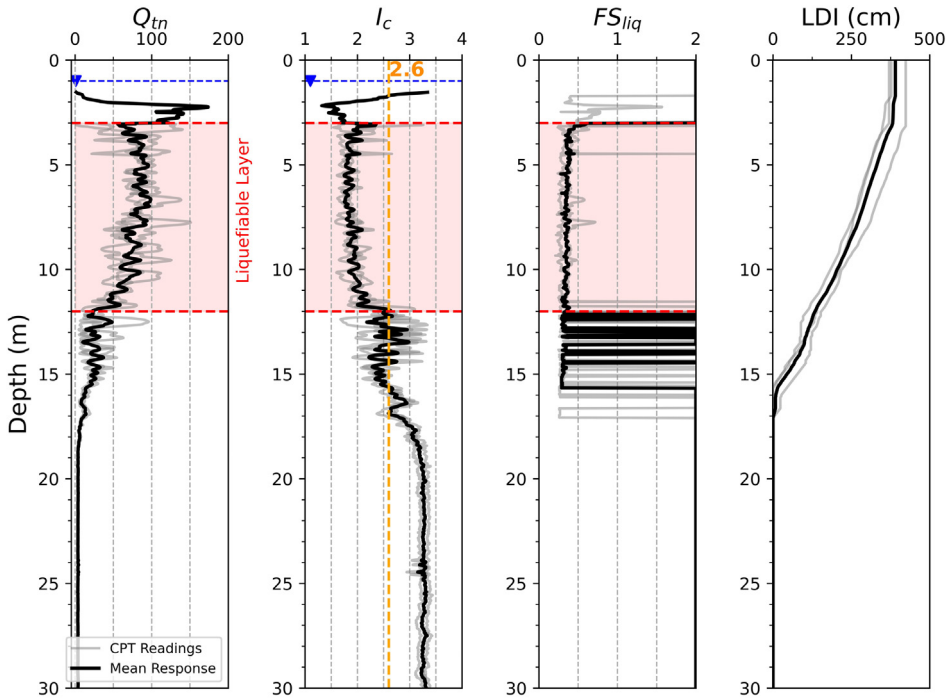
Figure 22. Range of normalized CPT readings (Q_{tn}) at LS2 and LS3 with calculated I_c , FS_{liq} , and LDI profiles. Soil unit with $FS_{liq} < 1.0$ is denoted as the liquefiable layer.
