Scientific Drilling

Drilling-induced and logging-related features illustrated from IODP–ICDP Expedition 364 downhole logs and borehole imaging tools

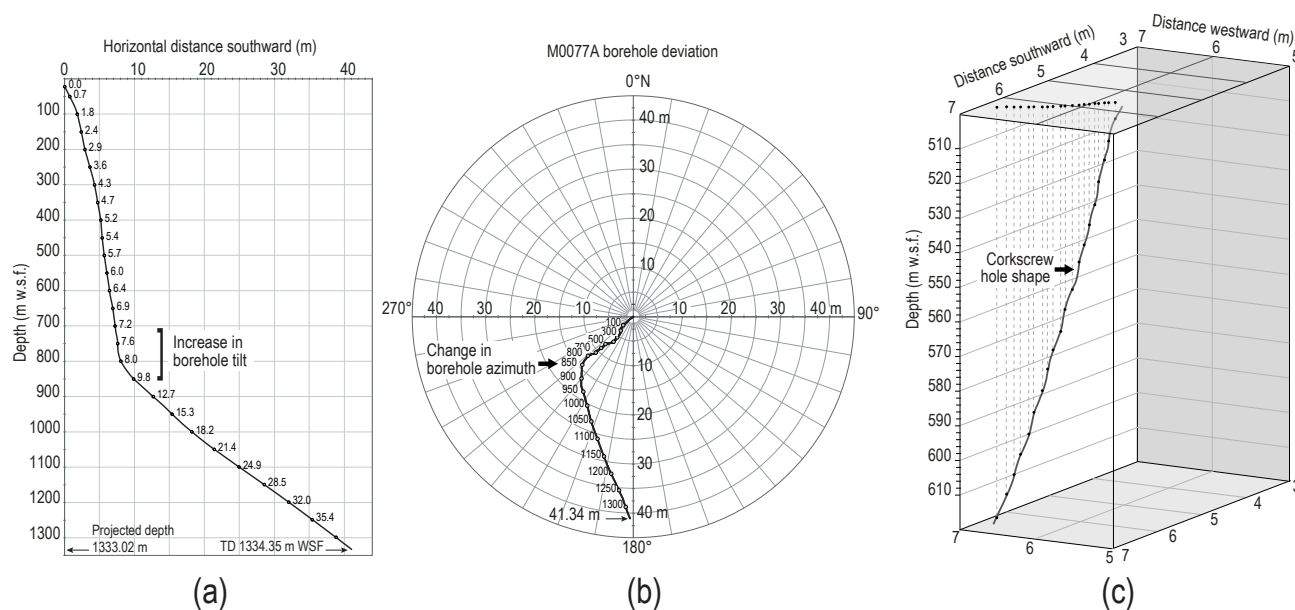
Figure 2. (a) true vertical depth and southward deviation of Hole M0077A. Note the increase in borehole tilt between 750 and 850 m w.s.f. **(b)** top view projection of the borehole path (modified from Gulick et al., 2017). Note the change in hole direction from southwest to southeast between 800 and 950 m w.s.f. **(c)** zoom on the 500–610 m w.s.f. interval in post-impact carbonates illustrating a corkscrew borehole shape. m w.s.f. is meter wireline depth below seafloor.

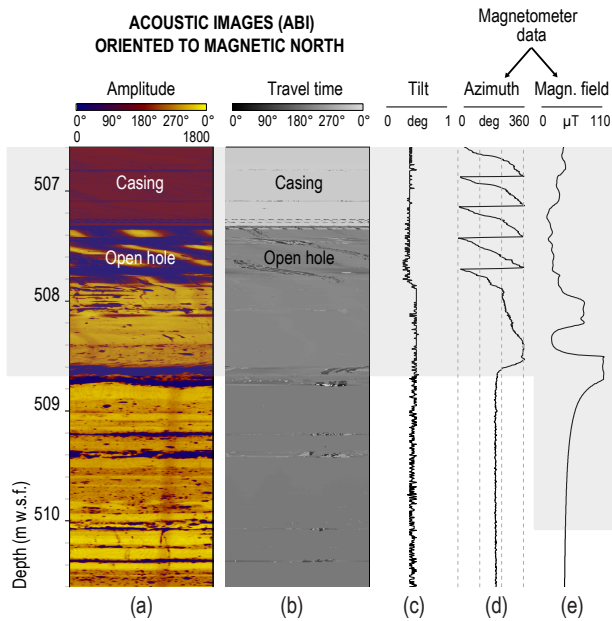
Both the OBI and ABI contain a three-axis magnetometer and three accelerometers that allow for the orientation of the logging tools with respect to the magnetic north (azimuth) and vertical direction (tilt) to be determined. Such information can be used to compute the borehole's trajectory in 3-D (Fig. 2) and is key in orienting the borehole images with respect to the magnetic north. Consequently, any perturbation of the local earth's magnetic field to the borehole prevents the proper registration of the true magnetic north by the logging tool and results in incorrectly displayed or oriented borehole images. This problem is most commonly observed when, during up-log acquisition, the bottom entrance to the steel pipe or casing is approached as the presence of this ferrous metal locally distorts the magnetic field (e.g., Lofts and Bourke, 1999; Shipboard Scientific Party, 1993). During Expedition 364, this phenomenon has been clearly observed in both ABI and OBI data. In Fig. 3, perturbation in the ABI image and azimuth starts about 1.4 m below the casing entrance and increases upward (Fig. 3a, b, d). A deviation in the magnetic field intensity is also observed, starting ∼ 2.5 m below

the casing (Fig. 3e). The disturbance of the total magnetic field (Fig. 3e), calculated from the three magnetometer components (X, Y, Z), starts deeper than the one of the azimuth (Fig. 3d), which is derived from the radial components (X, Y). This is because the axial component of the pipe magnetization is stronger than the radial one. As a consequence, the axial component (Z) of the magnetometers on the logging tool is more influenced by the pipe further below than the radial components (X, Y) that are disturbed much closer to the pipe. Importantly, it is also notable that the depths at which the perturbations are observed below the pipe entrance are overestimated by ∼ 1.2 m for both the ABI image and azimuth and the total magnetic field intensity logs. This is related to the way the ABI images are processed in the Well-CAD software and how the depths of the various sensors are displayed. Indeed, for a given depth, the 360° ABI image is oriented with respect to the magnetic north thanks to the deviation sensor data that are acquired 1.2 m above the acoustic window data at the same instant. The magnetic field is thus assumed to be constant over this 1.2 m long interval, which is true most of the time, with the exception of the presence of a strong magnetic anomaly such as the one generated by the casing. As a consequence, the perturbation of the total magnetic field starts in reality about 1.3 m below the casing entrance while the perturbation of the azimuth occurs when the magnetometers inside the ABI almost reach the casing shoe. For future works on the IODP expedition 364 downhole magnetic data from Site M0077, both the azimuth and

Figure 3. Commonly encountered magnetometer perturbation observed when approaching the entrance of a steel pipe or casing as the presence of metal close to the tool perturbs the magnetic field **(d, e)**. As a result, the acoustic borehole image is incorrectly displayed and oriented **(a, b)**. Grey shaded area indicates the zone under casing influence, overestimated here (see discussion in Sect. 3.1). m w.s.f. is meter wireline depth below seafloor.

magnetic field logs should thus be shifted upward by 1.2 m over the entire hole before any interpretation.

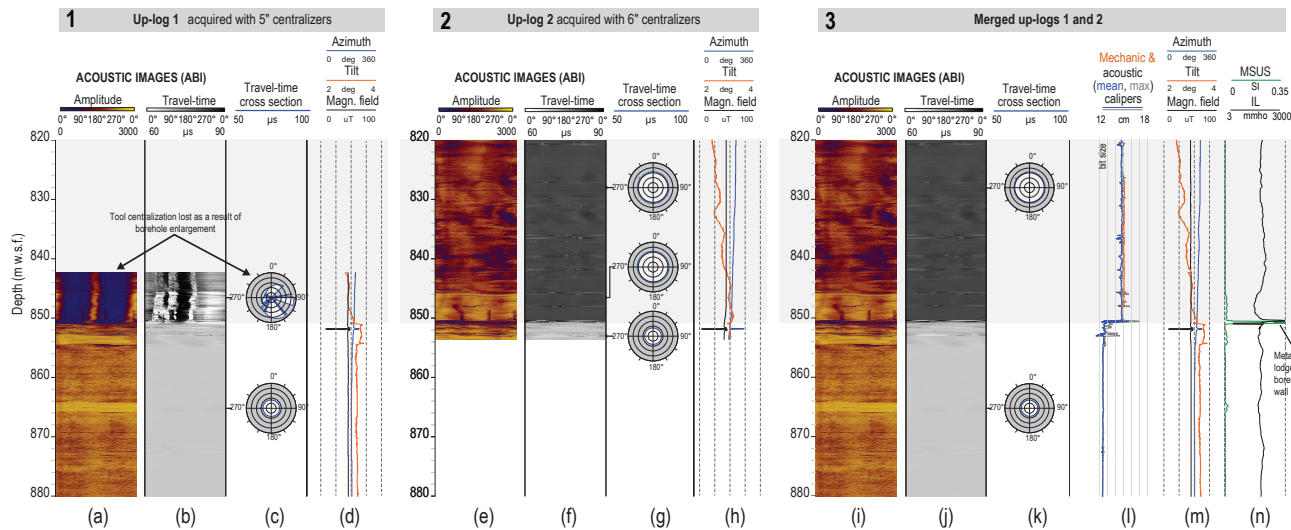
Figure 4. Drilling induced borehole enlargement as a result of fallen metal pieces (see discussion in Sect. 4.3). (1) Up-log 1; (2) Up-log 2; (3) merged Up 1 and Up 2 logs. Change in borehole diameter is evidenced at ∼ 850 m w.s.f. by acoustic borehole image data **(b, f, j, l)**. The presence of steel pieces lodged in the borehole wall at the same depth is highlighted by azimuth, magnetic field, magnetic susceptibility, and conductivity spikes **(m, n)**. Note that the travel-time cross sections' lower limits have been set to 50 µs **(c, g, k)**. m w.s.f. is meter wireline depth below seafloor.

Below ~ 700 m w.s.f., the borehole shape at Site M0077 was good to excellent (Fig. 1e). During up-log ABI data acquisition, logging-tool centralization was however lost at ~ 850 m w.s.f. (Fig. 1d), suggesting drastic borehole enlargement. The tool string was brought back to the surface and the 5″ centralizers replaced by 6″ centralizers. These later allowed for a proper centralization of the logging tool string from 850 to ~ 702 m w.s.f. (casing entrance). As shown in Fig. 4l, this borehole enlargement is confirmed by acoustic travel-time data that evidence a change in diameter from ~ 12.5 cm (close to the outside diameter of the drill bit of 12.26 cm) below 850 m w.s.f. to ~ 14.7 cm (~ 2.5 cm larger than the outer bit diameter) above 850 m w.s.f. (Fig. 1a). The enlarged borehole diameter is observed over the entire 850–702 m w.s.f. interval (Fig. 1e).

No clear explanation exists to account for this oversized borehole since (1) although the drill bit has been replaced by a new one at 823.24, 829.34 and 851.65 DSF (driller's depth below seafloor), the entire 702–1334 m b.s.f. interval was nominally drilled with the same bit size (Fig. 1a), and (2) no major change in lithology is observed at 850 m w.s.f., except for the presence of a ~ 5 m thick dolerite dike intrusion, extending from 846.3 to 851.1 m b.s.f. (Fig. 1c). This dike is characterized by a high amplitude on the ABI image (yellowish color in Fig. 4e, i), as dolerites are harder than the surrounding granite. It also has a higher magnetic susceptibility (Fig. 4n), as dolerites are enriched in iron compared to granitoids. The change in lithological properties when entering in the dolerite dike was probably responsible for the need to change the drill bit at ~ 851 DSF. However, it cannot

explain why the borehole diameter is oversized above that depth.

Besides the change in borehole diameter, large spikes in both conductivity and magnetic susceptibility are also noticeable at ∼ 850 m w.s.f. (Fig. 4n). These anomalies are not observed on resistivity and magnetic susceptibility MSCL data acquired on whole round cores taken at the same depth (Morgan et al., 2017), and we consequently interpret these spikes as reflecting the presence of pieces of metal lodged in the borehole wall. This interpretation appears to be confirmed by pieces of steel that were found in the liners of cores 136R–138R (850.6–852.9 m DSF), among which a large piece (>1 cm) of a casing shoe found in the liner of core 137R (Fig. 1a) and coming from the casing shoe positioned at ∼ 702 m w.s.f. Some other pieces possibly come from a misaligned casing located at ∼ 307 m w.s.f., which we drilled through during the coring operations, as well as from a broken drill bit (Fig. 1a, picture of drill bit replaced at 701.6 m DSF). In order to explain for the oversized borehole diameter over the 702–850 m w.s.f. interval, we tentatively suggest that some large pieces of casing shoe and damaged drill bit were trapped outside the drill bit during the coring phase, which led to an enlargement of the hole over this entire interval in the relatively soft granitic basement. The damages done to the successive drill bits are illustrated in Fig. 1a (pictures of drill bits replaced at 823.2 and 829.3 m DSF). Although the hole shape remained relatively subcircular, a change in borehole quality is clearly observed on both the ABI amplitude image (Fig. 4i) and mean caliper (Fig. 4l) when crossing 850 m w.s.f., with a smoother borehole below 850 m w.s.f. and a more rugose one just above. The presence of these pieces of metal outside the drill bit also seems to have affected the borehole trajectory at some point, since a drastic increase of the borehole tilt and a clear change in the borehole azimuth are observed from ∼ 750 to 850 m w.s.f. (Fig. 1f and Fig. 2a, b). The above observations are a nice example of how operational difficulties at shallower depths indirectly induced changes in borehole diameter, shape and trajectory at greater depths.

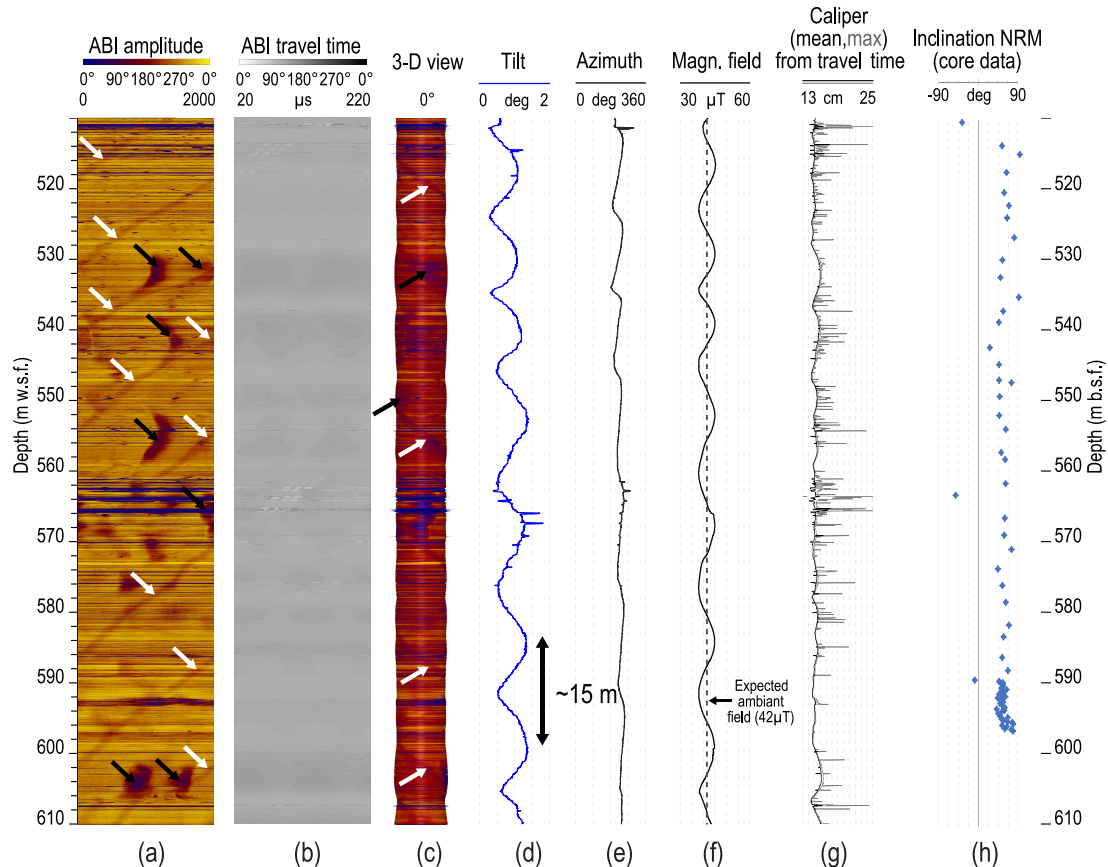
Figure 6. Drilling-induced corkscrew borehole shape in the post-impact carbonates, possibly due to drill bit wobble, steel wedged at the bit or overfeed of rods. This shape (see also Fig. 2c) is evidenced by cyclic oscillations in both accelerometer (tilt) and magnetometer (azimuth) data **(d, e)**. One continuous regular spiraling narrow dark stripe (white arrows in **a** and **c**) may result of the drill pipe rubbing on the carbonate formation. Drilling induced re-magnetization of the formation is tentatively proposed to account for the cyclic changes observed in the magnetic field **(f)**. **(h)** Non-demagnetized NRM measured on core samples dominated by positive inclination (indicative of normal polarity), suggesting a pervasive normal polarity remagnetization. m w.s.f. is meter wireline depth below seafloor; m b.s.f. is meters below seafloor.

Boreholes are rarely drilled as perfect vertical cylinders. In particular, some drilling operations can cause the borehole to take the shape of a corkscrew (spiral). Such a shape can result from drilling and reaming operations including the bit-whirl and wiper trips. In the post-impact carbonates at Site M0077, 10 to 15 m long regular undulations are observed in both the tilt and azimuth of the ABI logging-tool data between 510 and 610 m w.s.f. (Fig. 6d, e). Tilt and azimuth are provided by two distinct types of sensors, accelerometers (accuracy: ±0.5 degree) and magnetometers (accuracy: ±1.2 degree), respectively. The observed undulations are interpreted as reflecting

a corkscrew shaped hole (see zoom of the borehole trajectory over this depth interval in Fig. 2c). Oscillations <2 cm in the acoustic borehole caliper are also observed with a shorter wavelength (2–8 m). The local presence of one or two large low-amplitude dark stripes on the ABI amplitude image (black arrows in Fig. 6a, c) occurred where the borehole shows a non-circular shape and is enlarged. As discussed in Sect. 3.2, these stripes possibly reflect logging-tool eccentering. Superimposed on these possible eccentering features, the amplitude image also displays one continuous, spiraling, narrow dark stripe (white arrows in Fig. 6a, c) wherein the path is independent of the changes in borehole diameter and shape in cross section. A clear link is, however, observed between the orientation of this stripe and the tilt and azimuth (Fig. 6a, d, e). The origin of the stripe remains unclear, but based on the tight link with borehole geometry, we suggest that it may reflect a mark on the borehole wall (see also Sect. 4.2) resulting from the drill pipe rubbing the carbonate formation

during operations. This can occur as the bit engages the formation and the stand drill-pipe torques into a helical.

At the drill site, the expected ambient field intensity as given by the World Data Center for Geomagnetism (http://wdc.kugi.kyoto-u.ac.jp/index.html, last access: 12 October 2018) is $\sim 42\,\mu T$ (Fig. 6f), which corresponds to the mean intensity value measured by the magnetometers over the 510 and 610 m w.s.f. intervals. However, apparent 10–15 m long cyclic oscillations in the local magnetic field are also observed with values ranging between 38.2 and 45.5 µT (Fig. 6f). These oscillations in the magnetic field intensity (as measured by the magnetometers) vary jointly with the borehole tilt (as measured by the accelerometers). High values in the local magnetic field (Fig. 6f) correlate with high tilts (Fig.6d), and vice versa. We tentatively interpreted this cyclical pattern in magnetic field intensity as a possible drilling-induced magnetization overprint in the surrounding rocks. Indeed, in the 510 and 610 m w.s.f. interval, the lithology mainly consists of marlstone and limestone (Morgan et al., 2017) with low coercivity (Urrutia-Fucugauchi et al., 2017). Such material is susceptible to acquiring drilling-induced magnetization (e.g., Jackson and Van der Voo, 1985). The effect of drilling and sawing on the magnetization of rocks is a known phenomenon, and the magnetic overprint imparted by the drill string is a problem commonly encountered in cores taken by the IODP (e.g., Fuller et al., 1998). Preliminary paleomagnetic measurements performed on discrete samples within this depth interval (Fig. 6h) suggest that a pervasive normal polarity re-magnetization of the carbonates likely occurred within the low-coercivity fraction of magnetic grains, supporting the idea that overprinting may readily occur in this formation. Therefore, we suggest that the drilled carbonates have undergone magnetization overprinting during the drilling operations possibly as a result of the rotary perforation of the formation associated with the presence of a steel BHA, steel wedged at the bit or overfeed of rods. As the changes in ambient field intensity follow the changes in the borehole tilt, we also suggest a possible link between the degree of drilling-induced magnetization and the drilling conditions that cause the borehole to take the shape of a corkscrew.

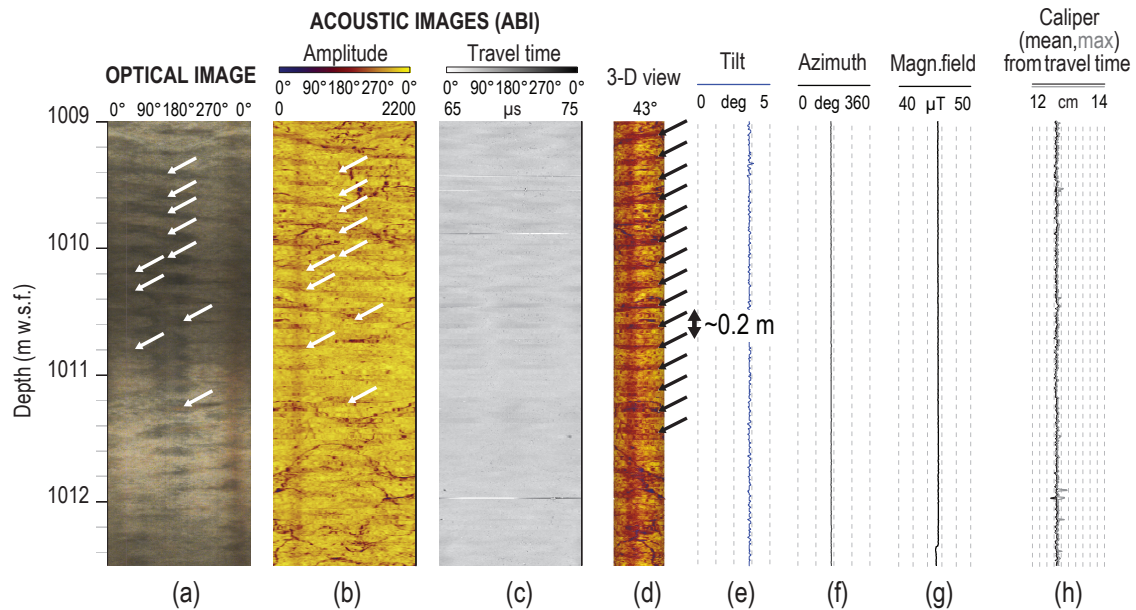
During Expedition 364, helical stripes with a wavelength of ~ 0.2 m are observed locally on the borehole wall images acquired in the peak-ring granitoids (Fig. 7). They are evidenced through either low amplitudes zones on the ABI images or dark zones the OBI images (arrows in Fig. 7a, b, d). They are also slightly visible on the travel-time images (Fig. 7a). Unlike the corkscrew related stripes (see Sect. 4.1 above), these stripes are not associated with any changes in the borehole tilt or azimuth (Fig. 7e, f). They are interpreted as drilling-induced markings on the borehole wall, left by a drilling tool in a relatively soft, shock-metamorphosed gran-

ite with an unusually low density (Morgan et al., 2016, 2017; Christeson et al., 2018).

Figure 7. Drilling-induced helical marking on the borehole wall, evidenced by helical stripes (arrows) on both the optical and acoustic borehole images. m w.s.f. is meter wireline depth below seafloor.

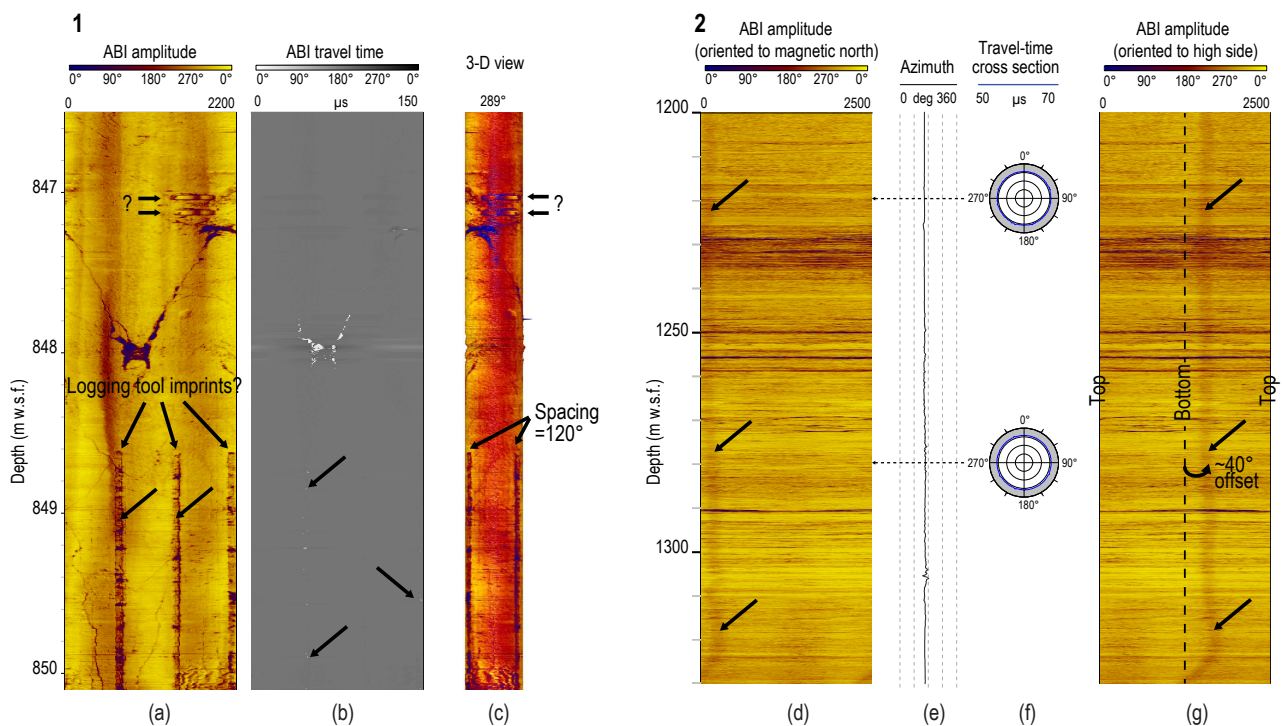
In another example, at a larger scale, a low amplitude, dark stripe (Fig. 8d) is observed in the lower half of the hole (Fig. 8d) where the tilt is increased to about 4.2° (Fig. 2a and b). The mean orientation of the path of the stripe is $\sim 25°$ N (Fig. 8d). Orienting the image to the high side (Fig. 8g) instead of to the magnetic north (Fig. 8d) clearly shows that the stripe is parallel to the axis of the hole, thus illustrating a clear link between the presence of this stripe and the borehole inclination. We thus tentatively interpreted this large-scale stripe as a key-seat-related feature that developed in the inclined part of the hole because the drill pipe was rubbing the bottom side of the borehole. However, no clear groove cut is observed on the acoustic caliper data (Fig. 8f). In addition, the stripe is not oriented to 180° (i.e., aligned on the lowest part of the hole), as expected from a key seat, but at $\sim 220°$, i.e., with an offset of $\sim 40°$ (Fig. 8g) westward. This angular offset may result from the change in azimuth of the hole observed at 850 m w.s.f. (Fig. 2b), which deviated the drill pipe and forced it to the lateral westward side of the borehole.

Figure 8. Marks on the borehole wall. (1) possible tool imprint oriented to 120°, and residue possibly left in mud residue by arms of the mechanical caliper. (2) ABI image oriented with respect to the magnetic north **(d)** and to the high side, **(g)** illustrating that the continuous regular narrow dark stripe (black arrows) is closely related to borehole inclination and may be the result of the drill pipe rubbing on the borehole wall. **(f)** travel-time cross section (magnetic north orientation) illustrates a regular borehole shape with no evidence for groove cut to be associated with the narrow dark stripe. Note that the travel-time cross sections' lower limit has been set to 50 μs.

Just before the change in borehole diameter described above, we noticed the presence in both the amplitude and travel time of borehole images of an unusual feature consisting of three vertical narrow stripes oriented to 120° and extending from 846 to 850.4 m w.s.f. (Fig. 8a, b). This feature cannot be interpreted as drill marks (see also Sect. 4.2) on the borehole wall, since no drill tool with such a shape has been used during the drilling/coring operations. We believe that these marks have been left by the three arms of the mechanical caliper in a thin layer of mud residue covering the borehole wall. This mud may have been left over from the formation during flushing because of the borehole enlargement and associated increase in the annular space between the pipe and the geological formation, thus reducing annular circulating fluid velocity. If this interpretation is correct, this is an example of a combined drilling- and logging-induced feature. Above these vertical imprints, two sub-horizontal features are observed at ∼ 847 m w.s.f. (Fig. 8a). Their origin remains unknown so far.
