# **A Case History of Highwater Shore Erosion and Bank Stabilization via Tree Roots**

**Bret N. Lingwall<sup>1</sup>**

## **ABSTRACT**

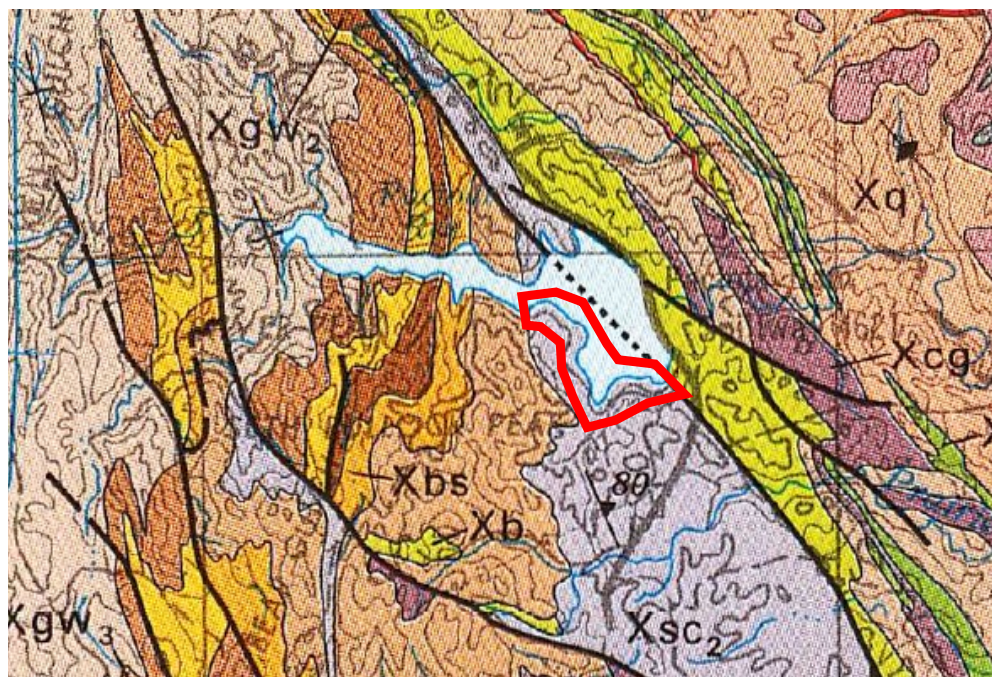
The hillside in question that experienced high-water erosion is mapped in Figure 1 as shale. This hillside dips at approximately 8° to 25° towards the pool, with the shale bedding layers dipping at approximately 30° preferentially towards the pool. Thus, the rock bedding planes are slightly steeper than the hillside itself in the area of the erosion. The rock itself tends to be mostly grey to dark grey siliceous biotite phyllite and schist with some shale and chert, and minor amounts of

siltstone. The rock at the location of the erosion event is highly anisotropic, with the rock being weaker in the direction of the bedding planes.

**Figure 1. Geology map of Pactola. Shore erosion area outlined in red. Base-map from DeWitt et al. (1989). Formation Xcs<sub>2</sub> in which shore erosion is entirely located is metamorphosed carbonaceous shale (early Proterozoic).**

The rock is highly fractured, with an RQD of 20% or less. Discontinuities are spaced at 50 to 100-mm, are smooth, and infilled with soft silty to clayey soil. Discontinuity thickness ranges from 2 to 10-mm. The intact rock has uniaxial compressive strength of 10 to 40-MPa and may be broken by hand or by a single blow from a geologic hammer. There are occasional inclusions of harder granitic cobbles and boulders at the west edge of the erosion area. The Rock Mass Rating is 20 or less. The infilling of the wide discontinuities accounts for 10% to 30% of the formation by mass. The infilling is silty in nature, with low to moderate plasticity. Grains size distributions show that the material has 15% clay by mass or less, with fine sand content of 20 to 30%. When wet, the soil infill has shear strength of 40 to 80-kPa, but when dry the soil infill has shear strength of 140 to 190-kPa, as measured by pocket penetrometer. A slaking test of oven-dried infill material shows full slake at 4 minutes inundation, while slaking does not occur in the rock after 96 hours. Therefore, the soil infill material loses 100-kPa or more shear strength when saturated, and near surface dry soils will break apart within a few moments of inundation whereas the rock is stable.

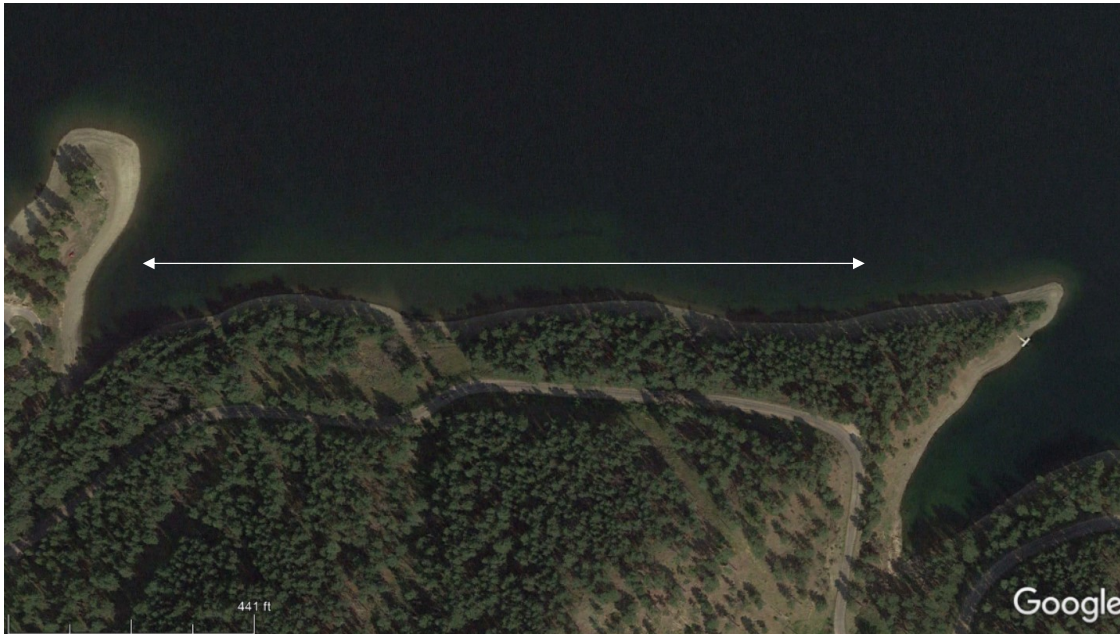
Overtop of the rock, there is a thin topsoil overburden of approximately 30-cm thickness. The topsoil is the same in composition and geotechnical properties as the infill material below, but with high amounts of organic material such as rootlets, woody debris, and pine needles. Figure 2 shows an aerial view of the area studied in this paper, indicating the heavy timber cover over the hillside.

**Figure 2. Extents of case history observations and measurements. Base satellite imagery courtesy of Google Earth™.**

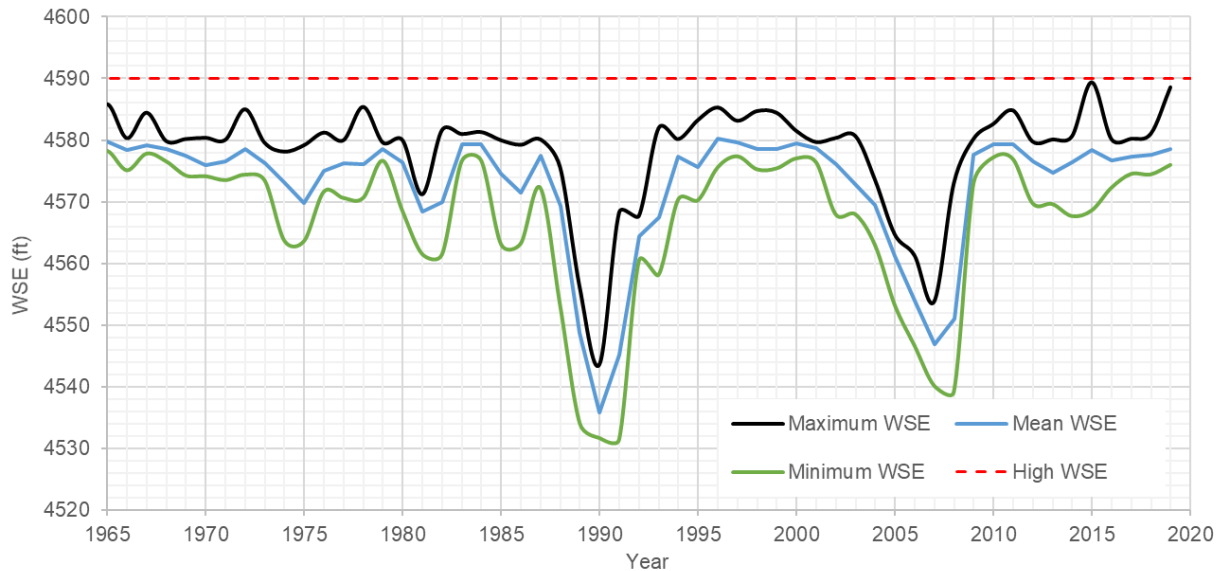
Documentation of the high WSE in 2015 and 2019 are shown in Figure 4 from the United States Geologic Survey (USGS) gauge station at Pactola, located across the lake from the erosion site. The records for the pool begin at initial filling in the early 1930s, but the USGS gauge station was only installed in the 1960s. Bureau of Reclamation records show that the WSE pre-USGS gauge never exceeded the data shown in Figure 4.

**Figure 5. Water level record for Pactola Reservoir. Source: USGS gauge station on site.**

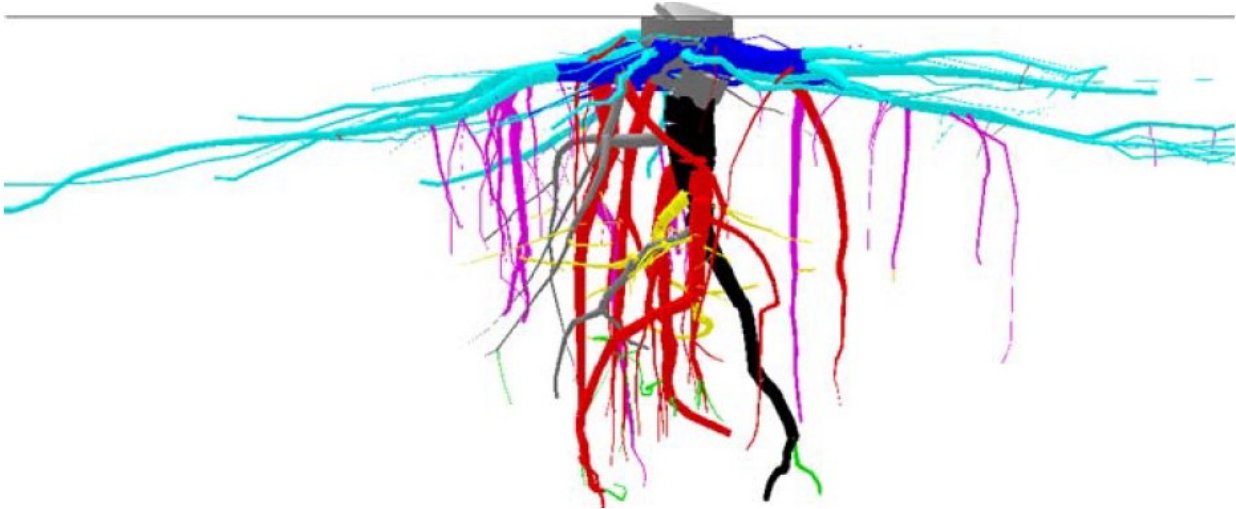
**Figure 6. Digital rendering of the root structure of a 27-years-old *P. pinaster* tree from the south of France in a sandy spodosol. Colors represent the orders of the roots from taproot (black) through 4<sup>th</sup> order and sinkers. Typical of large conifers in deep thick sandy soils. Depth of penetration is 2/3 radius of spread. Modified after Danjon et al. (2005 and 2008).**

The woody root structure of Figure 6 is generalized, and not all large conifer specimens will have a woody root structure with that number of sinkers. The tree in Figure 6 was growing in a deep and loose sand deposit, and thus may be an idealization. Figure 7 presents a classic case of a different large conifer growing in thin soil cover over hard competent rock. In the case of Figure 7, the taproot is limited due to the extreme hard growing conditions beneath the bole, few sinkers have developed, and the tree is forced to use the spreading woody roots for most of its stability. The mapping of Figure 7 shows more of the 1<sup>st</sup> order rootlets in addition to the thick woody roots. These rootlets were omitted from Figure 6. In order to understand the specific species at Pactola, a young specimen growing in an area of thick, loose, sandy soil was exposed and the woody roots are presented in Figure 8. Note that this specimen has a small taproot.

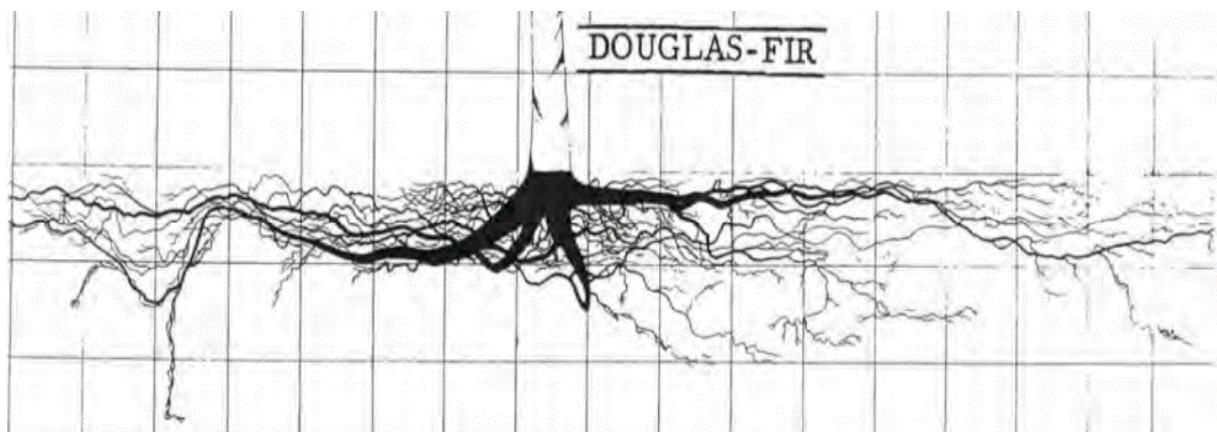
**Figure 7. Rendering of the root structure of a Douglas Fir in the western United States growing in thin surficial soils over top of rock. (from Berndt and Gibbons 1958). Maximum penetration is less than 1/4 radius of spread. No sinkers on this specimen.**

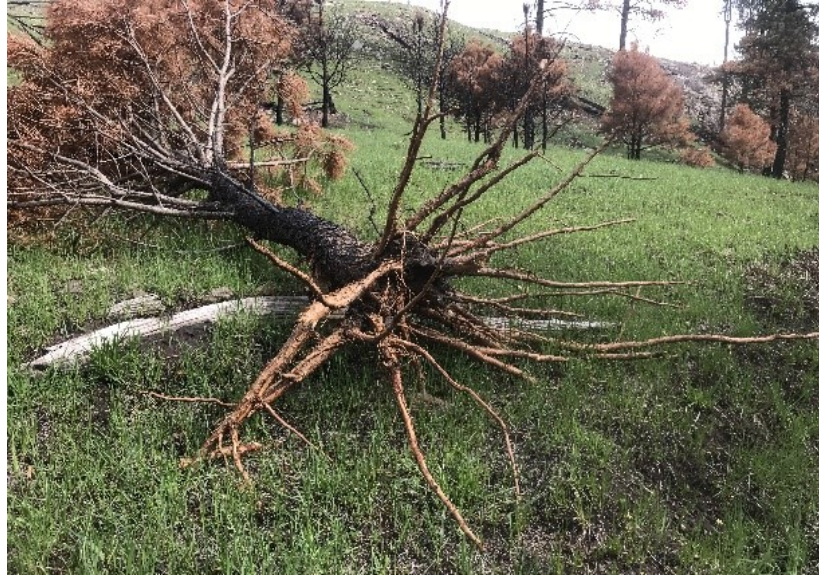
**Figure 8. Woody root structure of a *P. ponderosa* local to Pactola away from any water courses that grew on a gentle slope in thick sandy soil. Taproot depth is approximately 1/3 of the radius of spread of the woody root mat. Note: no sinkers on this specimen.**
