# **Liquefaction-Induced Ground and Building Interactions in İskenderun from the 2023 Kahramanmaraş Earthquake Sequence**

Significant and widespread liquefaction occurred in İskenderun during the 2023  $M_w$  7.8 Kahramanmaraş earthquake. Liquefaction effects on buildings were observed in several areas of İskenderun, predominantly in areas of reclaimed land and near historic shorelines. Liquefaction-induced building settlements were particularly concentrated in the Çay District, which is almost entirely reclaimed land. Liquefaction-induced ground and building settlements were either marginal or not apparent in areas away from the historical shorelines. Building settlement and ground deformation were documented at 26 buildings in İskenderun through lidar scans and laser-level hand measurements. Liquefaction-induced building settlements ranged from 0 to 740 mm. Building-ground interactions were evident from hogging ground deformations, including cases where buildings deformed nearby ground and damaged nearby buildings, and sagging buildings. Historic land development affected the spatial extent of observed liquefaction-induced building damage. Representative liquefaction-induced bui

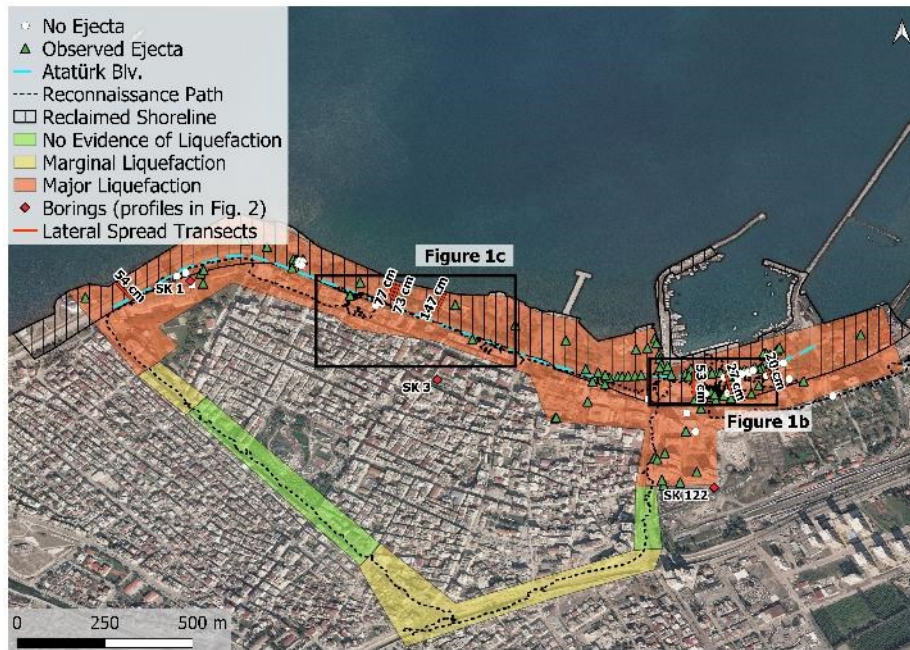
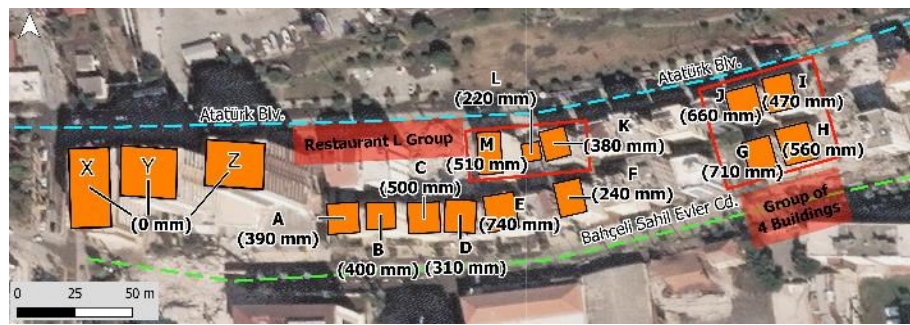
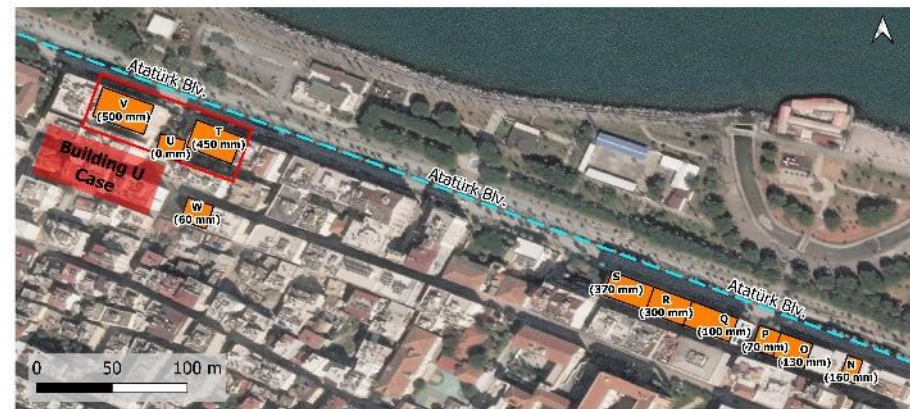
**Figure 1.** Overview of İskenderun reconnaissance: (a) İskenderun with interpreted areas of liquefaction, observed ejecta, reclaimed land, and lateral spreading. Areas of liquefaction are only inferred from areas where reconnaissance was performed, as shown by the shaded areas. (b) Buildings surveyed in the Çay District. (c) Buildings surveyed in the Yenişehir neighborhood. Each surveyed building is referenced by the letter shown, and the average building settlement is in parentheses. Base images were captured on February 12, 2023 from Maxar Technologies (2023).

Figure 1a summarizes the evidence of liquefaction in the Çay District and north-central İskenderun observed by GEER teams in February and March 2023. Green triangle symbols in Figure 1a represent locations where liquefaction ejecta were observed by GEER teams, in photos uploaded to SiteEye (2023), or by residents. White circles represent locations where no liquefaction ejecta was observed. These locations of ejecta and no ejecta are provided as the locations captured by the photographs as opposed to the geotag of the camera location. The ejecta observations are limited to February 2023 since it was assumed that much of the ejecta was either degraded by flooding, rain, or wind or cleaned up before March 2023. Reconnaissance also confirmed that major liquefaction occurred at the İskenderun port (Çetin et al. 2023), located east of the area captured in Figure 1.

Zones of “major liquefaction,” “possible or marginal liquefaction,” and “no evidence of liquefaction” are shown on Figure 1a. The zones are interpreted in areas where observations were made by GEER teams or SiteEye teams; this study does not provide an assessment of whether liquefaction did or did not occur outside of these zones. Representative GPS tracks of the GEER teams are shown in Figure 1a to provide the context of where the ground reconnaissance was performed in İskenderun. The zones of no evidence of liquefaction are areas where the teams deliberately looked for evidence of liquefaction (e.g., ejecta, settlement, rolled curbs), and none were observed. These zones include the southwestern part of Figure 1a, away from the shoreline. The zones of possible or marginal liquefaction are those where building settlement less than 30 mm was observed, and there was no surficial evidence of liquefaction. A possible or marginal liquefaction area is the underpass that runs approximately east-to-west through İskenderun. Flooding and sand in the underpass were evident in aerial photos on Google Earth in the days following the earthquake, which was confirmed by a local taxicab driver. However, the only possible surface evidence of liquefaction was nearby buildings that appeared to have settled less than 30 mm. The flooding and sand may be evidence of subsurface buildup of excess porewater pressures that were relieved through the storm drains at the base of the underpass.

The zones of major liquefaction are associated with land between the historic shoreline and the current shoreline (i.e., reclaimed land) and near the historic shoreline. Liquefaction ejecta were observed south of the Çay District, about 200 m from the historic shoreline, and further from the historic shoreline than other observations of liquefaction in İskenderun. This occurrence could be associated with historic infill of low-lying swampy areas, historic depositional environment, or some other factor.

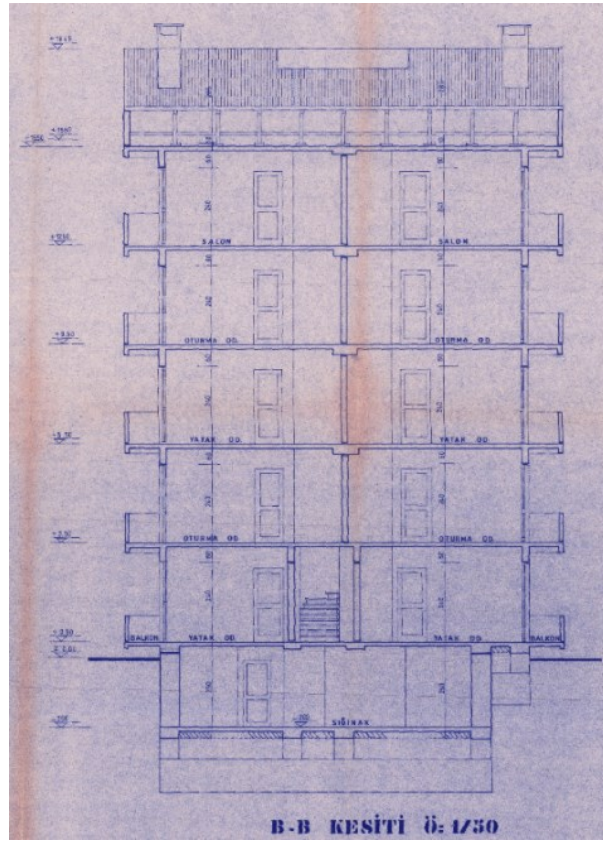
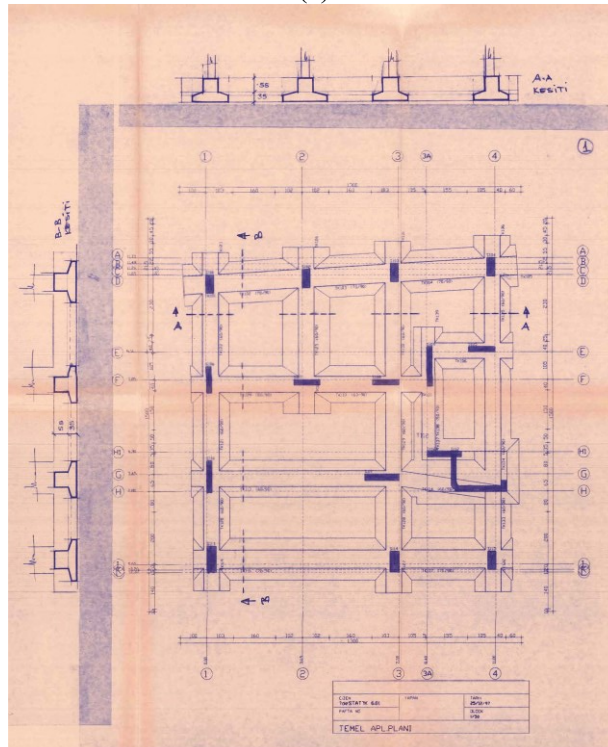
Building plans from two five-story buildings in the Çay District are shown Figure 7. These two building plans represent typical foundation types for mid-rise buildings in the Çay District. Figure 7a shows plans from Building D (36.5902N 36.1776E), which settled an average of 310 mm. Building D has a half basement across the front (south) half of the building; the cross section in Figure 7a pictures the half of the building with the basement. A mat foundation extends across the entire building footprint at 3.4 m depth; fill soil is in place above the mat in the non-basement area. Figure 7b is a plan view of the foundation of Building C (36.5902N 36.1774E). The foundation of Building C uses strip footings in orthogonal directions across the building footprint. Building C was surveyed with laser-level hand measurements and lidar scans; the settlement at Building C is estimated to be 500 mm on average.

**Figure 7.** Building plans for two buildings in the Cay District: (a) cross-section view of Building D (36.5902N 36.1776E) on Bahçeli Sahil Evler Street showing the mat foundation; (b) plan view of foundation at Building C (36.5902N 36.1774E) on Bahçeli Sahil Evler Street showing the strip footings that orthogonally intersect.

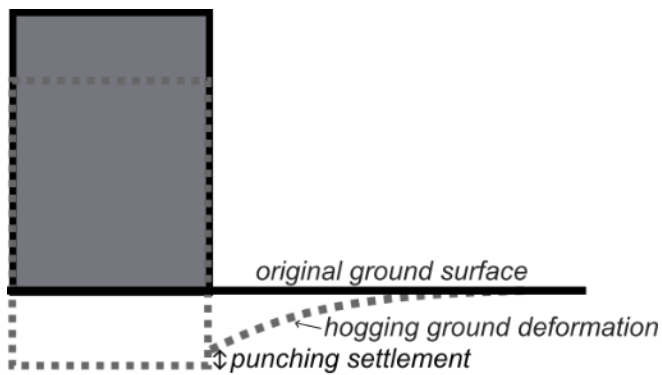
Documented building-ground interactions in the Çay District and İskenderun indicate a distinct pattern of ground deformations induced by building settlement. It appeared that building settlement dragged down adjacent ground over a length of several meters from the building edges, with the ground settlement decreasing with increasing distance from the building. This resulted in convex ground surfaces near the buildings as depicted in Figure 12 and described herein as a “hogging” pattern of ground deformation. The hogging ground deformation was observed in the ground surrounding buildings that settled significantly, which differs from hogging due to differential building settlement with the exterior of a foundation settling more than the center. Most of the buildings in the Çay District and İskenderun had stiff foundations that appeared to settle without significant internal distortion. Free-field observations did not provide evidence of ground settlement or heave that would be an alternate explanation for the observed hogging ground deformation surrounding buildings that settled significantly. In addition to the building settlement associated with ground hogging, some punching settlement was observed where the building settled into the ground immediately adjacent to the building. However, in general, the punching settlement was notably less than the building settlement associated with ground hogging settlement throughout the Çay District and İskenderun.

**Figure 12.** A schematic of building-ground interaction observed at several sites in İskenderun with contributions from punching and building-induced ground hogging. The dashed line represents the post-earthquake building and ground; the solid line represents the original ground surface and building.

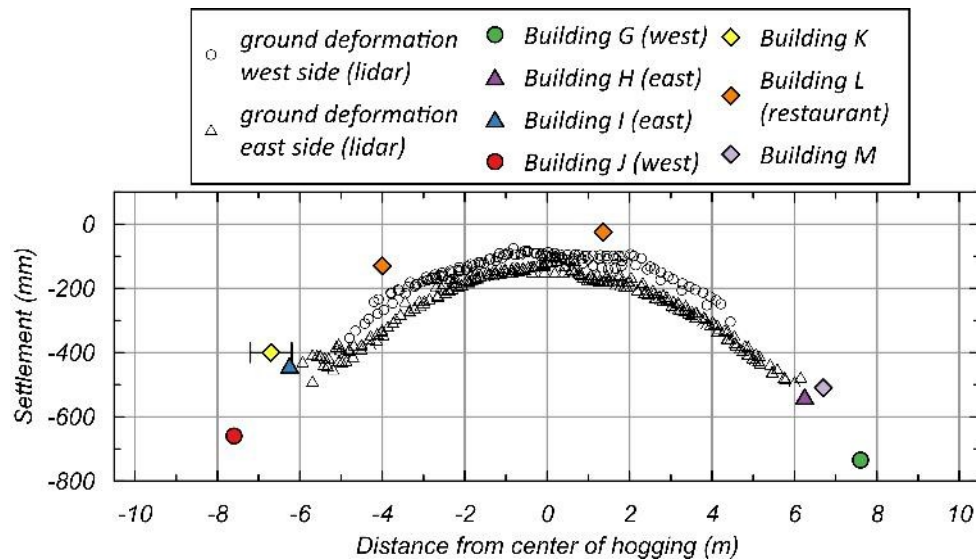
**Figure 17.** Hogging ground deformation pattern between the four buildings with measured settlements at other sites where hogging ground deformation was observed. Settlement of the K, L, and M buildings are also shown.

Elevation differences between the middle of the courtyard and the reference planes indicate that free-field conditions did not exist between the buildings, and there were likely interactions between the ground deformations induced by the settlements of each building. The area between Buildings G and J is 60 mm lower than at the west edge of the courtyard (where it is assumed that the ground did not settle), and the area between the Buildings H and I is 130 mm lower than at the east edge of the courtyard (where it is also assumed that the ground did not settle). A schematic of the interpreted building-ground interaction between these buildings is illustrated in Figure 18, including the overlapping of the zones of influence between the

The measured settlements at Building L and the adjacent buildings are plotted with the diamond symbols in Figure 17; note that the error bars on the symbol for settlement at Building K represent uncertainty in the distance between it and Building L. The convex point of the ground deformation is assumed to be the middle of the distance between Buildings K and M. The pattern of ground deformation is similar to the deformations measured in the group of four buildings discussed previously. The consistency of deformation suggests a characteristic pattern for building-ground interactions in this area. Further investigation is required to understand the role of the buildings and subsurface conditions on these ground deformation

The ground deformations in the Çay District (group of four buildings and the Building L restaurant) had similar relationships between vertical deformation and distance from the building, as shown in Figure 16. However, the Building T and V settlements and ground deformations do not strictly follow this pattern. The settlements at Buildings T and V were similar to the Çay District mid-rise buildings with the smallest settlements (i.e., Building K and I), however, the distance from Buildings T and V over which the hogging was observed (9.9 m) was larger than at Building K (6.7 m) and Building I (6.25 m). Possible explanations

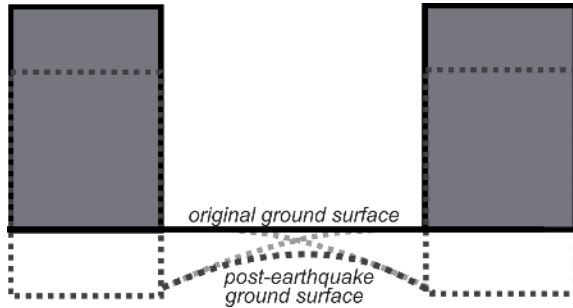
**Figure 18.** A schematic of interpreted building-ground interactions at the group of 4 buildings. The post-earthquake building settlement and ground is shown by the dark dashed lines, which is the result of overlapping ground deformation from each building (light grey dashed lines); the original ground surface is the solid black line.
