SEISMIC PERFORMANCE OF A STICK-BUILT CURTAIN WALL SYSTEM IN A FULL-SCALE BUILDING SHAKE TABLE TEST

S.L. Wynn¹, K.L. Ryan¹, W. Roser¹, Y. Ji¹, T.C. Hutchinson² & R. Madeley³

This paper evaluates the seismic performance of the two-story non-structural curtain wall system. The 60-minute fire-rated curtain wall system features stiff, fire-resistant steel mullions along with 27 mm thick multilayer-laminated glazing. This C-shaped curtain wall system was supported on a steel ledger protruding from the edge of a concrete slab at the base and was attached to the structure at each floor slab. The subassembly has been designed to rack along with the movement of the floor diaphragms, while the glass lites are intended to rotate within the glazing pocket to accommodate movement within the framing. The cantilevered slab supporting the curtain wall caused vertical acceleration amplitudes up to 3 times higher than the input ground motions, which may have caused damage to the door latch mechanism. The results also showed that out-of-plane motions can lead to higher component acceleration amplitudes compared to the in-plane component amplification. After the 88 ground motions, including four MCE_

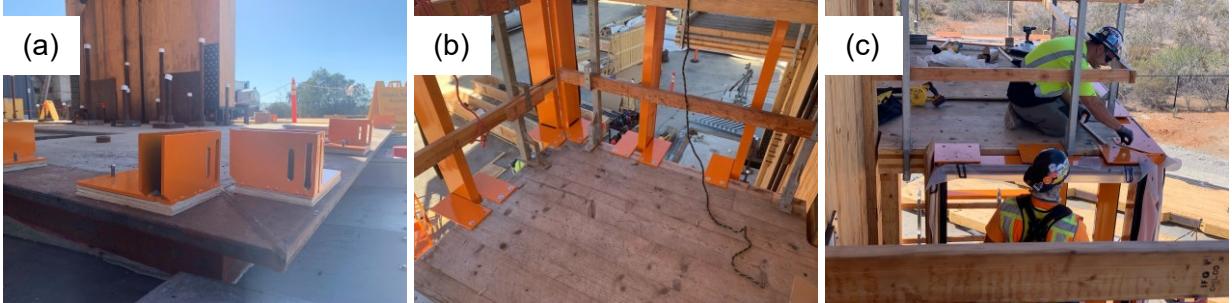
Figure 3: (a) Slotted sill anchor at the foundation, (b) slotted windload anchors at 2nd floor diaphragm, and (c) slotted head anchors at 3rd floor diaphragm.

- The slotted anchors connecting the vertical mullions to the floor slabs were intended to accommodate vertical movement of the curtain wall relative to the floor slabs. The bolts in the slots of the wind load anchors at Level 2 were spray-painted to identify movement across the slotted connection. Observations revealed that approximately 1 cm of residual movement had occurred, indicating that the connection accommodated the vertical movement.

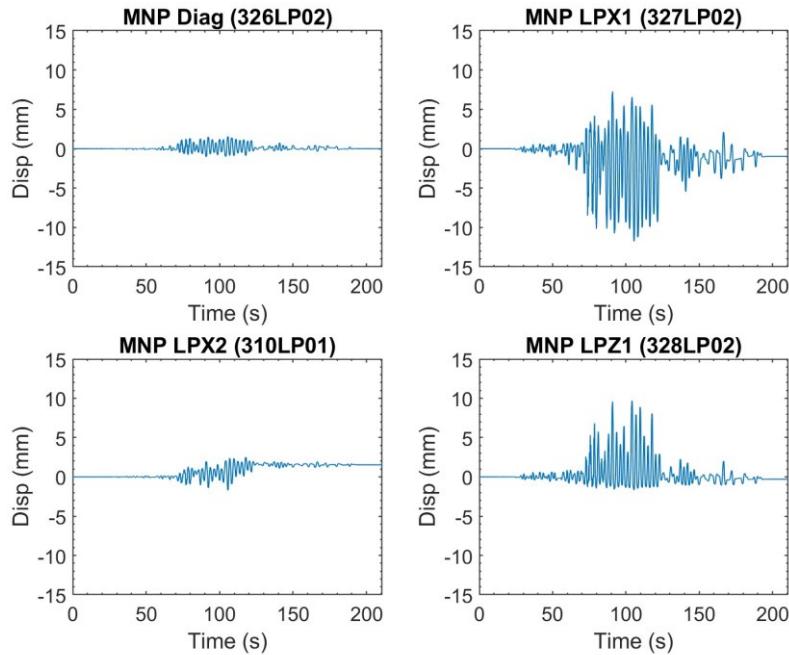
Figure 12: Middle North Panel (MNP) linear potentiometer time histories during MID93 – MCE_R Tohoku X

The displacement histories of the linear potentiometers instrumented on the Middle North Panel (MNP) during MID93 are presented in Figure 12. Larger relative movements were observed at X1 and Z1 than at X2, with small displacements observed in the diagonal linear potentiometer. The difference between the X1 and X2 values indicates that the glass panel was subjected to both rotation and translation within the framing, and the data measuring the framing may give insight to the panel movement in terms of its drift accommodation mechanisms. Figure 13 shows the extent of the panel movement from its initial position to one of its peak displacements during MID93.

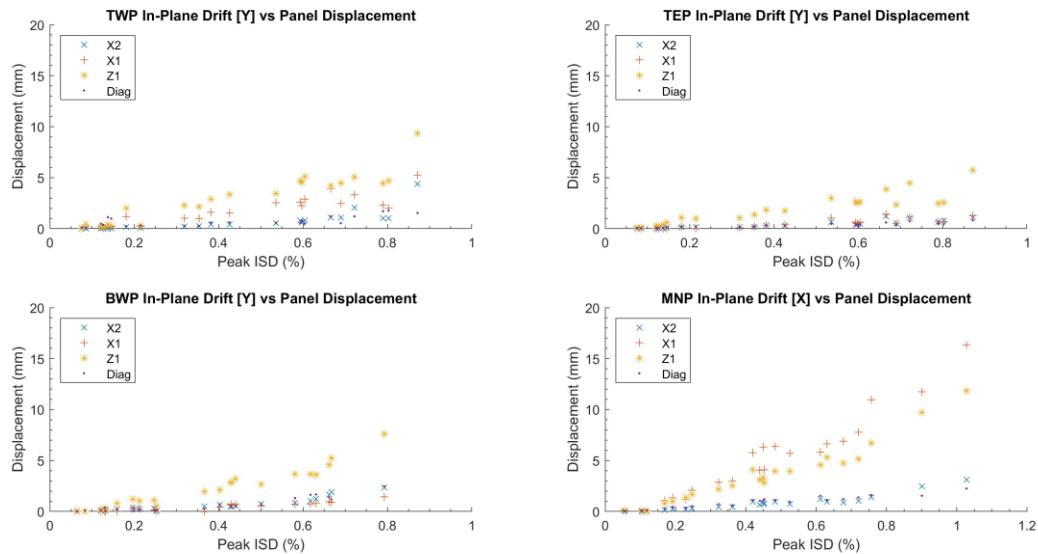
Figure 14: Peak ISD vs panels' relative displacement

Figure 14 presents the relative panel displacement within the framing for different panel locations versus the in-plane peak ISD for each of the selected motions, excluding out-of-plane only motions. For instance, the in-plane drift considered for the MNP was in the global X direction and the Y-only motions were excluded. The relationship illustrates that the peak panel displacements essentially vary linearly with the in-plane peak ISD. The MNP is the only panel to experience larger X1 displacements than Z1 displacements, likely due to the larger aspect ratio (width-to-height) compared to the other panels. The panels with larger aspect ratios were noted to experience larger vertical displacements than the panels with smaller aspect ratios.
