## SHAKE TABLE TEST OF A BALLOON-FRAMED, COLD-FORMED STEEL FAÇADE WITH DRIFT CLIPS

W. Roser<sup>1</sup>, K.L. Ryan<sup>1</sup>, Y. Ji<sup>1</sup>, S.L. Wynn<sup>1</sup>, T.C. Hutchinson<sup>2</sup>, C. Melcher<sup>3</sup> & R. Belvin<sup>4</sup>

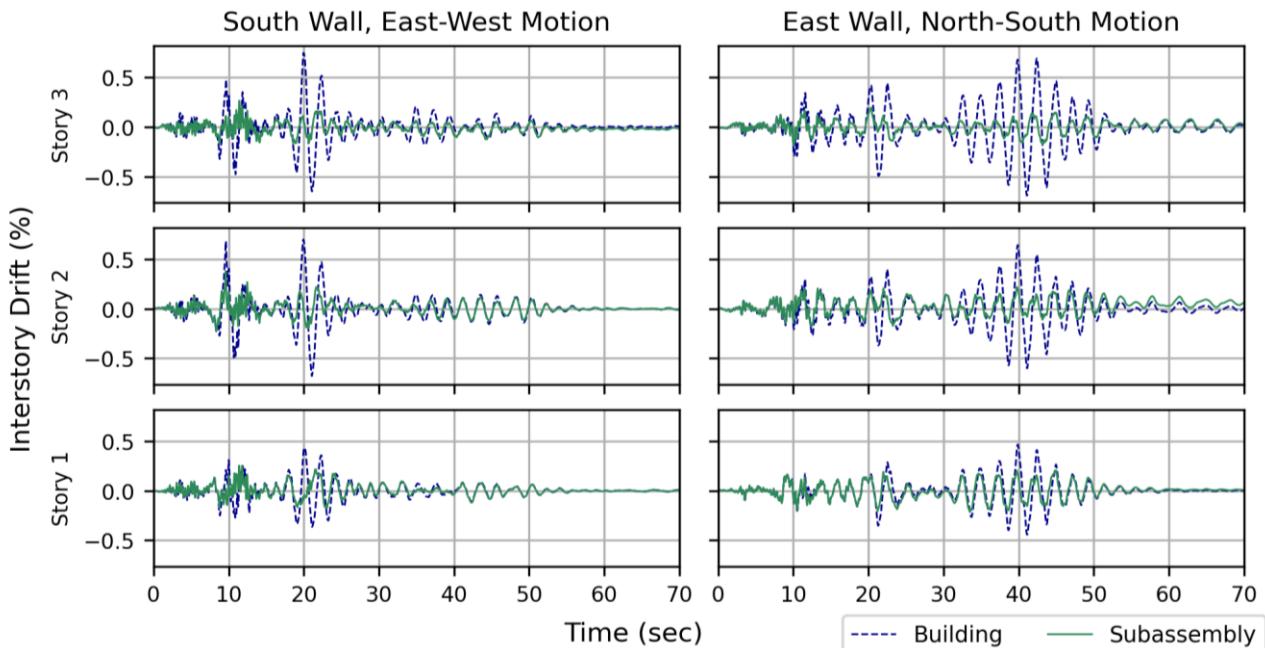
Figure 9 shows an interstory drift time history of the subassembly compared to the structural interstory drift in the same direction taken from MID46, a bidirectional motion taken from the 1999 Chi-Chi earthquake, TCU075 station, scaled to 475-year hazard level. This time history demonstrates typical behaviors of the subassembly observed throughout the testing program. Subassembly motion was computed by subtracting slip measured by the string potentiometers between the wall and building from the story displacements derived from accelerometer measurements. The corresponding time history of the slip response is shown in Fig. 10. When structural interstory drifts were smaller at the beginning and end of an individual test, the subassembly's response matched that of the structure and negligible slip was observed. As structural interstory drifts increased in amplitude, the subassembly began to slip relative to the building (Fig. 10), and subassembly interstory drift decreased relative to building interstory drift (Fig. 9).

Figure 9: Representative interstory drift response of balloon-framed subassembly compared to building interstory drift for 475 Chi-Chi XY

Despite slipping, the response of the subassembly remained in phase with the building, which indicates that even when slip was occurring, friction between the drift clips and the U-strut the wall was not fully uncoupled from the structure's motion. An advantage of this effect is that staying in phase reduces the differential movement between the wall and building that could occur if the wall were to oscillate out of phase with the building, which would be more likely to exceed the limits of movement between the exterior wall and other building components.

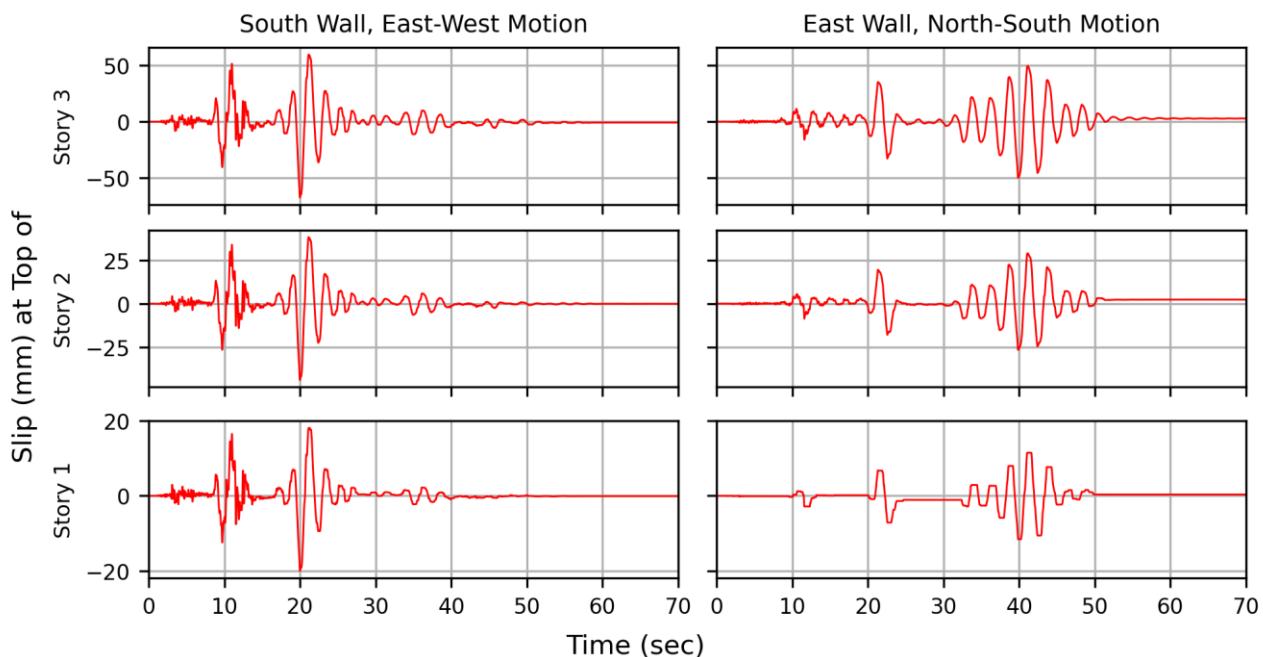
The interstory drift time histories for the three stories each had roughly the same amplitude while the slip response increased with the height of the building. This is an indicator that the sliding clip mechanism does not activate due to interstory drift. Instead, interstory drifts accumulate over multiple stories, meaning that for constant interstory drift the difference between subassembly and building displacement is roughly three times as high for the third story than the first. The slip response was not perfectly proportional to height because the friction between the clips and the U-strut prevented slipping until the difference in floor displacement was sufficiently large. As a result, on portions of the slip history the upper story slips while the lower story does not.

Figure 10: Representative time history of slip between wall and building floor for 475 Chi-Chi XY

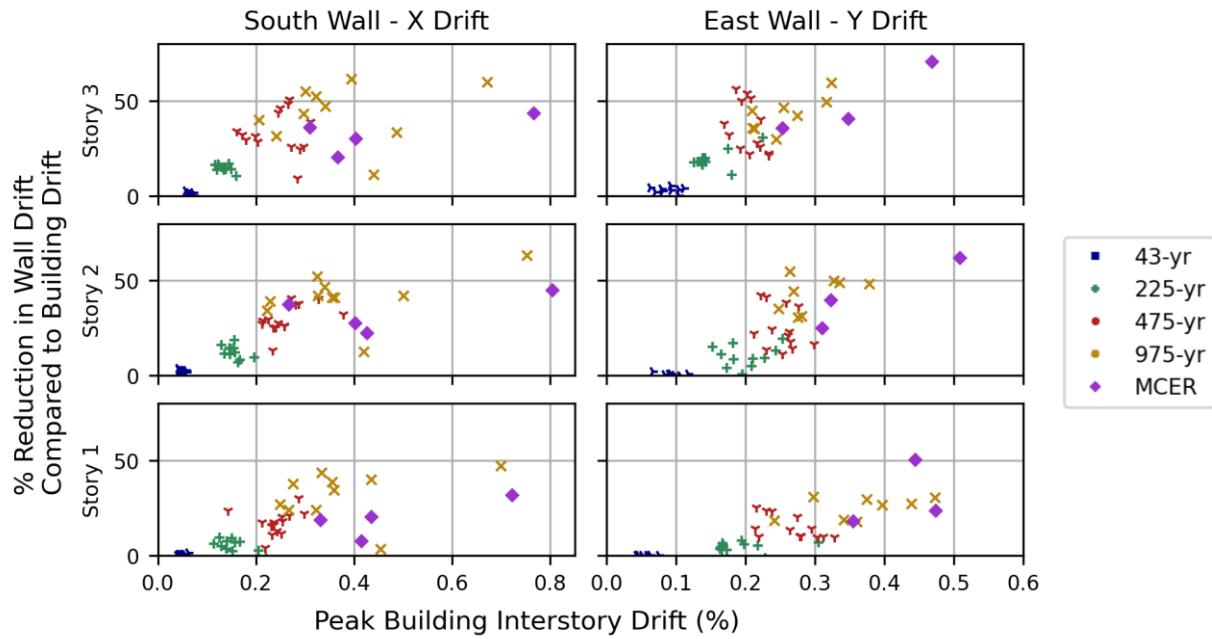
Figure 11 compares the peak interstory drift in the building to the percent reduction in peak subassembly interstory drift, calculated as the difference between building and subassembly maximum story interstory drift divided by maximum building interstory drift, across the testing program. The first 29 tests are excluded due to data synchronization issues. Interstory drift in the subassembly was consistently less than building interstory drift.

A trend between peak building interstory drift and drift reduction is visible. As building interstory drift increased, drift reduction also increased, indicating that the slip/drift joint plays a greater role in large earthquakes than small ones. This could be a desirable feature: the low building interstory drifts of frequent, smaller earthquakes do not cause damage, so the slip response is not needed. However, the increase in interstory drift reduction as demand interstory drift increases shows that the slip mechanism does activate in response to the larger interstory drifts that do cause damage that occur during more intense ground motions.

Figure 11: Percent reduction in nonstructural wall interstory drift compared to building interstory drift. Only tests with excitation in the direction of the plane of the wall are included.

Interstory drift reduction does not increase as markedly at the higher shaking intensities. This leveling out effect could be attributed to the fact that the exterior façade wall was isolated from the building drift, not the ground motion itself. A larger ground motion still increases the drift of the subassembly. This effect may also be an artifact of normalizing these reductions to the building interstory drift. A 20% reduction in interstory drift for a MCE<sub>R</sub> earthquake is still larger than a 20% reduction for an equivalent 475-year earthquake.

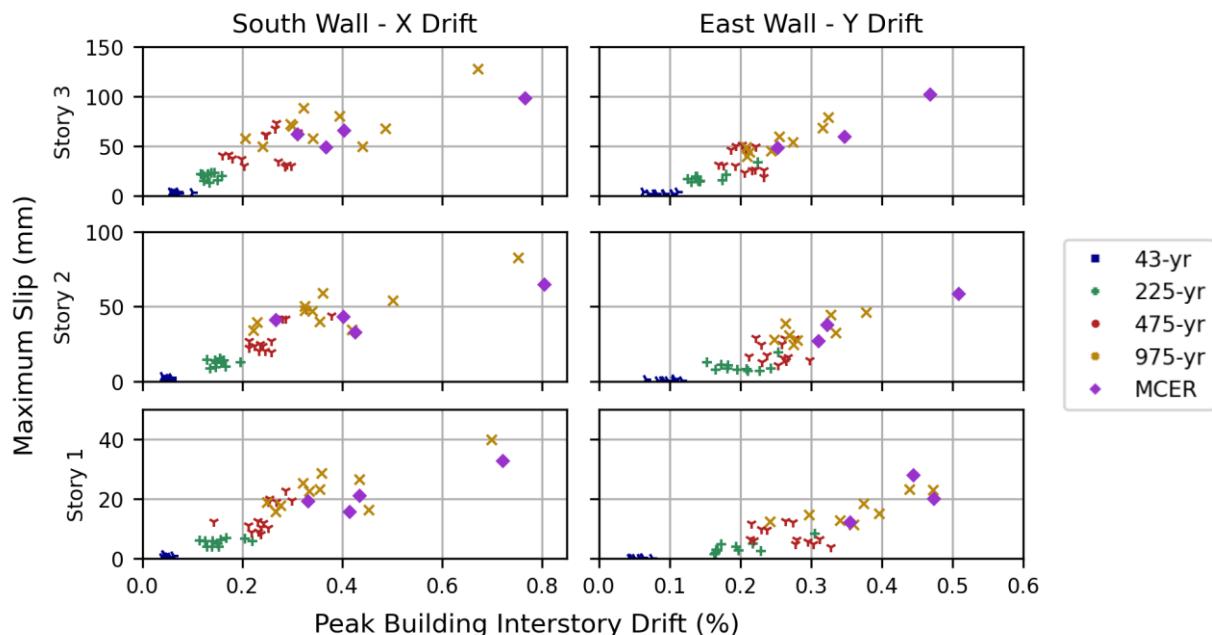
The 43-year ground motions saw little reduction in interstory drifts, despite building interstory drifts being nonzero. The slip mechanism does not activate at all for small earthquakes (Fig. 12). If the shaking intensity is not large enough to overcome friction and dislodge the clips from the U-strut, meaningful slip does not occur. However, as more intense earthquakes produced larger building interstory drifts, the walls experienced proportionally less interstory drift compared to the building as the amplitude of slip increases.

Conversely, slip between the wall and building (Fig. 12) continues to increase as interstory drift increases without an apparent upper limit. This experiment did not identify a limit on the amount of slip the sliding clip system is able to accommodate. However, the increase in slip does not counteract all building motion, so the system could reach a limit state when the interstory drift in the subassembly is enough to cause damage to wall sheathing and framing.

Figure 12: Absolute peak building interstory drift vs maximum slip
