# Deep Trouble! Common Problems for Ocean Observatories

Ocean Observing Infrastructure and Sensing – Technical Lessons Learned and Best Practices; Moss Landing, California, 23–25 September 2016

By [Bruce M. Howe](#) and Eric McRae © 22 May 2017

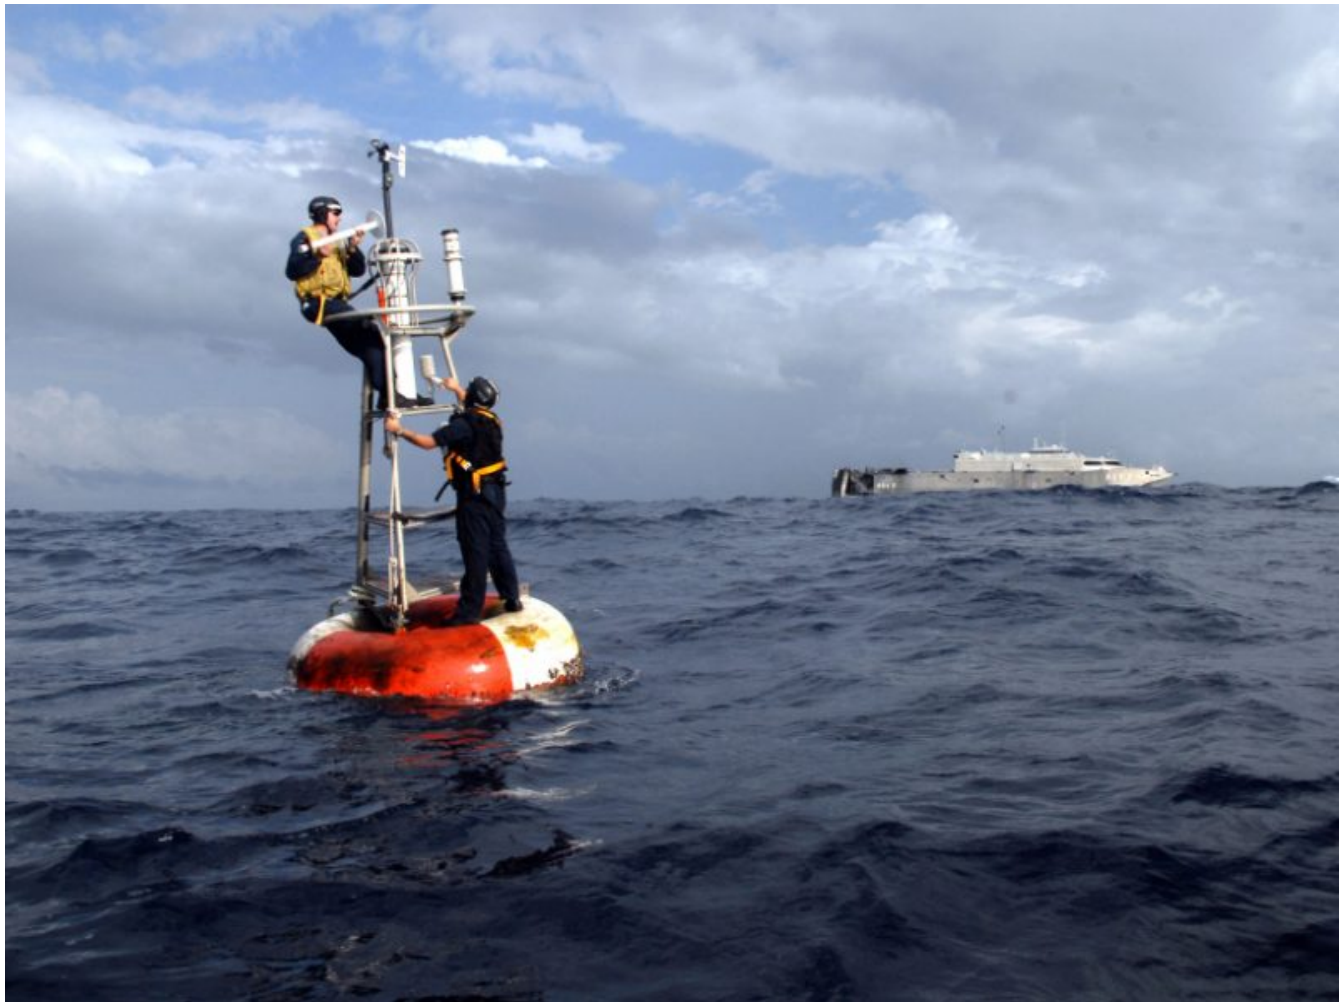
Members of the U.S. Navy repair a National Oceanic and Atmospheric Administration buoy in the Atlantic Ocean on 25 January 2008. In September 2016, representatives from ocean observatories gathered at the Monterey Bay Aquarium to discuss how to improve upkeep of scientific equipment that collects ocean data. Credit: Elizabeth Merriam, [U.S. Navy](#)
