GEOTECHNICAL ASPECTS OF THE 2016 KAIKŌURA EARTHQUAKE ON THE SOUTH ISLAND OF NEW ZEALAND

(Submitted March 2017; Reviewed April 2017; Accepted May 2017)

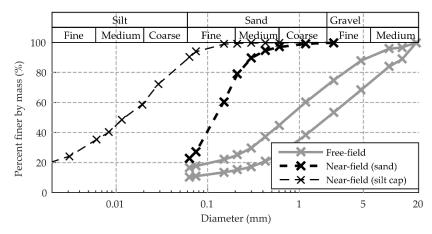
Some liquefaction-induced lateral spreading caused minor damage at the 4-span Needles Creek Bridge, located just north of the town of Ward about 35 km south of Blenheim on SH1. Figure 26 shows some of the damage observations at the Needles Creek Bridge. Moderate liquefaction ejecta was observed under the bridge between several of the piers, and minor ejecta was found in one location on the north bank, 25 m west of the bridge. Between the bridge piers, the ejecta had separated into a sandy portion near the piers (i.e. where it exited from the ground) and clayey silt which had pooled on the raised floodplain of the creek. The free-field ejecta (25m west of the bridge) was very coarse compared with the ejecta beneath the bridge and elsewhere in the region. Free-field lateral spreading 30m west of the bridge (Figure 26 a) resulted in localised movements of up to 50cm, with individual cracks being 15-25 cm wide. A local farmer reported that there was additional lateral spreading located east of the bridge, but this was several hundred meters away and not investigated.

Figure 27: Particle size distributions of ejecta at Needles Creek Bridge.

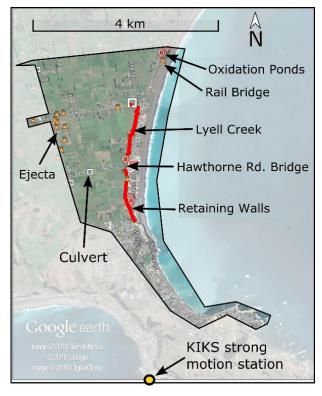
Figure 28: Reconnaissance in Kaikōura (Approx. coord. of image: -42.389°, 173.682°; Basemap: Google).

The area covered by the overall reconnaissance efforts is shown in Figure 28, along with key locations where damage was observed. Due to the rural nature of this area, the damage to infrastructure was quite low. Damage was concentrated along Lyell Creek, where large lateral displacements were observed within 30 m of the creek resulting in heavy damage to many houses built close to the river, and to one short-span bridge. While these displacements resulted in cumulative crack widths of up to 3m, it was apparent that the driving mechanism was not due to classic liquefaction-induced lateral spreading, as discussed subsequently. Other damage in the region included cracking and deformation of the roads, as well as some damage to the liner systems in embankments at the oxidation ponds to the north of the town. Liquefaction ejecta was noted in some areas outside of the main township, though the overall impact of liquefaction was quite small.

Large lateral ground displacements were observed along both sides of Lyell Creek (shown in red in Figure 28) and were highly variable from location to location. On the east side of the creek (boundary of the township), horizontal displacements of up to ~3 m were recorded at a few locations in the area between 140 and 190 Beach Road (~500 m stretch of road), though cumulative crack widths of 1-2 m were quite common. The area of major ground cracking was generally concentrated within 30 m of Lyell Creek. The land on the west side of the creek is mostly used for agricultural purposes and hence ground displacements had little direct impact on built structures.

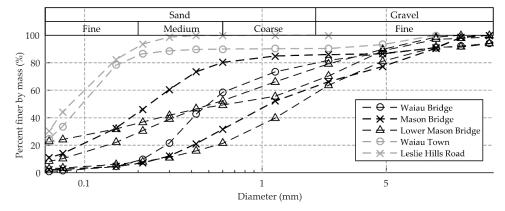
Samples of ejecta were taken from a sand boil within Waiau town, as well as a minor sand boil close to the fault rupture on Leslie Hills Road. The particle size distributions of these samples are shown in Figure 49 and indicate the ejecta material is relatively clean fine sand. Also shown in this figure are the gradings associated with ejecta material found near the

Figure 49: Particle size distribution of ejecta samples collected across the Amuri and Emu Plains.
