Hurricane Michael in the Area of Mexico Beach, Florida

Abstract: Category 5 Hurricane Michael made landfall near Mexico Beach, Florida on October 9, 2018, with measured high water marks (HWMs) reaching 7.2 m NAVD88. The town itself received great damage, with many areas destroyed down to the foundations. In this study, we document the storm and its effects on the greater Mexico Beach area: hazard, structural damage, and their relationships. Wave and surge damage was nearly total for low-lying properties, but damage decreased greatly with increasing elevation. Major wave and surge damage was noted in Federal Emergency Management Agency (FEMA) X zones, which are out of the 100-year floodplain, and it is suggested that the 100-year storm is a deficient measure for categorizing flood risk. **DOI: 10.1061/(ASCE)WW.1943-5460.0000590**. *This work is made available under the terms of the Creative Commons Attribution 4.0 International license, https://creativecommons.org/licenses/by/4.0/*.

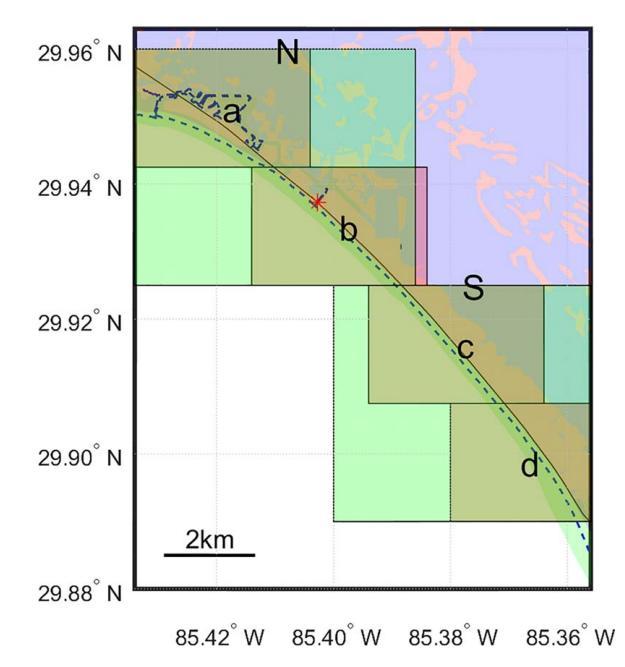
Fig. 10 shows the overall surge and wave induced damage ratings for all structures surveyed by the team in the Mexico Beach area, divided into the four subregions shown in Fig. 9. It is clear that in area (a) (furthest NW), large areas near the shoreline suffered complete damage, while the furthest SE section (d) showed areas near the shoreline with damage, but not anywhere near the extent of (a), with (b–c) demonstrating intermediate levels of damage.

Fig. 9. (Color) Locations of subregions a–d, and N–S used in Figs. 10, 13, 15, and 16. The red asterisk shows the eastern end of the region where all structures seaward of US98 were evaluated for damage.

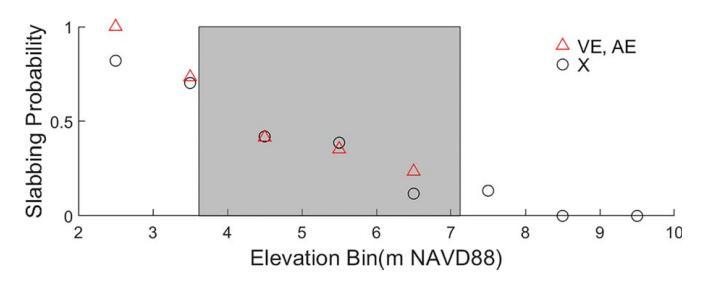
The immediate survival or destruction of a structure is an important safety consideration. In this study, destruction is defined by damage category DS6, where the structure is slabbed; that is to say, it is completely removed from its foundations. Fig. 12 shows the probability of slabbing during Michael for aggregated VE–AE zones and X zones. Unsurprisingly, the probability of survival increases strongly

Fig. 12. (Color) Slabbing probabilities as a function of elevation over the Mexico Beach region for combined VE and AE zones (triangle); X zone (circle). The shaded region shows the range of observed HWMs.

with increasing building elevation. Somewhat surprisingly, the probabilities for VE–AE and X zones are almost identical, indicating that structural elevation was the overwhelming factor for survival. Because there was a range of inundation over the Mexico Beach region, this is reflected in the slabbing probabilities. Because Michael so greatly exceeded the 100-year event, the near coast DFIRM zones behaved like one. We note that this study looks almost exclusively at structures in the first few hundred meters from the shore, and slabbing behavior would certainly be different further inland.

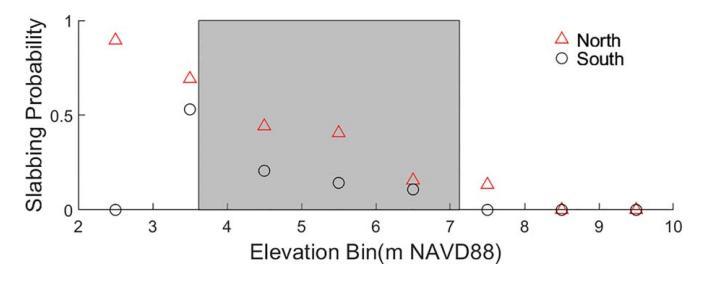
Fig. 13. (Color) Slabbing probabilities for all flood zones combined as a function of location. North Mexico Beach (triangle); South Mexico Beach (circle). The shaded region shows the range of observed high watermarks.
