Performance of Manufactured Housing during Hurricanes Irma and Michael

Elaina J. Sutley, Ph.D., A.M.ASCE¹; Karen Vazquez, S.M.ASCE²; Jae H. Kim, S.M.ASCE³; Thang Dao, Ph.D., A.M.ASCE⁴; Blythe Johnston, S.M.ASCE⁵; and Josh Hunt, S.M.ASCE⁶

Author keywords: Mobile home; Manufactured housing; Hurricane Michael; Hurricane Irma; Wind damage.

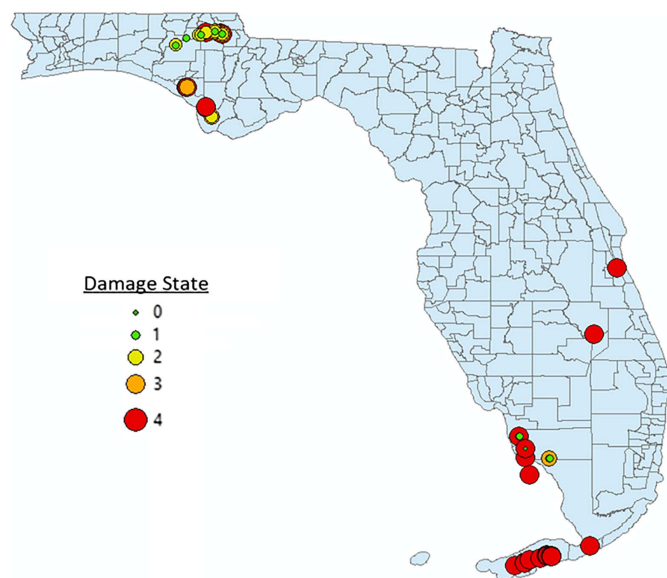
Fig. 2. Geospatial depiction of posthurricane damage to manufactured homes in Florida.

post-Hurricane Michael. In some cases, particularly with the Hurricane Irma data, minor levels of damage were distinguished by comparing post-Irma photos with pre-Irma imagery to determine as best as possible what was different because of the hurricane. Fig. 2 provides a geospatial damage distribution of the sampled manufactured homes across both hurricane events in Florida; varying marker sizes are used to show damage distribution across the survey sites. Table 3 tabulates the distribution of damage assessed after Hurricanes Irma and Michael. The following sections provide imagery comparisons exemplifying each damage state; damage to different portions of the structure, including the foundation, trailer, and attachments; and a closer look at how manufactured homes constructed across the three fabrication periods performed during both events and in different geographic areas.

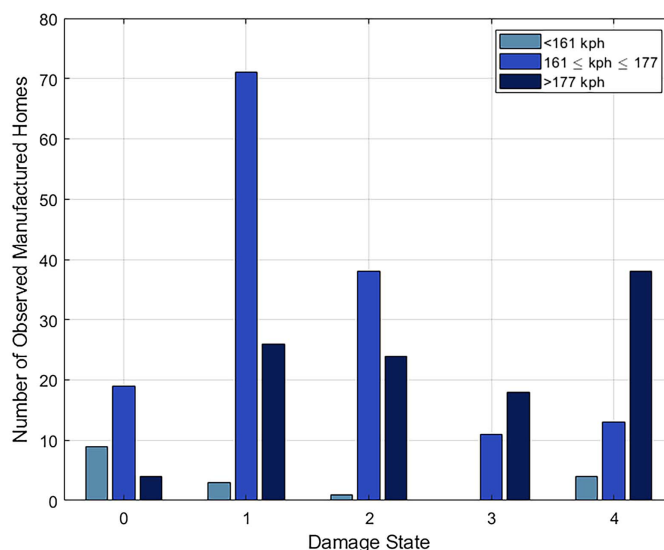
Fig. 7. Manufactured housing damage distribution across wind speed ranges ($n = 279$).

of homes experiencing no damage experienced the lowest wind speed range, and the highest proportion of homes experiencing complete damage experienced the highest wind speed range. Of the homes located within the highest wind speed range (greater than 177 km/h), 4 homes were recorded after Hurricane Irma as having no damage; 19 were recorded after Hurricane Irma and 6 homes were recorded after Hurricane Michael as having minor damage; and 8 homes were recorded after Hurricane Irma and 16 were recorded after Hurricane Michael as having moderate damage. It was expected that all homes would be severely or completely damaged after experiencing wind speeds greater than the design wind speeds, which vary based on the HUD zone and fabrication year. Thus, this discrepancy in the data can be attributed to (1) fabrication year of the home, and any further enhancements to the structure; and (2) the fact that peak wind speeds are based on predicted contours, and do not perfectly represent the actual peak wind speed recorded at the site, which could have been different from the contour values.

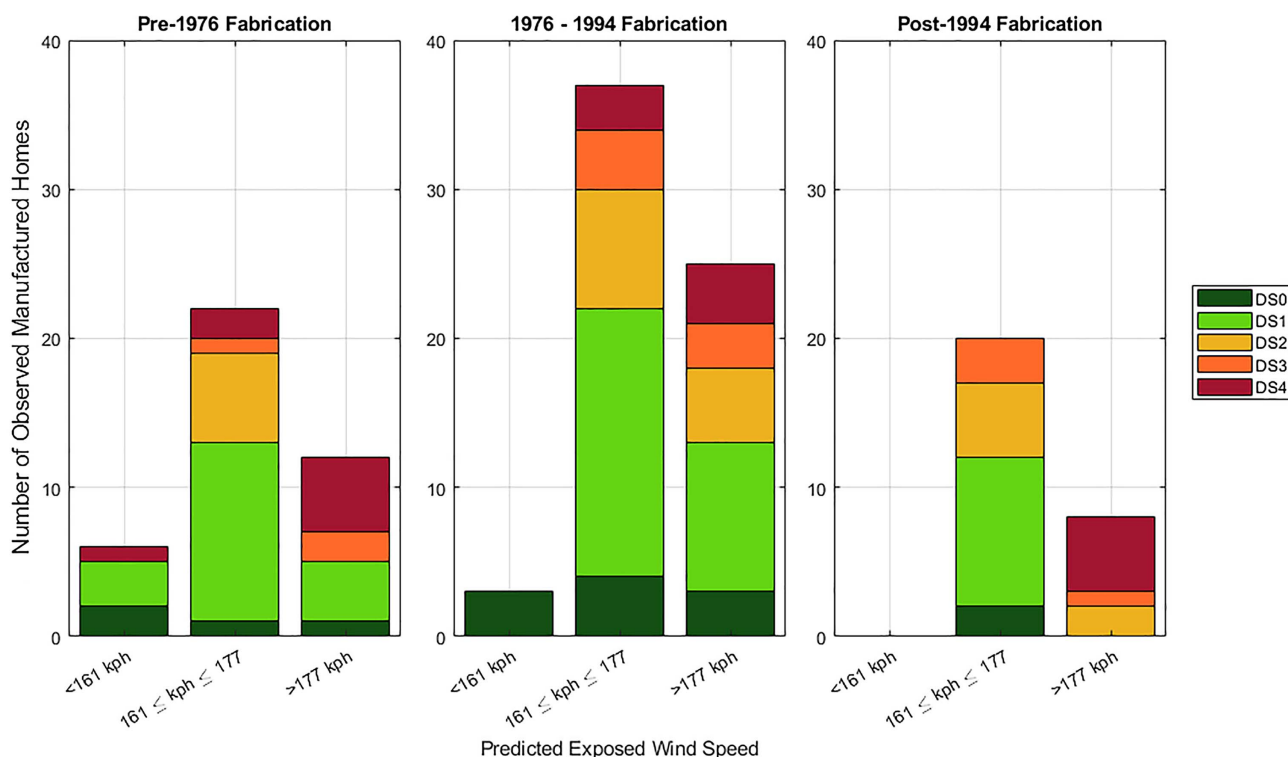
Fig. 8. Observed manufactured housing damage distribution across fabrication periods and wind speed ranges ($n = 133$).

Based on ARA estimates, wind speeds peaked very near the design wind speeds for these homes, considering any fabrication year. The results in Fig. 8 are consistent with the well-documented findings that homes built prior to 1976 experience more damage and more severe damage at lower wind speeds. Pre-1994 fabricated homes also tended to have more damage and more severe damage overall and in the medium to high wind ranges, although both had considerable variability. Similarly, detailed images were provided of the failure modes of the foundation, trailer, and attachments, which were consistent with past findings despite the fact that most homes utilized engineered foundation systems.

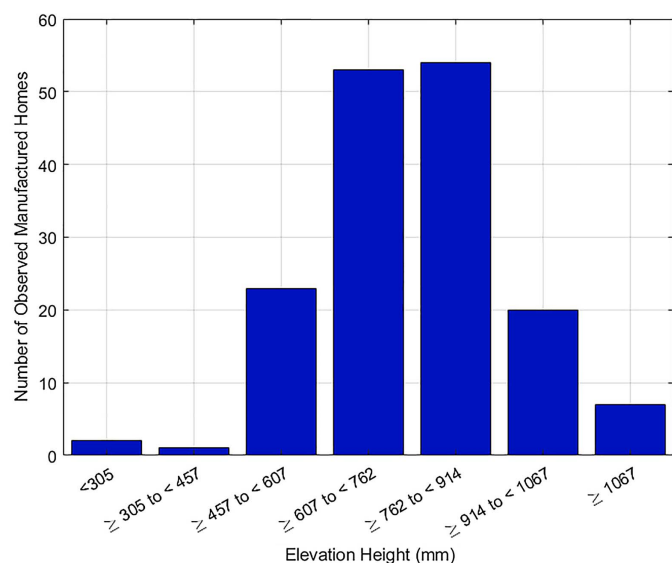
Fig. 9. Histogram of manufactured home elevation heights.

Fig. 9 provides a histogram of the range of elevation heights measured in the field, in which the first bin captures heights up to 305 mm (1 ft) in elevation and the last bin captures heights more than 1,067 mm (42 in.) in elevation. Most homes were elevated between 457 and 914 mm (18 and 36 in.); recent wind tunnel tests showed that buildings raised to these lower heights experience high suction pressure coefficients on their floor underside (based on forthcoming work by the authors). Fig. 10 provides examples of the types of damage observed to the foundation, including anchorage devices becoming detached from the ground or the unit, and wood or concrete blocks being displaced and even collapsing. The images in Fig. 10 are in addition to complete failures related to the foundations of manufactured homes, in which common failure modes included the trailer rolling off of the foundation or experiencing a pancake-like collapse onto the foundation.
