Case Studies in Construction Materials

Condition assessment of concrete and glass fiber reinforced polymer (GFRP) rebar after 18 years of service life

Concrete cores containing GFRP bars were extracted from dry-dock no. 4 at Pearl Harbor in Oahu, Hawaii. The original structure for the dry-dock was built in 1942 for the US Navy with reinforced concrete walls of thickness 7.6–9.1 m [27]. The dry-dock walls significantly degraded over time and repairs were performed to the fascia in the early 1990s using steel reinforcement with a 50 mm thick concrete cover. Due to subsequent corrosion of the steel reinforcement used in the first repair (and the consequent delamination and spalling of the concrete), a need rose for additional repairs, which were executed and completed in 2001 by removing affected concrete and steel reinforcement and replacing them using concrete reinforced with GFRP bars [27]. The condition of the dry-dock fascia during the execution of the second round of repair is shown in Fig. 1, depicting the areas where the deteriorated concrete was removed. This picture also shows the approximate locations where the concrete cores were extracted 18 years later for this study.

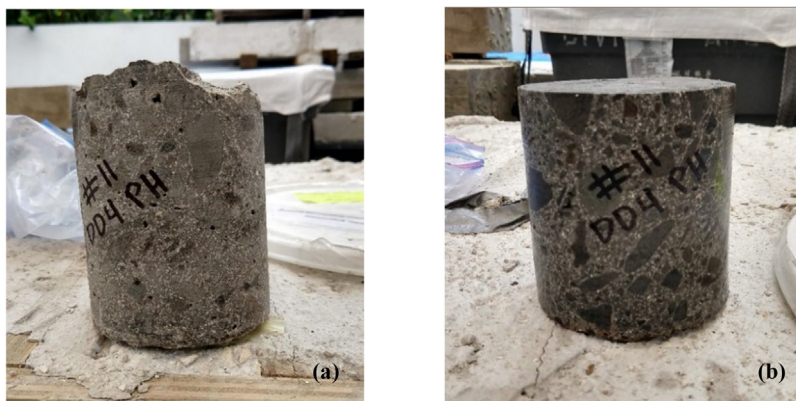
The cores received were not of “full” length but were broken into smaller pieces enabling multiple tests on each core. Further, the cores did not have a uniform length and had uneven end surfaces. An example core as received at the laboratory is shown in Fig. 4a. The surfaces of the cores were prepared by carefully cutting with a wet saw to obtain smooth end surfaces needed to carry out concrete testing, as shown in Fig. 4b. The cores (cores #1, 4, 10, 12, 13, 14, 15, and 16) did not have the desirable “standard” length (i.e., a 2 to 1 aspect ratio) before or after sample preparation. Finally, some cores (cores #2, 5, and 8) had a significant amount of macrovoids or extremely irregular end surfaces (which, if cut, would have led to specimen sizes that could not be tested). Such cores were used for measuring concrete carbonation depth and chloride penetration.

Fig. 4. Representative images of cores (a) as received, and (b) after preparing ends. (Core #11 – Region II).

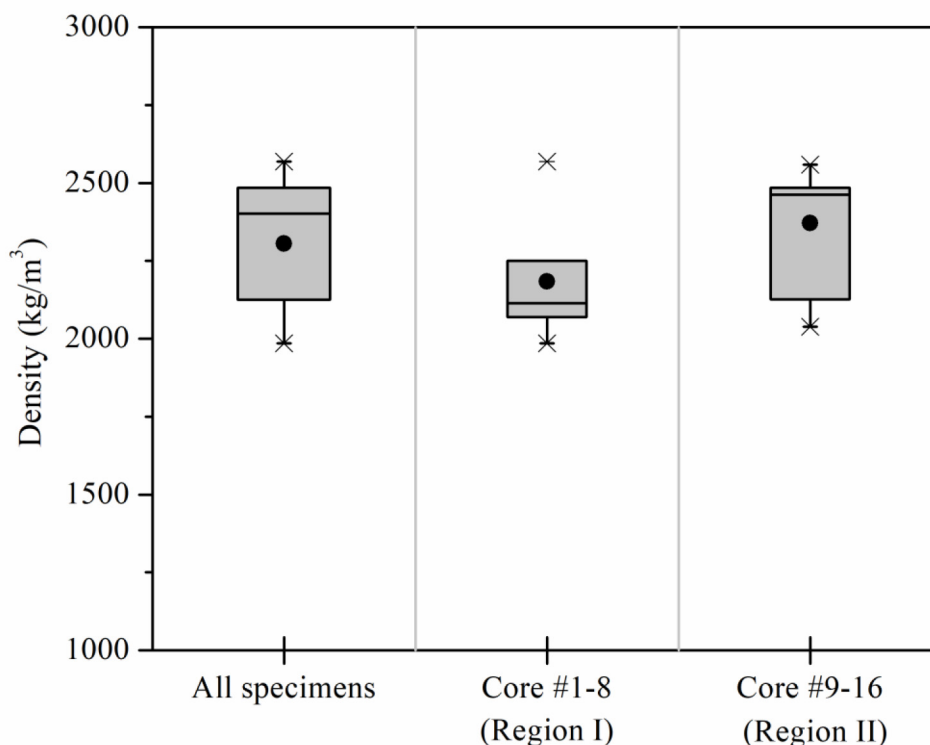
Fig. 6. Range of density values for the cores.

The average density is 2305 kg/m^3 and the values range from 1985 to 2568 kg/m^3 . The large range of density clearly shows the concrete variability. When specimens are grouped into those coming from Region I (cores #1-8) and Region II (cores #9-16), the spread in the data does not appear to be reduced. Specimens from Region II have an average density higher than those in Region I by 9%. Low densities are an indicator of concrete damage during the service life due to cracking, leaching, or spalling, although they could also be due to differences in mixture design. Decrease in concrete density due to leaching of calcium has been observed in literature [32].

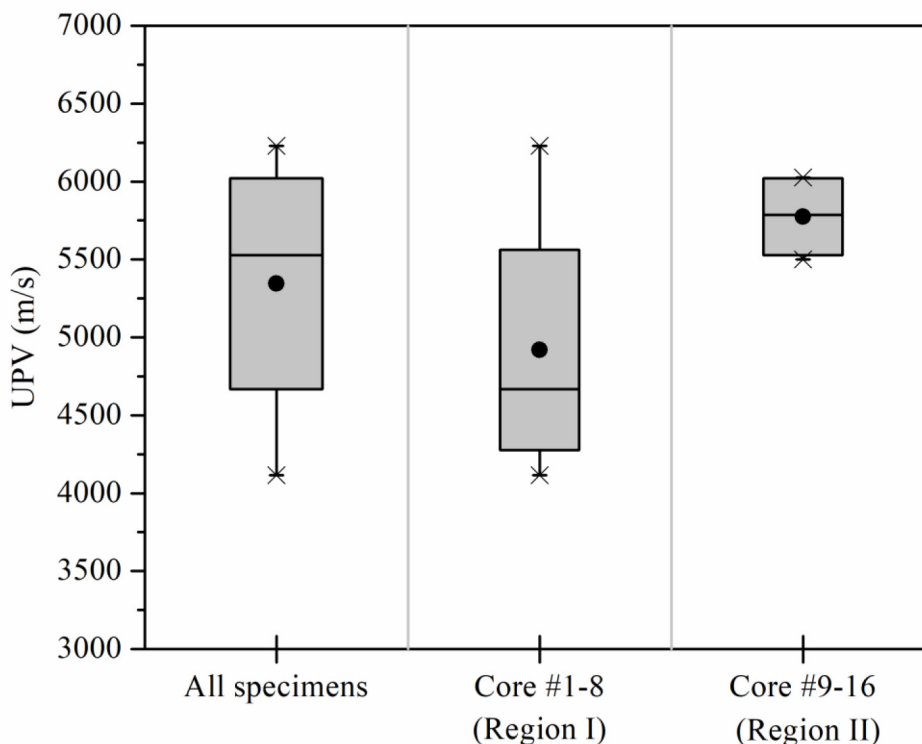
Fig. 7. Range of UPV values for the specimens.

The UPV values (shown in Fig. 7) range from 4114 m/s to 6229 m/s with an average UPV value of 5347 m/s . These values are high; which is expected considering the concrete age. Interpretation of UPV in carbonated specimens with unknown saturation states is complex, but the range is further evidence of the concrete variability. The high values of the UPV suggest that the concrete quality is generally good [33,34], however, some portions of the structure, particularly Core #6 (UPV = 4437 m/s) and Core #7 (UPV = 4114 m/s), appear to have deteriorated, considering the lower UPV values. Visual inspection confirms this interpretation, and some concrete in this zone has spalled and cover concrete has been lost. It is not possible to further evaluate deterioration, considering the properties of the original concrete(s) are not known. Separating out data from Region I and Region II shows that the latter have a statistically higher UPV mean than the former. Cores from Region I appear to show a greater data range in the UPV measurements. High COV values are somewhat expected in field mixtures [35], and severe exposure tends to exacerbate variability.

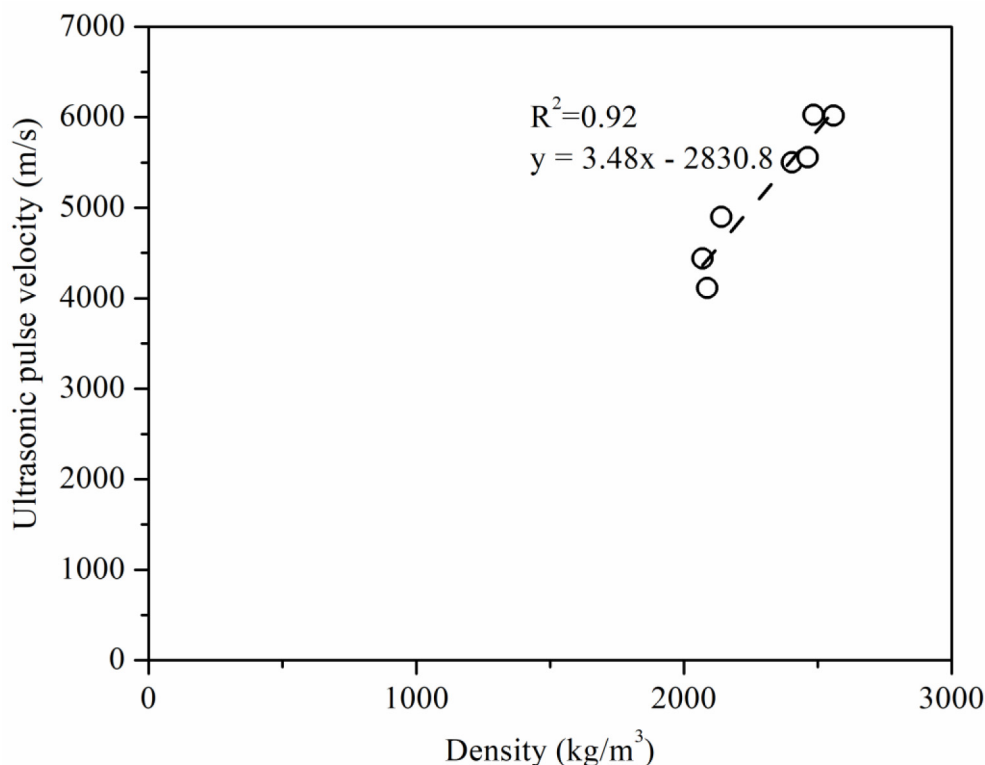
The density and the UPV values strongly correlate, although the number of data points is somewhat limited. As the concrete density increases, the UPV value increases (Fig. 8). The explanation for this behavior is that ultrasonic waves travel faster through a denser medium compared to a less dense medium with pores and lower density [36,37]. Similar trends regarding concrete density and UPV have been observed in literature where there is a decrease in UPV values with a decrease in density of concrete [37]. The strong correlation seen here, combined with visual assessment, suggests that the lower density and lower UPV concrete is of poorer quality, likely due to damage, although lack of information regarding the original concrete prevents drawing further inferences.

Fig. 8. Correlation between density and UPV values.

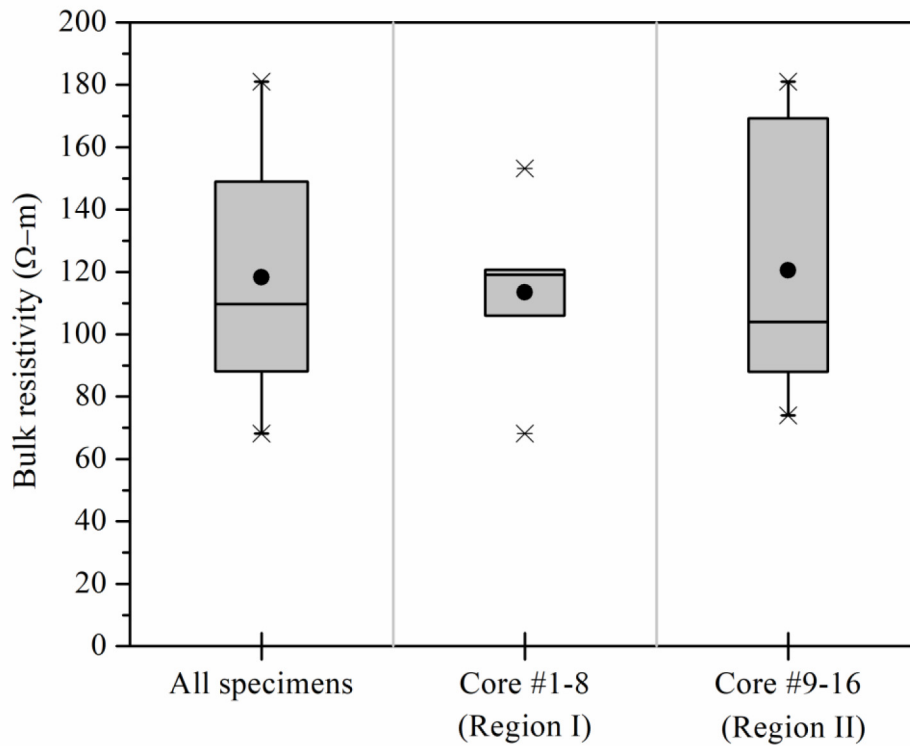
Bulk resistivity values (shown in Fig. 9) of the concrete showed significant variation, ranging from 68 to 180 Ω -m, with an average bulk resistivity of 118 Ω -m and a standard deviation of 37 Ω -m for 16 specimens. Only five measurements were within 15 % of the mean value and four cores showed values greater than one standard deviation on the mean. While the actual mixture design for the concrete is unknown, it is possible that supplementary cementitious materials would have been used in the concrete mixture. If this assumption is true, the bulk resistivity values are significantly lower than what is expected for a concrete mixture at ages later than 10 years. Bulk resistivity values for concrete exposed to similar conditions typically range from 300 to 1000 Ω -m [38]. The lower bulk resistivity values suggest concrete deterioration, due to leaching and ingress of aggressive species such chlorides from the seawater. One must keep in mind that interpreting bulk resistivity values can be tricky in specimens of unknown degrees of saturation even in the lab and drawing conclusions for field specimens is therefore fraught with uncertainty. There does not appear to be a significant difference in the bulk resistivity values for cores from Regions I and II, when considering the data variability.

Fig. 9. Range of bulk resistivity values for the specimens.

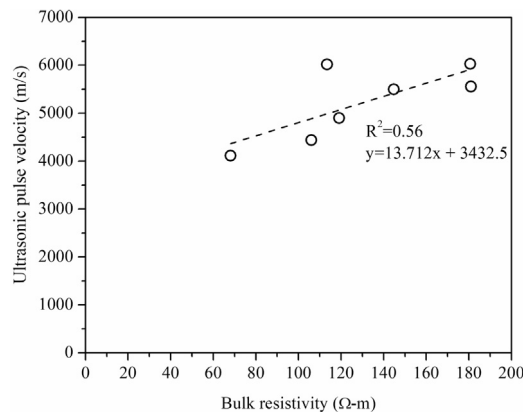
Bulk resistivity and UPV values for the same specimens show a moderate correlation (Fig. 10), likely because both measures are indicators of concrete quality. Good correlations have been observed in literature for UPV and bulk resistivity [39,40] for lab specimens. However, since the specimens have an unknown degree of saturation, the correlation is only moderate here.

Fig. 10. Correlation between bulk resistivity and UPV.

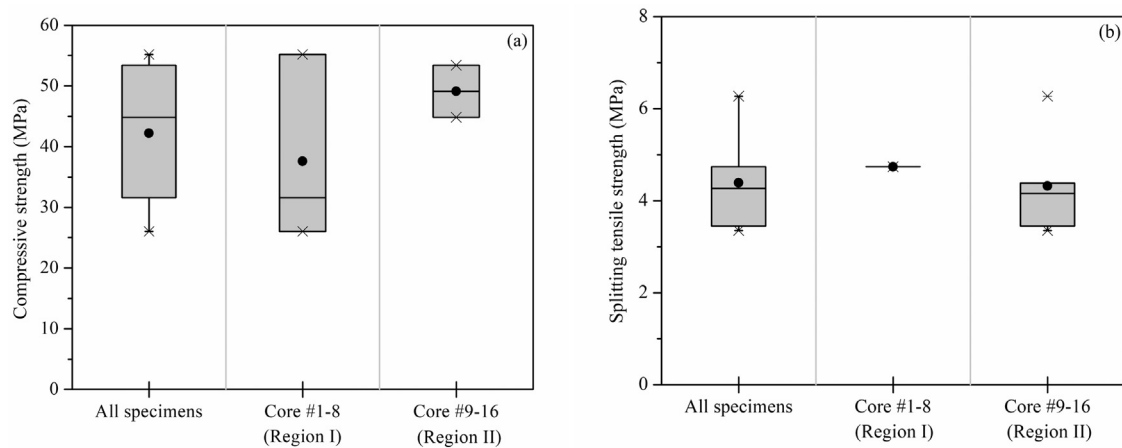
Fig. 11a and b show the range of values for compressive and splitting tensile strengths of the concrete core specimens tested. The compressive strength shows significant variation and ranges from 26 to 55 MPa, with an average compressive strength of 42 MPa and COV of 31 %. In compression, cores from Region II show a statistically greater strength than cores from Region I (though note the limited number of specimens tested for Region II). The splitting tensile strength also shows significant variation, with values ranging from 3.5 to 6.3 MPa, with an average value of 4.4 MPa (COV of 32 %). Not enough specimens from Region I and Region II were tested to be able to compare the data in detail, though splitting tensile and compressive strength values did appear to correlate. The variations are significantly higher than what is expected from concrete mixtures in the lab but are to be expected from field mixtures with different levels of deterioration. The high COV values are consistent with the results from the other non-destructive test results. Since information regarding the initial design strength or the 28-day compressive strength of the concrete mixture is unavailable, no further analysis about deterioration can be made.

Fig. 11. Mechanical properties for the core specimens – (a) compressive strength and (b) splitting tensile strength.

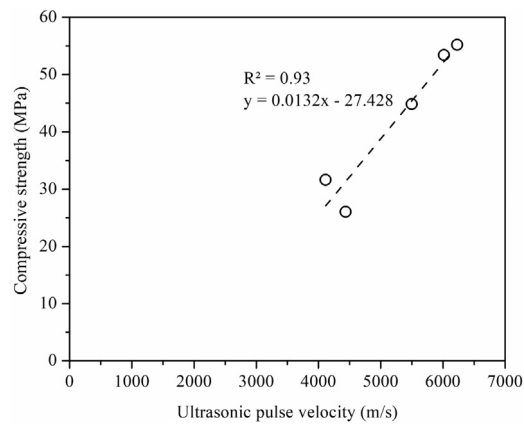
A strong correlation is observed between compressive strength and the UPV values as seen in Fig. 12. Similar correlations between UPV and compressive strength have been shown in literature and the UPV values could be used to predict the compressive strength of concrete specimens. It has been suggested that theoretical equations [41,42] can be used to predict the compressive strength of field specimens based on UPV data. However, in this case, the UPV values predict that the compressive strength values should be significantly higher than what was observed. This discrepancy could be due to cracks induced in the concrete during specimen preparation (resulting in lower compressive strength measurements) or due to granitic aggregates (which can lead to higher UPV values [43]). The ultrasonic pulse velocity method is not sensitive enough to capture distributed microcracking in the matrix [44].

Fig. 12. Correlation between compressive strength and ultrasonic pulse velocity.
