Title No. 117-M99

Assessment Study of Glass Fiber-Reinforced Polymer Reinforcement Used in Two Concrete Bridges after More than 15 Years of Service

by Ali F. Al-Khafaji, John J. Myers, and Antonio Nanni

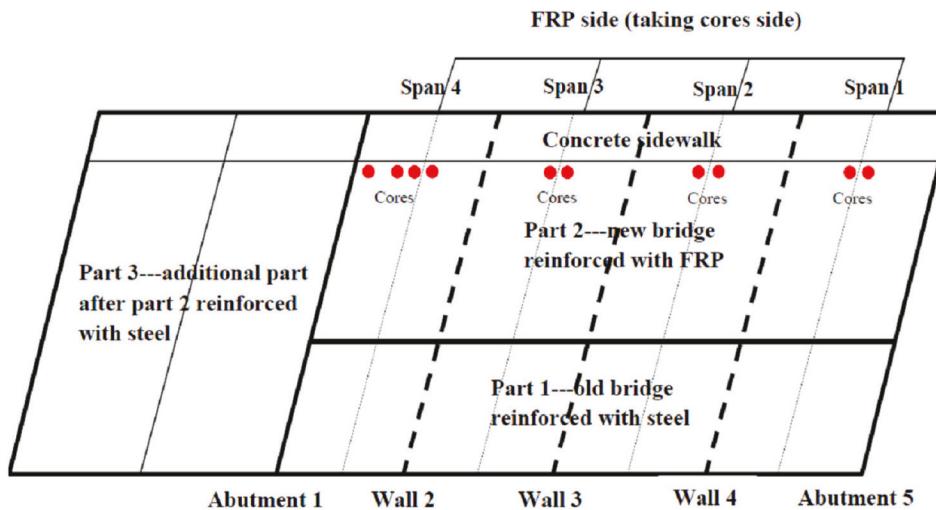
Fig. 2—Core locations of Southview Bridge.

Concrete cores of 102 mm (4 in.) diameter with encapsulated GFRP bars were extracted from the bridges in 2015. A total of 10 cores were taken from the deck of Southview Bridge in the following manner: two cores from each of span one, two, and three, and four cores from span four. On the other hand, five cores were extracted from the overhang of Sierrita de la Cruz Bridge. In both bridges, the core holes were filled immediately after the core extraction with a fast-curing durable cementitious grout. The extracted cores were then sent to the laboratories of the collaborated universities. Two cores, CM1 and CM2, from Southview Bridge and one core, CT, from Sierrita de la Cruz Bridge were sent to the laboratory of Missouri University of Science and Technology for examinations. In both bridges, all the extracted GFRP bars were 19 mm (3/4 in.) diameter. Figure 6 shows one core from each bridge and Table 1 shows the GFRP bars' information.

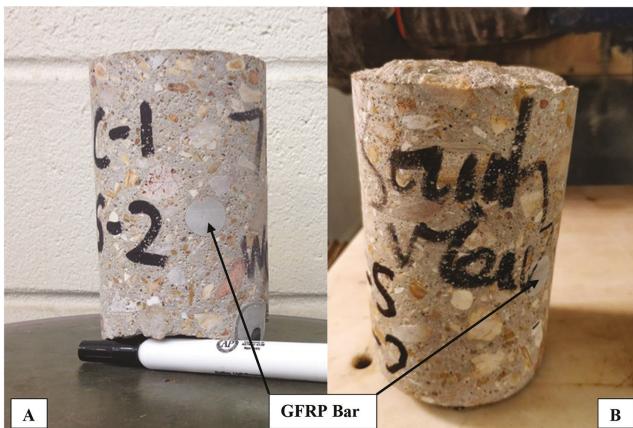
Fig. 6—Cores from: (a) Southview Bridge, Rolla, MO; and (b) Sierrita de la Cruz Creek Bridge, Amarillo, TX.
