# Liquefaction and Related Ground Failure from July 2019 Ridgecrest Earthquake Sequence

#### **ABSTRACT**

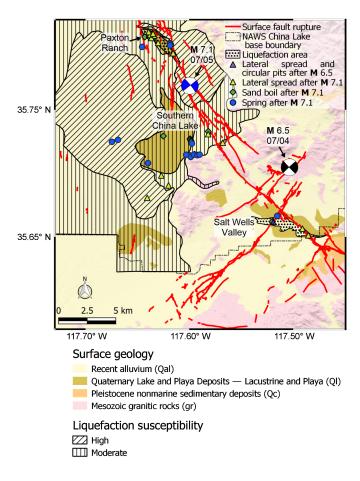
**Figure 2.** Surface geologic map of eastern portion of Indian Wells Valley (from Jennings *et al.*, 1962) showing locations of mapped liquefaction features. Liquefaction susceptibility zones modified from mapping by Banks (1982). The color version of this figure is available only in the electronic edition.

As shown in Figure 2, areas of liquefaction-related ground failures from the Ridgecrest earthquake sequence are found within three primary areas on the NAWS base: Paxton Ranch, the southern end of China Lake Playa, and Salt Wells Valley. Site conditions in which liquefaction features exist included saturated or very shallow groundwater levels, loose, fine-grained playa and lacustrine sediments, and areas where natural springs occur at bedrock–alluvium contacts. In addition, near the southern edge of the China Lake playa, leakage from the sewage ponds, and corresponding drainage channels from Lark Seep to the playa are a contributing factor. Seasonal rains collect in both the China Lake and Salt Wells Valley areas, promoting shallow groundwater conditions.

Liquefaction features appeared to coincide with surfacefault rupture locations in the Paxton Ranch area. Lateral spreads were prominent throughout the central portion of the small playa in this area and concentrated just inside the outer edges of the playa (Fig. 2 and Fig. S1). Ground failures that occurred in the Paxton Ranch area did not appear to impact infrastructure, as these features appeared to be fairly constrained to the small, unnamed northern playa surface.

In southern China Lake, springs or seeps were located within the playa deposits, approximately 35-50 m from the bedrock-alluvium contact (35.714920°, -117.592197°). Based on pre- and postevent satellite imagery, we determined that these features were triggered by the 2019 earthquake sequence. Large sand boils with central openings 2-4 m in diameter were located 125-160 m west of the main M 7.1 surface rupture (35.733098°, -117.582061°), as shown in Figure 2 and Figure S8. Ground failures were noted in the China Lake area at a sewer treatment pump house, located within the eastern portion of China Lake playa, about 1.7 km west of the main M 7.1 rupture. Damage to this structure included excavation backfill settlement (ring fractures) and external pipe connection dislocations. Foundation settlement was not observed, although shallow groundwater pumping extended outside the building, and some external utility poles were tilted. Lateral spread features were observed along the southern end of China Lake playa near a shallow detention basin (35.723812°, -117.567984°), about 70 m away from the bedrock-alluvium contact (Fig. S10). Other buildings located along the southern edge of the China Lake playa (35.711727°, -117.601528°) exhibited foundation settlement, displaced or broken water lines, and tilted utility poles.

In the Salt Wells Valley area, lateral spreads were common near channel margins and along edges of Salt Wells Valley creek in which sediments were moist to wet. Observations of liquefaction features within Salt Wells Valley did not appear to impact infrastructure at the base, and no incidents were reported to us during our reconnaissance. Some ground-failure features (lateral spreads and three circular pits) were observed in the Salt Wells Valley area following the M 6.5 event, but prior to the M 7.1 mainshock (Fig. 2 and Fig. S14). The lateral spreads were not on the surface rupture, but the three circular pits were immediately on top of the surface rupture (Fig. S14). We think, they may have formed by water flowing into open cracks, as with piping, and may not necessarily be indicative of soil liquefaction. These circular pits did not have ejecta rims. No ground-based investigation was possible until after the M 7.1 event, so we only have the photographic evidence from prior to the M 7.1 mainshock.

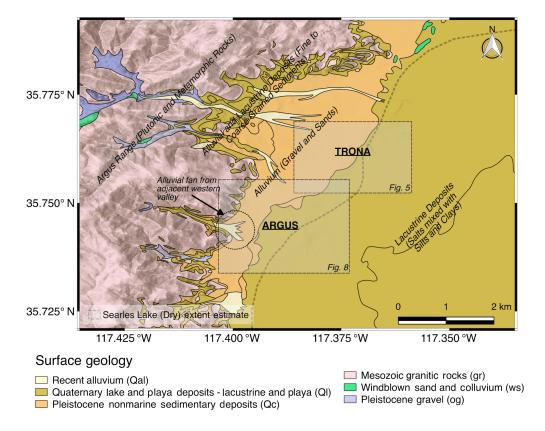
**Figure 3.** Map of the northwestern portion of Searles Valley showing the general geologic material underlying the towns of Trona and Argus. The estimated extent of the dry Searles Lake is also depicted. The color version of this figure is available only in the electronic edition.

As shown in Figure 3 (vicinity of Trona and Argus), Searles Valley has a similar stratigraphy to Indian Wells Valley with Pleistocene and Holocene alluvium, consisting of fine-to-coarse sand with little gravel and fines, Holocene playa silt and clay, and Holocene aeolian dune sand. However, the lacustrine deposits differ in that they contain thick evaporite deposits interbedded with lacustrine silts and clays. The evaporites consist primarily of halite, thermonatrite, thenardite, and ulexite with gypsum, locally common in some units (Smith, 2009).
