Coastal Engineering Journal

Impacts of Hurricane Dorian on the Bahamas: field observations of hazard intensity and performance of the built environment

SURVEY REPORT

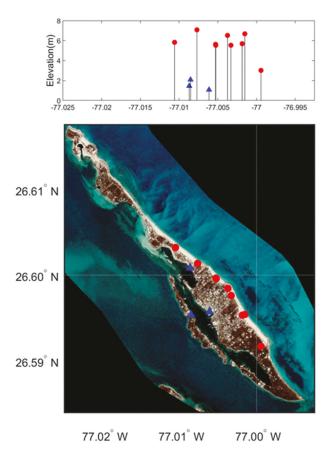
Figure 5. Measured high water marks on Man-o-War Cay, referenced to mean sea level. Red circles show observations on the exposed side, while blue triangles are on the sheltered side.

waves, and maximum water levels around 2 m, measured from the elevation of a grounded boat. This difference is entirely due to the lower wave runup and/or setup because the strong hydraulic connection

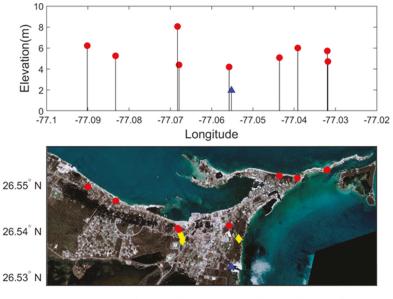
A similar difference was observed in Marsh Harbour on Great Abaco Island (Figure 6) between the exposed (northern) and sheltered (eastern) coastlines. Highwater marks on the exposed coast are up to approximately 8 m, with many in the 5-6 m range. These were again driven by wave runup and left both small debris lines and much larger debris fields on the coast. The eastern coast (sheltered) had far fewer measurements, but only around 2 m water levels were observed around a marina, and relatively small inland inundation limits were seen at other locations. The impacts of the wave runup in Marsh Harbour were in part mitigated by the local topography (Figure 7), as a pronounced 2D ridge runs along the northern coast (along Pelican Shores Dr.) approximately 18 m above mean sea level. However, this feature is not present in the heavily impacted regions of Marsh Harbour known as the Mudd and Pigeon Peas. These notably more low-lying areas of Marsh Harbour were home to large settlements of Class 1 residential structures. The elevated topographical features also do not extend up to Treasure Cay, which features a flatter and more homogeneous terrain.

Figure 6. Measured High Water Marks in Marsh Harbour, Great Abaco Island. Observations at red circles (exposed) and blue triangle (sheltered) are referenced to mean sea level, while yellow diamonds are relative to local ground elevations.

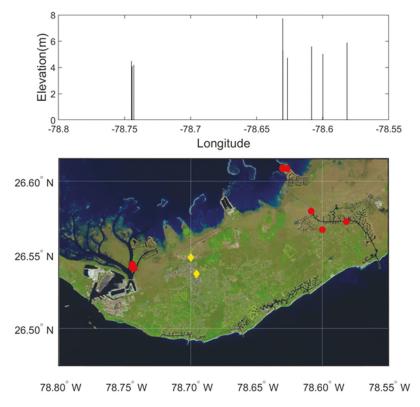
On western Grand Bahama Island near Freeport (Figure 8), the largest inundation evidence was documented on the northern (exposed) shore from small chunks of asphalt that were deposited at around 7.7 m elevation. These were likely generated from wave runup

Figure 8. Measured High Water Marks on Grand Bahama Island; observations at red circles are referenced to mean sea level, while observations at yellow diamonds are relative to local ground elevations.

onto the coastal road below and splashup to a higher elevation, as it does not appear that large waves reached this higher elevation. HWMs not influenced by large wave runup were lower, with numerous measurements to 4.5 m in Queen's Cove west of Freeport. Further east, on and near the Grand Lucayan Waterway, large quantities of floating debris suggested inland HWMs from 5.4-5.9 m. Although the waterway is normally at sea level, these elevations may have resulted from a combination of inland runoff and storm surge. No elevations were taken within the city of Freeport, but water levels 2.9 m above ground were noted at Grand Bahama International Airport, and 1.7 m water levels above ground at the Freeport Police Headquarters approximately 2.7 km from the closest coast.

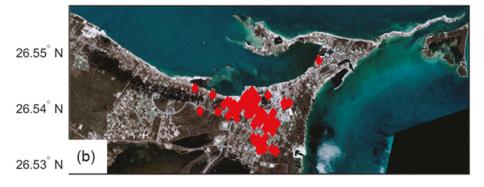
Storm-surge-transported shipping containers have very distinctive shapes in satellite imagery and tend to originate from coastal shipping yards for which predisaster satellite imagery is generally available to confirm debris sources. Figure 9b visualizes the locations of potential storm-transported shipping containers visible in the satellite images in Marsh Harbour postDorian. Although containers were seen everywhere in pre-storm images, the port area was likely the source of many containers, and the largest concentrations of post-storm containers were found just inland of this area with other debris.

Figure 9. (a) Areas of debris concentration observed from satellite images; (b) Locations of apparent shipping containers post-Dorian, without confirmation of source.

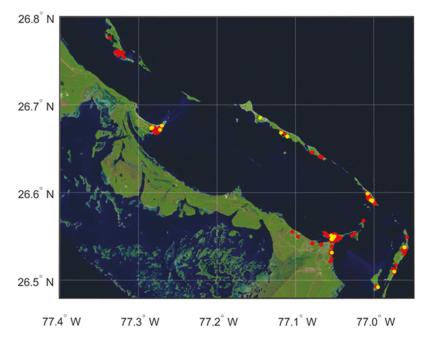
Sunken and stranded boats mapped in Figure 10 offered another indicator of storm intensity and could be either a navigational hazard or another costly cleanup. These were visible around almost all marinas and areas with small craft; from the little that could be determined, although a few small boats seemed to be transported long distances, possible original locations seemed near final resting places in almost all instances examined here. Because boats are anchored in what are normally sheltered locations, i.e. on the southwestern side of Man-o-War Cay, the waves and surge may have been lower than in some other locations but damage was still substantial.

Figure 10. Locations of observed sunken (yellow) and stranded (red) boats post-Dorian on the Abaco Islands.
