FIELD INVESTIGATION OF TWO RETROGRESSIVE BREACH FAILURES AT AMITY POINT

NICOLA BRILLI¹, NINA STARK¹, PETER NIELSEN², DAVID CALLAGHAN²,
MADELINE MANNING¹, JEFF CULP¹

Abstract: A 27-day field study was conducted to explore Retrogressive Breach Failures (RBF) at Amity Point, Queensland. Two events were documented over the course of the study, and videos and photographs were obtained of one event in progress. Beach profiles and recovering shoreline position were measured along with deployments of a simple penetrometer to obtain a proxy for surficial sand density. The sand appeared to be in a loose state prior to the second event, being controversial to theory of RBF. The recovering shoreline showed rapid accretion in the first 24-48 hours along with tidal erosion of the beach face. Wind speeds reached ~35 kilometers/hour out of the NNW on the day of each event, representing the only time these conditions were observed.

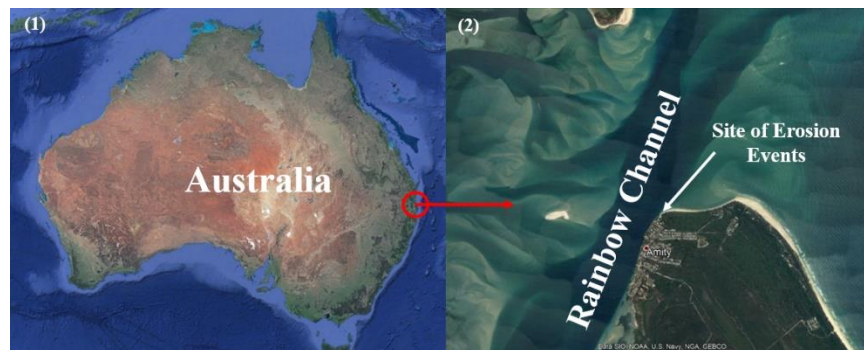
Amity Point on North Stradbroke Island in Queensland, Australia features a sandy beach adjacent to a tidal channel (Rainbow Channel) that has been characterized by frequent and large volume erosion events for over 100 years (Figure 1). Beinssen et al. (2014) monitored the morphology and discussed the potential mechanisms behind the failures. They concluded that the failures represented a form of beach erosion known as a Retrogressive Breach Failure (RBF). RBF

Figure 1: Site Location and Features (Source: Google Earth. 27°23'35.44"S and 153°26'24.32"E. (2): October 27, 2017, Accessed: May 28, 2018)
