Earthquake and Postearthquake Fire Testing of a Midrise Cold-Formed Steel-Framed Building. I: Building Response and Physical Damage

Tara C. Hutchinson, M.ASCE¹; Xiang Wang²; Gilbert Hegemier³; Praveen Kamath⁴; and Brian Meacham⁵

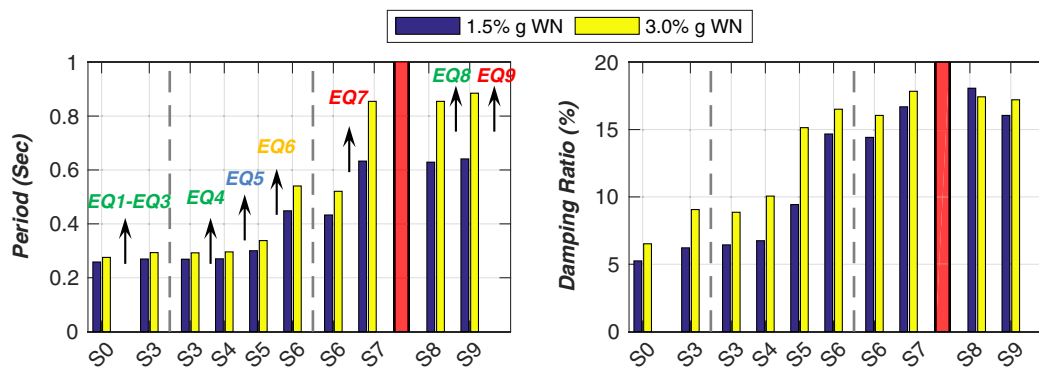
Fig. 5. Evolution of the natural periods and damping ratios associated with the building fundamental mode. Dashed line divides earthquake test dates, and red bar denotes the fire test phase.

period of ~ 0.25 s during the service-level test sequence (EQ1–EQ4) nearly doubled (>0.5 s) following the design test (EQ6) and increased by more than threefold (~ 0.9 s) following the MCE test (EQ7).

Correspondingly, the damping ratio associated with the fundamental mode increased from $<10\%$ during the service-level test sequence to $>15\%$ following the design event as a result of accumulated structural damage with the increased earthquake intensity. Notably, the modal parameters of the building underwent no substantial variations following the fire tests, which implies that earthquake-induced damage accumulated during the prefire test phase significantly outweighed the effect of fire-induced damage to the building. Furthermore, the natural periods and damping ratios appear to be dependent on the WN excitation amplitudes, particularly when the building damage became more pervasive following the design event EQ6 (S6 and the ensuing states). Increasing the amplitude from 1.5% g RMS to 3.0% g RMS led to a 10%–20% increase of the natural periods and a 20%–30% rise of the damping ratios.

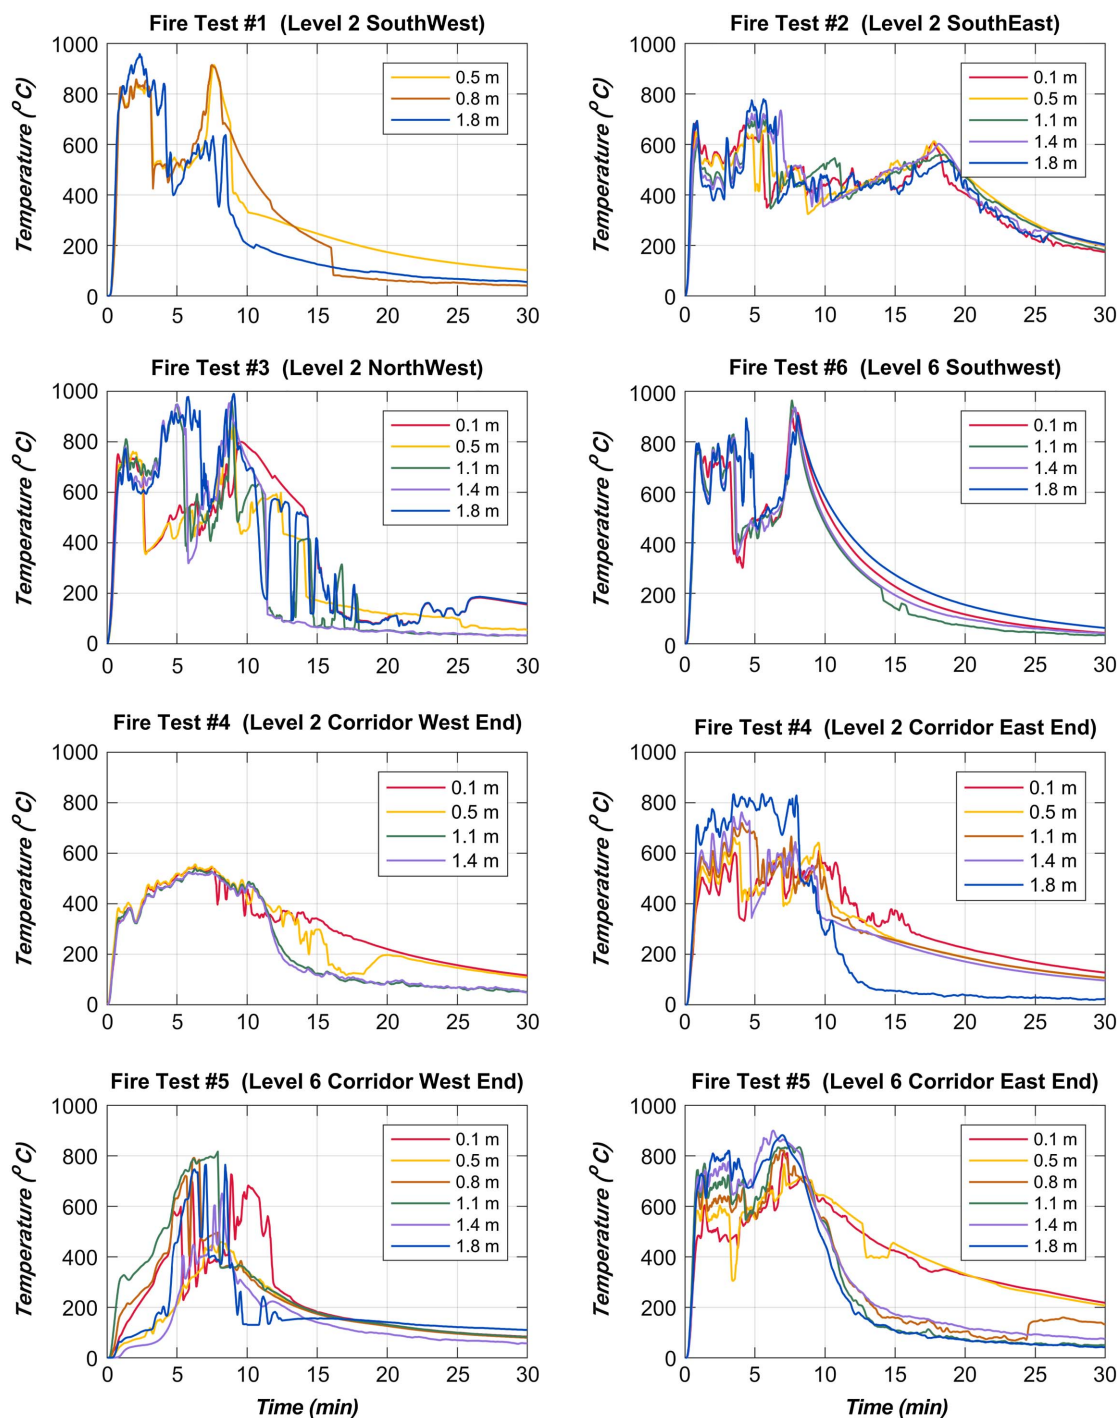
The temperature responses of all interior (room) compartments are characterized by a double-peak pattern, as shown in Figs. 10(a and b). The compartment temperatures increased rapidly and reached the first peaks of 700°C – 800°C in ~ 60 s from the onset of fire ignition, indicating the attainment of the flashover conditions

Fig. 10. Fire compartment temperature responses during the live fire tests. Value shown in the legend represents the distance of the thermocouple as measured from compartment ceiling.

in all fire test compartments. Dependent on the atmospheric effect on the compartment fire dynamics following the flashover, the temperatures attained the second peaks of 800°C–1,000°C in 300–450 s and subsequently descended to ~400°C, which was indicative of fuel burnout.

Comparison of the fire test results reveals that the temperature behavior of the southeast compartment at Level 2 (Fire test 2) differed from the remaining three compartments, as evident by slightly lower peak temperatures (~800°C) but longer duration prior to the temperature drop (>18 min). This is primarily attributed to the differences in the compartment ventilation conditions because the

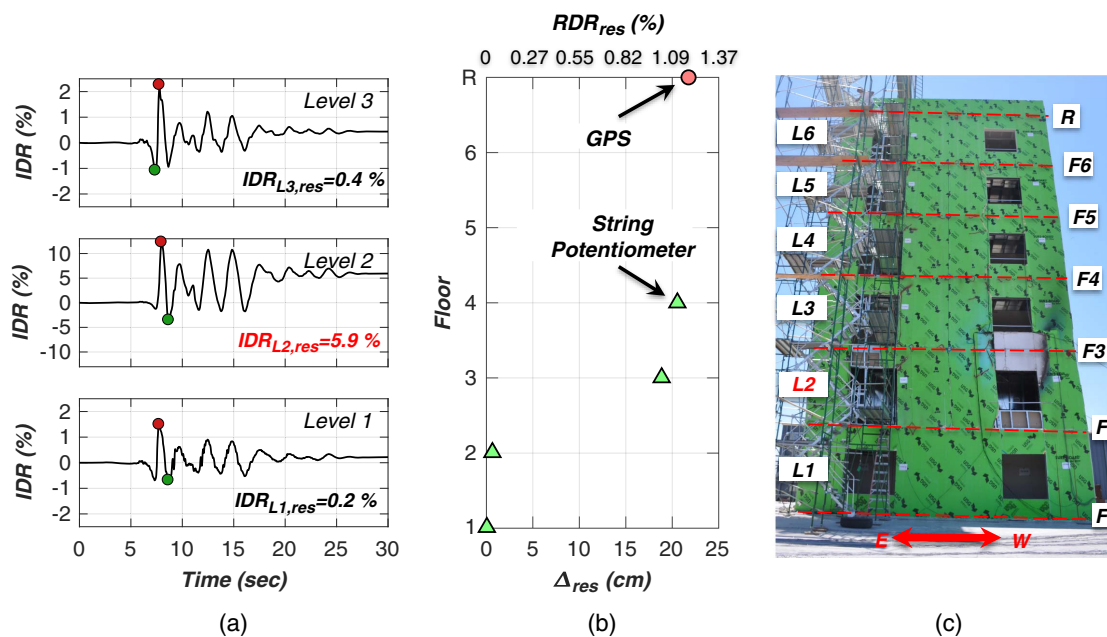
Fig. 12. Building responses associated with the final extreme event test (EQ9): (a) interstory drift ratio responses of the lower three levels; (b) building residual drift profile at the end of the test program (1 cm = 0.3937 in.); and (c) north elevation of the building at the end of the test program. Arrow denotes the direction of shaking, L# denotes level number, and F# denotes floor number. (Images by Xiang Wang.)

In contrast, the final earthquake test (near-fault extreme event EQ9) subjected the building to excessively large drift demands particularly at Level 2, which sustained a peak interstory drift ratio of above 12%. The extreme drift demands achieved during this test resulted in a near-collapse condition of the specimen, with its lateral resistance almost solely provided by the tie-rod and compression stud system, as discussed subsequently. The residual roof drift ratio of the building exceeded 1% following Test EQ9 (Table 2). This may be partially attributed to the fire-induced damage to the gypsum sheathing at Level 2, which reduced the shear capacity of the shear walls and consequently led to the formation of a soft-story mechanism during the final near-fault earthquake (EQ9) at this level.
