## Case Study Evaluation of Farm and Commercial Grain Bins during the August 2020 Iowa Derecho Windstorm

Christine E. Wittich, Ph.D.<sup>1</sup>; and Benjamin Praeuner<sup>2</sup>

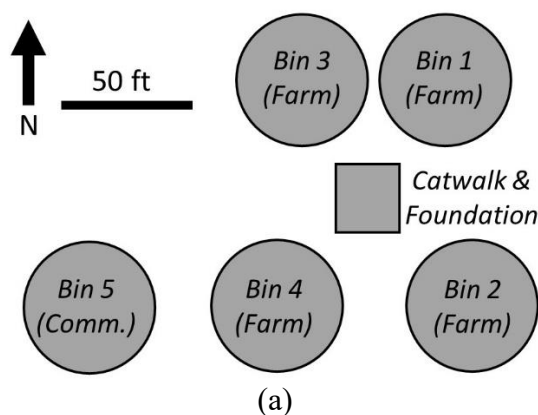
The grain bins at this site were located in a group, as shown in Figure 3a, and interconnected by a catwalk structure and filling/distribution system that was constructed of lightweight steel

truss. Bins 1 – 4 on the east side of the group were identical ‘*farm bins*’ purchased and installed at the same time (within the past 5 years). Bin 5, located on the southwest of the group, was more a more recently installed ‘*commercial bin*’. Regardless of whether the bin was ‘*commercial*’ or ‘*farm*’, each had a diameter of 48 ft, a sidewall height of 42 ft, a conical roof, and a concrete foundation. All bins were empty at the time of the storm in preparation for harvest.

**Figure 3. (a) Layout of the grain bins including identification of farm vs commercial styles and diameters. (b) Photograph of Bin 5 (commercial bin). Photograph by C.E. Wittich.**
