Microstructural Defects Governing Torsional Fatigue Failure of Additively Manufactured As-Built and Heat-Treated Inconel 718

Sanna F. Siddiqui^{1*} and Elise Araiza¹

¹Mechanical Engineering Department, Florida Polytechnic University,
4700 Research Way, Lakeland, Florida, US, 33805

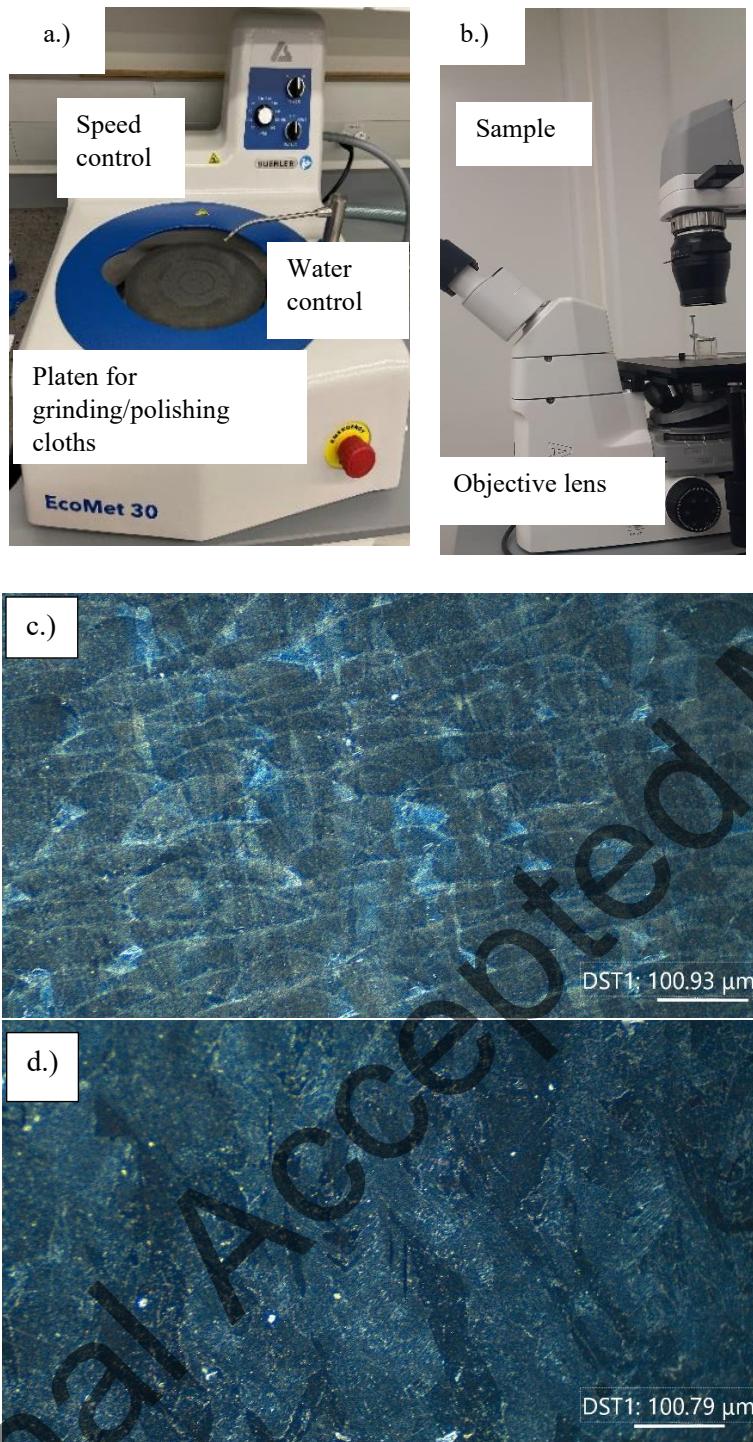
To correlate torsional fatigue findings reported in [3, 7] with defects at the microstructural level driving torsional fatigue failure, a variety of material characterization techniques were implored, as discussed in the experimental design section, from which the following results were found and discussed here. Torsional fatigue findings in terms of shear modulus reported in [3, 7] has been presented in Table 2, from which it is evident that heat-treatment overall was found to enhance shear moduli, G , with the largest shear moduli reported for the vertical and horizontal build orientations, with the lowest shear modulus reported for the diagonal build orientation [3,7]. Heat treatment was also previously reported to enhance shear stress range achieved by DMLS Inconel 718 of each build orientation [7]. Nevertheless, an analysis of grain microstructure of heat-treated sample in Figure 2d, reveals the characteristic elongated dendritic microstructure, similarly observed for as-built DMLS Inconel 718 samples [3]. This supports findings reported in [1, 25], in which heat-treatment to temperatures of 1000°C did not exhibit change in dendritic microstructure exhibited by additively manufactured Inconel 718. Melt arc pools are evident in

Figure 2c of a cross-section of the as-built AM IN718 horizontal build sample, as reported in literature.

Figure 2: Equipment used for metallographic specimen preparation and analysis of grain microstructure: a.) Buehler EcoMet30 manual grinder-polisher; b.) AxioV1 optical microscope; c.) as-built Inconel 718; and d.) heat treated Inconel 718.
