## Geotechnical reconnaissance findings of the October 30 2020, Mw7.0 Samos Island (Aegean Sea) earthquake

### Abstract

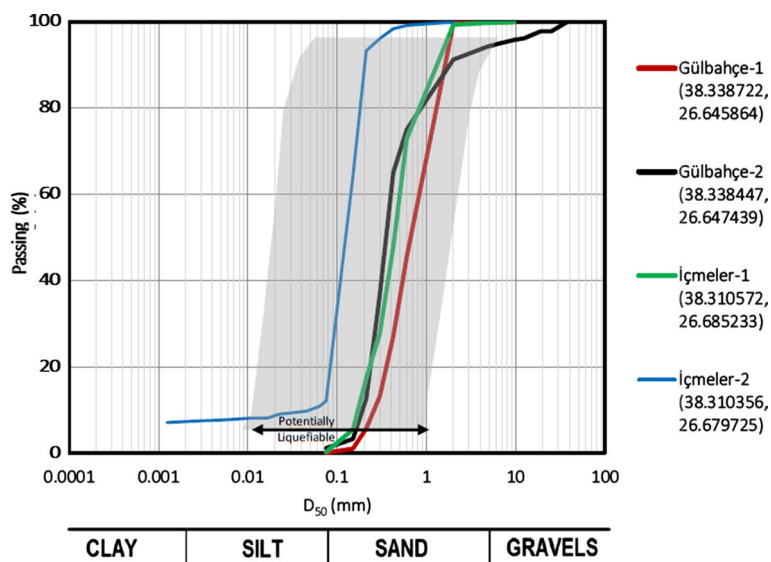
Consistent with the USGS susceptibility predictions, 45–50 km away from the rupture, along the shores of the Icmeler and Gulbahce districts, sand boils were observed, as shown in Fig. 7a through d. These sites were close to the Gulbahce fault zone, and documented artesian pressures along with hot water springs which are known to be present at these sites, which are also believed to have contributed to the observed soil ejecta formation. Figure 8 illustrates the results of grain size distribution analyses performed on soil samples retrieved from the sand ejecta. As can be seen, all samples were uniform and within the bounds typically delineated as liquefiable uniform soils.

**Fig. 8** Grain size distribution curves of sand ejecta obtained from Gülbahçe, along with the bounds of typically liquefiable non-uniform soils

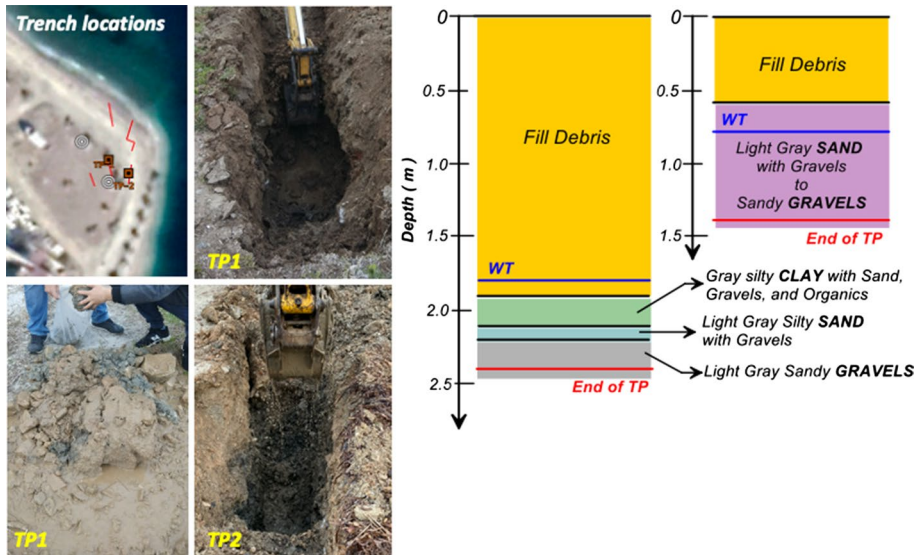
**Fig. 11** Trenching at the Malagari liquefaction site and rough stratigraphy resulting from it

their broader extent were still easily visible and distinguishable. In the same area, ground cracks compatible with a lateral spreading mode of failure were observed and are emphasized in the inset of Fig. 10. The combination of the aforementioned with a free face to water, like in Malagari, eases the process, but lateral spreading has been manifested also in case histories with no free face (e.g. Balboa Boulevard failure during the 1994 Northridge earthquake—e.g. Stewart et al. 1996, Pretell et al. 2020). Trenching and soil sampling at two locations at the Malagari site were performed, which yielded two rough cross-sections and three grain size distributions for samples at three distinct depth intervals at the site illustrated in Figs. 11 and 12 respectively. The fines portion in all three samples was found to be non-plastic.

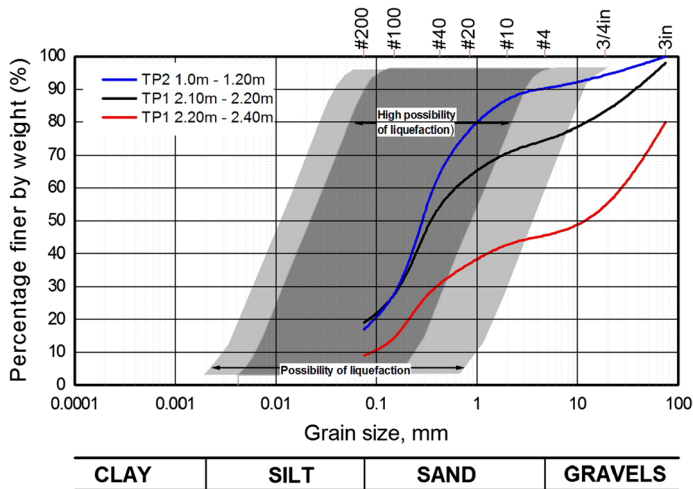
**Fig. 12** Grain size distributions of three samples retrieved from different depths at the two trenching locations at the Malagari liquefaction site, along with the bounds of typically liquefiable non-uniform soils. The fines were found to be non-plastic (NP). (Geographic coordinates are provided in Fig. 10)

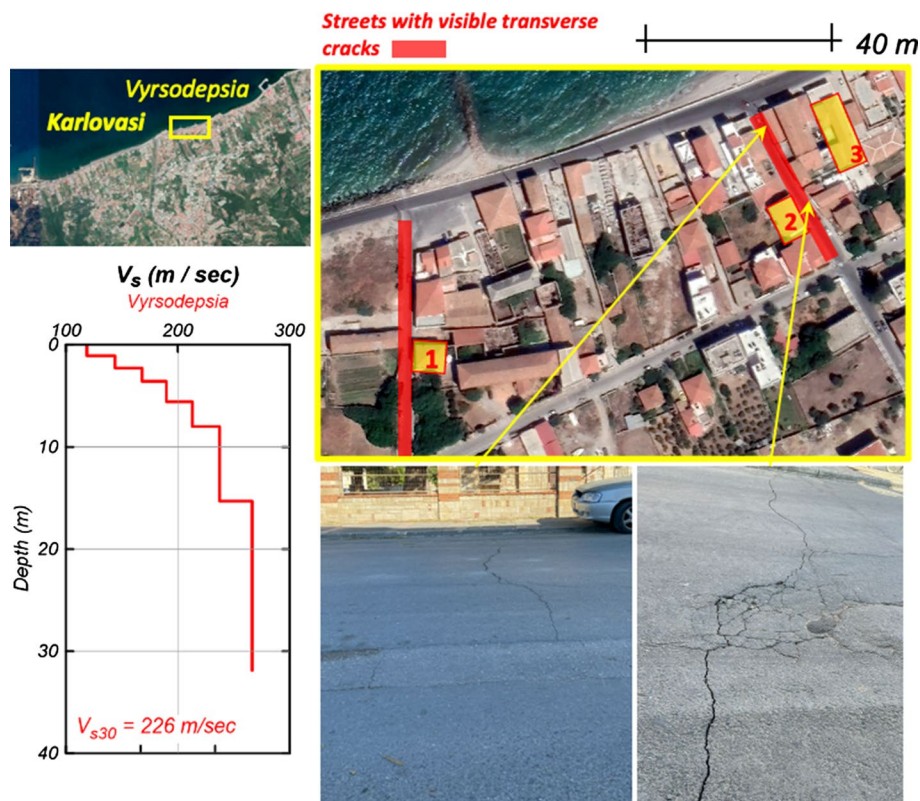
Lateral spreading effects were also evident through structural damage at other nearshore locations in the northern part of the island. Specifically, Figs. 14 and 15 illustrate three buildings and their location close to the north shore of the island, in the neighborhood Vrysodepsia in Karlovasi. No surface manifestation of liquefaction was identified nearby, but the ground cracking crossing the street pavement and running through the buildings (the two in Fig. 16 are about 70 m inland and the one in Fig. 17 is about 20 m inland), in combination with the level/mildly sloping ground, the shallow water table, and the free face to the sea are all compatible with the hypothesis of lateral spreading.

**Fig. 14** Plan view of Karlovasi and the Vyrsodepsia neighborhood with buildings likely affected by lateral spreading towards the seafront alongside with shear wave velocity profile of the area down to a depth of 30 m (aerial close up at 1382 ft, 37°47'57.94" N, 26°42'23.27" E). The enumerated buildings are individually shown in Figs. 16 and 17

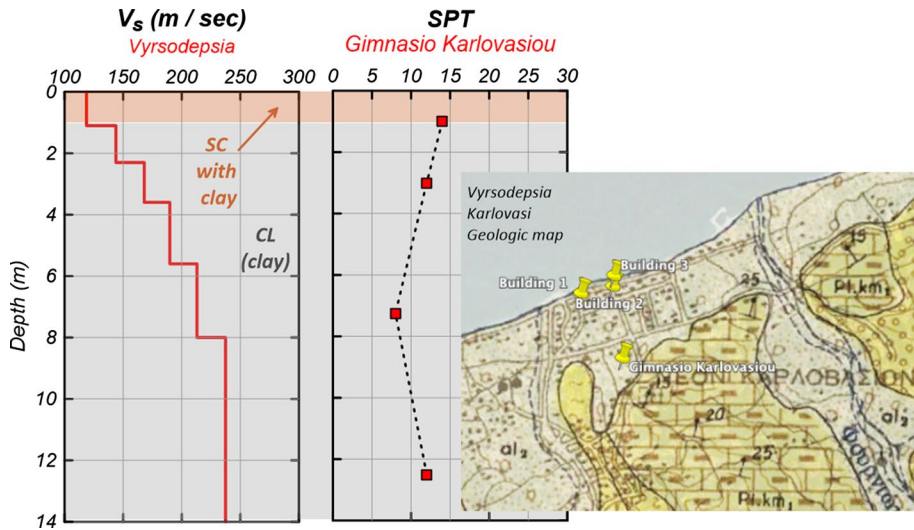
**Fig. 15** Shear wave velocity profile down to a depth of 14 m alongside with SPT blow count information from the nearest borehole at the High School of Karlovasi (Gymnasium). Locations are shown in inserted geologic map

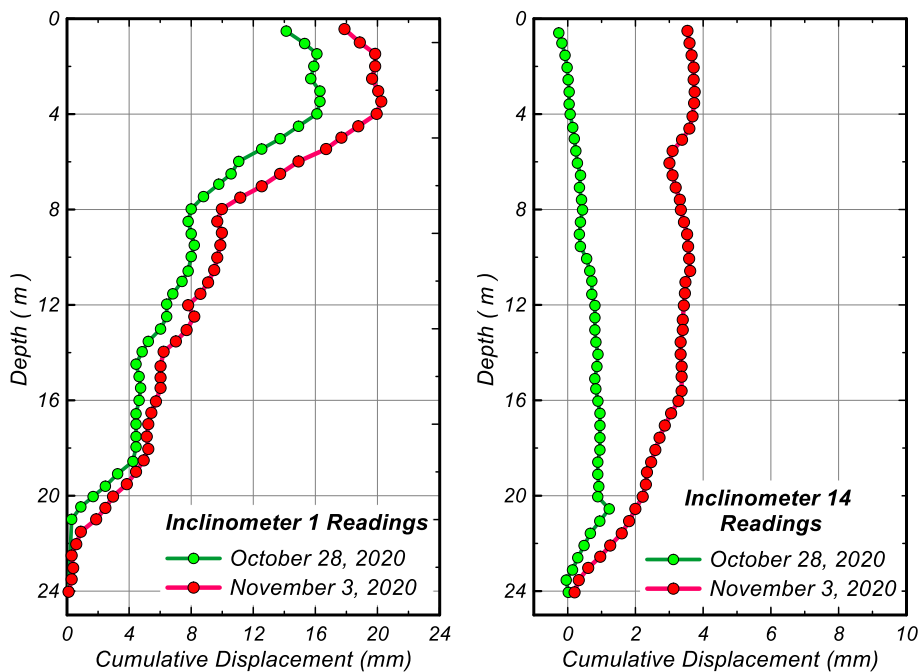
the installed monitoring system (Fig. 26). No failure or relaxation of pre-stressing loads on anchors was measured/observed. These observations are also supported by inclinometer measurements taken before and after the earthquake. The measurements suggest that the lateral displacements (illustrated in Fig. 26) accumulated during the earthquake were less than 2 mm. No relevant data are available from Samos (or any of the nearby islands) in Greece, since there are no similarly deep excavations constructed.

**Fig. 26** Inclinometer data covering the period of earthquake shaking, at a 9 m-deep excavation in Izmir, Turkey, supported by diaphragm walls

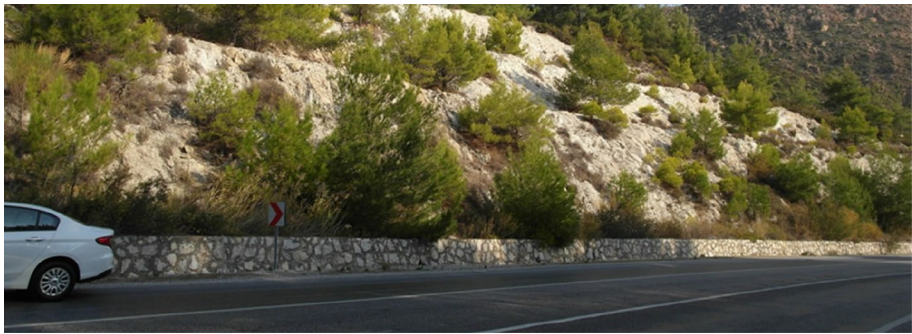
**Fig. 28** Short, stoned retaining walls on the toe of the highway cuts between Menderes and Gumuldur in the south of İzmir city center

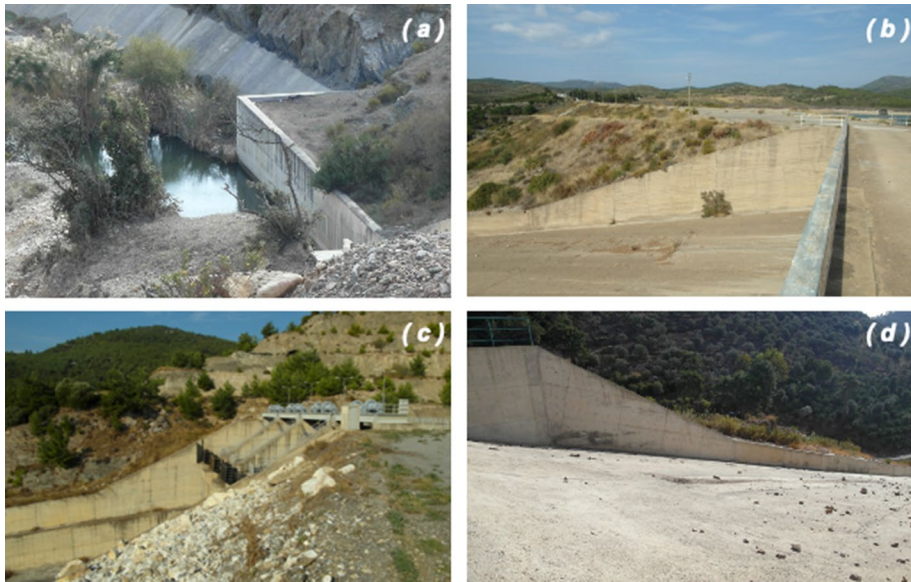
**Fig. 29** a Wall on the end of spillway chute of Kavakdere Dam, and side walls of spillways of b Urkmez Dam, c Tahtalı Dam, and d Gumuldur Dam

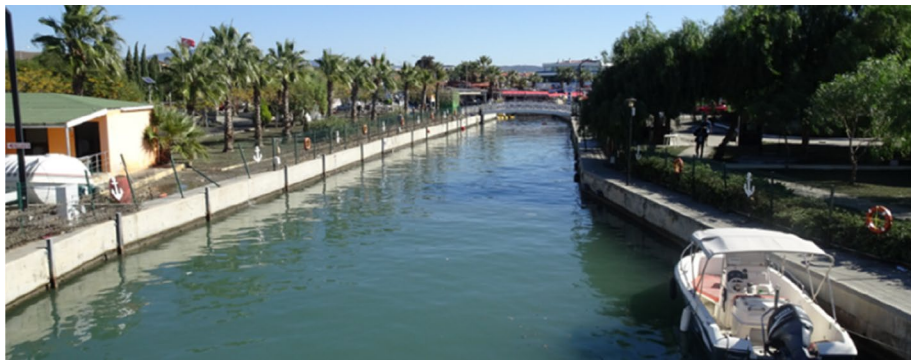
**Fig. 30** Sidewalls of the river canal in the Sığacık Marina where no displacements were observed (Photo: Courtesy of Gurel Özdemir). (38°11'33.86"N 26°47'4.07"E 14:16 / 31.10.2020)

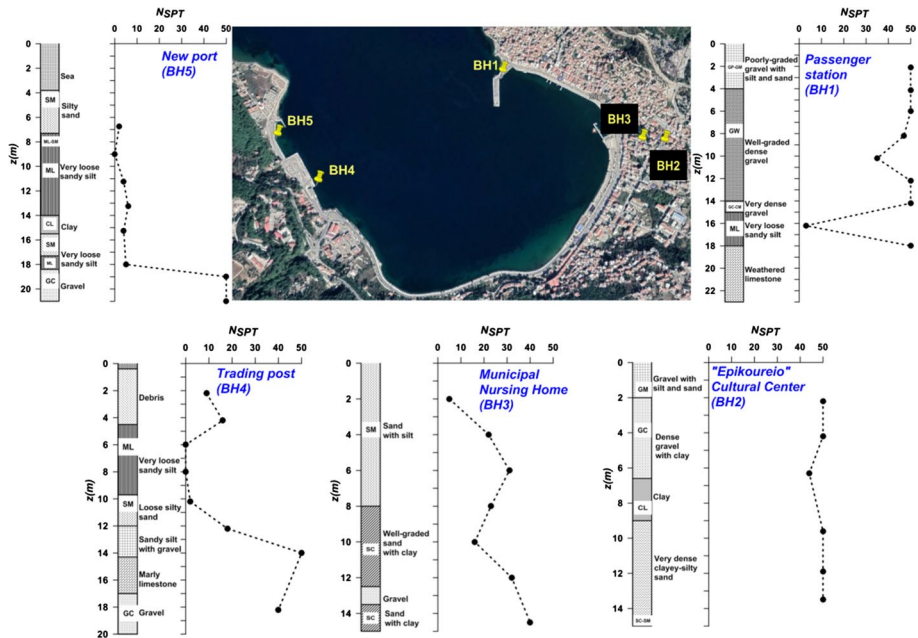
pattern that can be observed as one moves alongshore, from east (BH 1) to west (BH 4 and BH 5): if continuous, the layer of sandy silt or silty sand (ML-SM) emerges at shallower depths and also gets thicker (Fig. 33). However, given the distance between Vathy and Malagari as well as the relative depth and thickness of the ML-SM layer in each location, it is also possible that this is not the same layer across the sites. The associated SPT blow counts are extremely low (essentially zero), which indicates very low strength and high compliance. As the associated materials are non-plastic and saturated, this provides evidence of susceptibility to liquefaction.

**Fig. 33** Four geotechnical borehole logs (BH1, BH2, BH3, BH4) alongshore from the eastern (old) port to the western (new) port at Vathy (courtesy of G. Milionis—modified by Em. Rovithis). One offshore borehole (BH5) at the NW edge of the new port (kindly provided by the Ministry for the Environment, Physical Planning and Public Works of Greece – modified by Em. Rovithis)

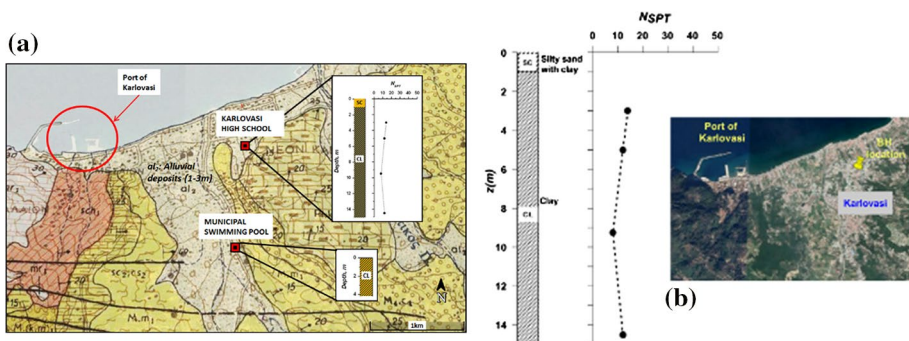
**Fig. 37** **a** Part of the detailed geological map of Samos Island, published by the Hellenic Survey of Geology and Mineral Exploration (HSGME 2020) with the location of two (2) geotechnical boreholes on the same geological formation (a12). **b** Borehole log next to the High School of Karlovassi (Gymnasium), at a distance of about 2 km from the east quay wall of the port and 550 m from the seafront
