# Understanding the Performance of Historic Masonry Structures in Mayfield, KY after the 2021 Tornadoes

Saanchi S. Kaushal<sup>a</sup>, Mariantonieta Gutierrez Soto<sup>b</sup>, Rebecca Napolitano<sup>a,\*</sup>

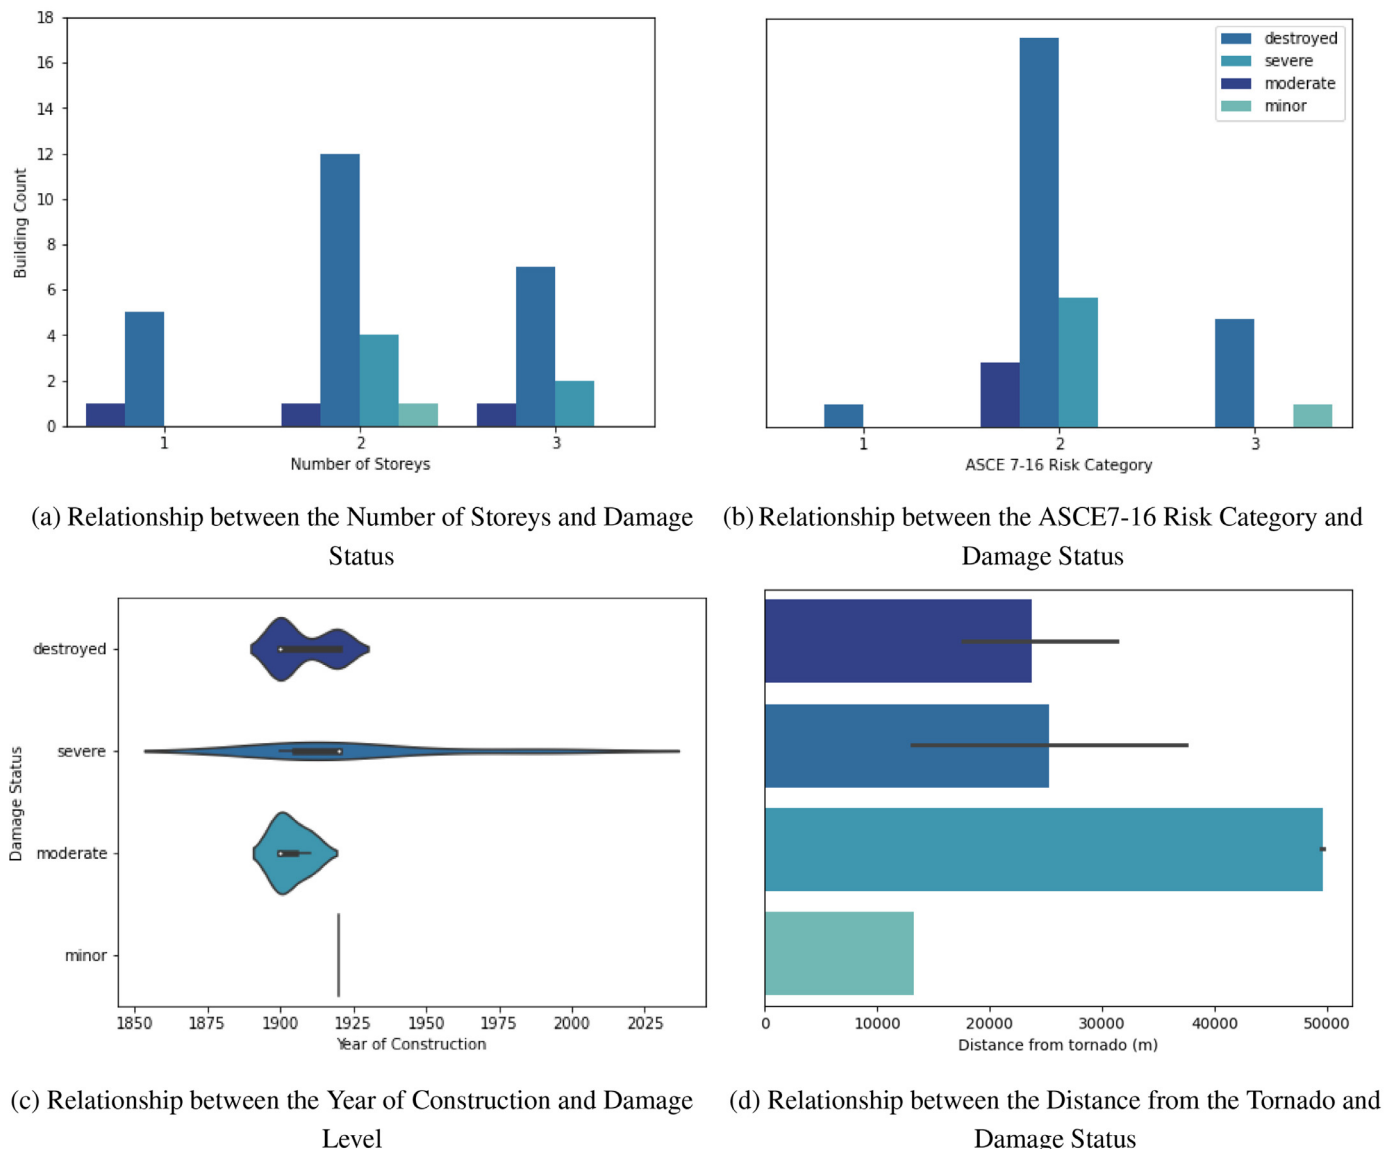
Fig. 5. Factors influencing damage levels for the historic buildings.

As illustrated in Fig. 5(a), while buildings with varying story numbers (1-3) suffered damage from the tornado, the documented single-story historic structures were either destroyed or severely damaged. Even though it is well known that the wind velocity increases with the height of the structure, the damage is also dependent on other factors, such as the structure's location with respect to the tornado's vortex [58]. Two-story historic structures exhibited the maximum variation in damage levels, which could be attributed to their higher density as compared to other building typologies. The damage levels of three-story buildings varied depending on the number of structures for which data was collected, but in general, they experienced moderate to severe damage. It is

worth noting that the number of stories did not directly correlate with damage levels. A regression model with building status confirmed this as a dependent variable and the number of stories as an independent variable, which yielded a correlation coefficient of only 0.01. Thus, the findings support the hypothesis that the number of stories alone did not play a significant role in determining the damage status of historic structures.

The correlation between the ASCE Risk Category and damage levels in Fig. 5(b) shows a similar trend, where Risk II level buildings saw the most variation in damage status while the one Risk I building was destroyed, and a majority of the Risk III level buildings were also destroyed. The most recent updates to the American Society of Civil Engineering design standard (7-22) do not apply to Risk Categories I and II [5]. However, as seen in the dataset, Risk Category II comprises almost 80% of the historic structures, which under current standards, would not be updated for wind loading. As denoted in Fig. 5(b), historic structures that fall in Risk Category II buildings are particularly vulnerable and were mostly destroyed. This correlation calculated for this is 0.07, indicating a weak linear

The violin plot in Fig. 5(c) illustrates that most of the historic buildings were constructed prior to 1925, before the implementation of any wind codes. The damages for these buildings ranged from moderate damage to destruction. The high variance observed for the destroyed and moderately damaged structures indicates heterogeneity of the data. However, it is essential to note that the shape can be affected by several factors, including the sample size and the data distribution. Since the data set utilized for this study was somewhat limited, the main takeaway from this correlation is that the older buildings showcased higher levels of damage.

while calculating the tornado path [11]. For example, Fig. 5(d) explores the relationship between the damage levels and the distance, where the structures located within 20000 m of the tornado were majorly destroyed, and the damage for the ones located between 20000 m to 50000 m varied between severely to moderately destroyed. This reinforces that the proximity of the tornado is proportional to the damage observed, with the closer structures undergoing higher levels of damage.

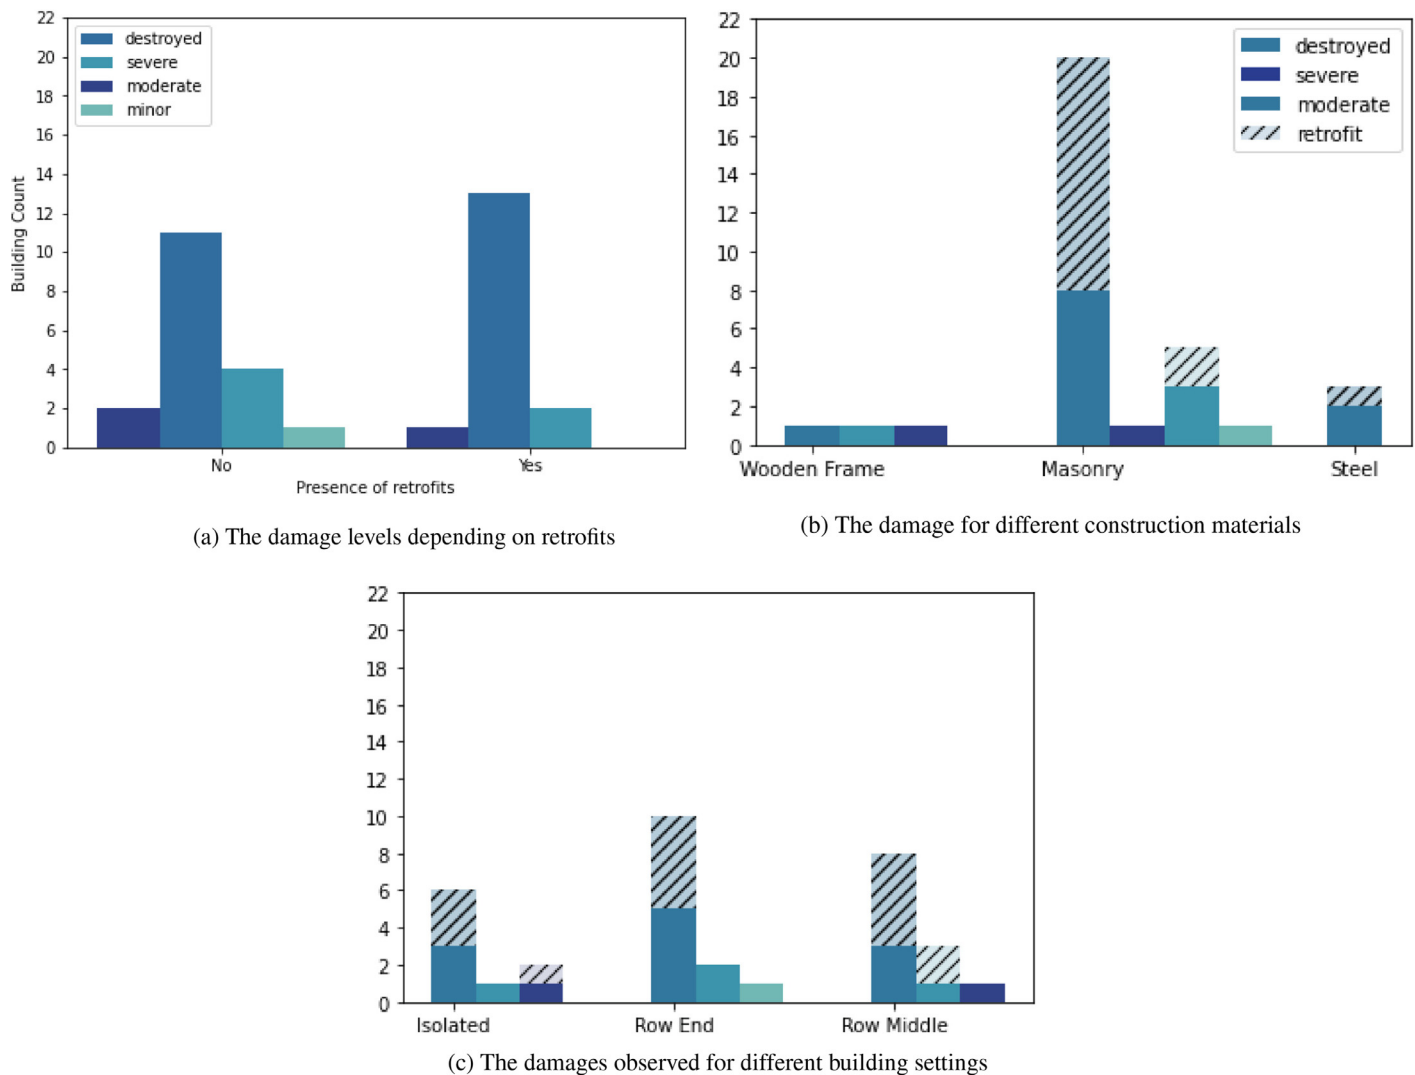
Fig. 6. The variation in damage levels based on structural attributes of the buildings.

As depicted in Fig. 6(a), the historic buildings showcased varying levels of damage irrespective of the retrofit's presence. It is interesting to note that even though a higher percentage of the historic buildings were retrofitted, a majority of them were classified as destroyed. Clearly, other factors, such as the proximity to the tornado, impacted the extent of the damage. An example in Mayfield highlighting this discrepancy was the two-story retrofitted

To highlight any underlying relationships between the construction type and the location of the buildings, categorical bar charts were generated. According to Fig. 6(b), the historic buildings were constructed out of wood, steel, or masonry. The wooden structures, known to be susceptible to wind damage, ranged from moderately damaged to destroyed over a normal distribution. Similarly, the steel frame buildings, while frequent, also have normal distribution across the damage status. Considering the sharp drop-off of the unimodal distribution, it can be concluded that the masonry structures were consistently destroyed. Thus, based on the unimodal distribution, it can be concluded that masonry buildings were the most vulnerable during the Midwest Tornado in Mayfield.

As concluded from the previous paragraphs, there was not one specific feature that influenced the extent of the damage but an amalgamation of all of them. Based on Fig. 6(b) and Fig. 6(c), there were a higher number of retrofit masonry structures as compared to wooden or steel, and they still underwent varying damage levels. The US Post Office, a retrofitted historic structure located a few

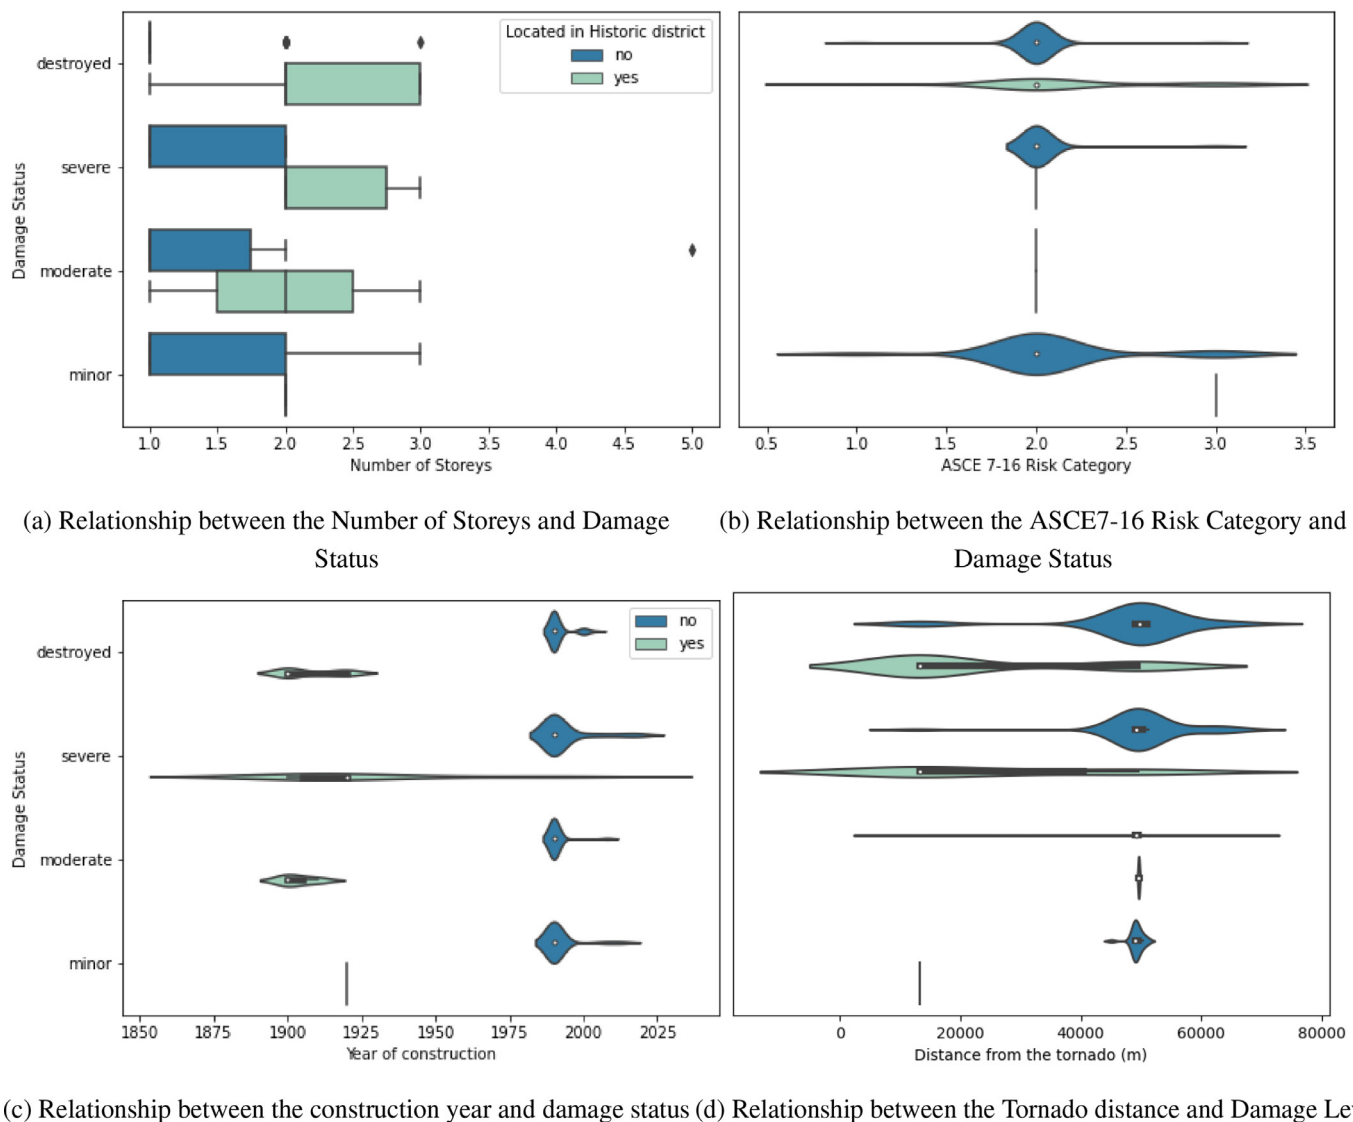
Fig. 8. Comparison between damage levels of historic and non-historic structures.

Fig. 8 (a) shows that, in the immediate vicinity of the tornado, in comparison to the historic structures, the non-historic structures were limited to two-stories or lesser. Notably, severe damage was the most significant damage observed in non-historic buildings, while many historic buildings of similar typologies were destroyed. On examining the relationship between the risk category and the damage levels (Fig. 8(b)), historic and non-historic buildings were primarily associated with risk category II. This empha-

As depicted in Fig. 8(c), newer buildings were constructed in the late 1900s, and both historic and non-historic buildings experienced damage ranging from minor to destruction, regardless of their year of construction. It is pertinent to mention that a higher number of historic structures were destroyed, while the non-historic ones showcased minor damage more frequently. Additionally, it must be noted that the non-historic buildings were also located further from the tornado, as seen in Fig. 8(d), which may be a reason for the lower damage levels.
