# Lateral spreading and flooding along the İskenderun coast in the 2023 Kahramanmaraş earthquake sequence

## ABSTRACT

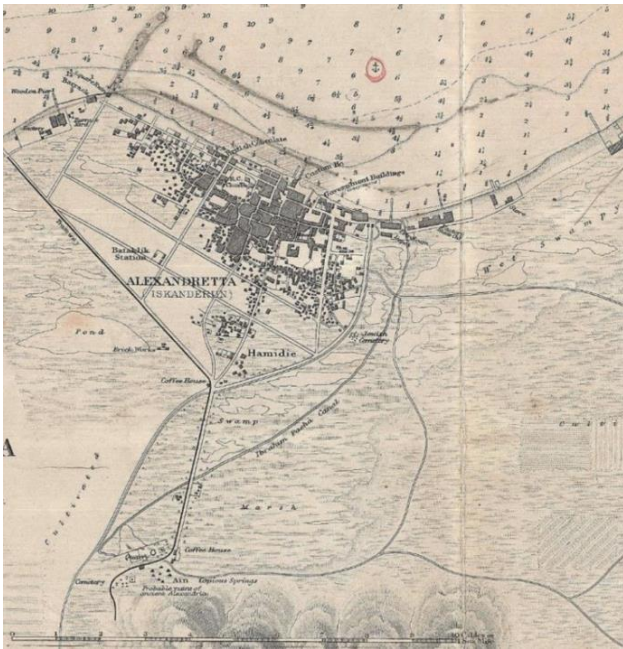
Fig. 1. 1916 map of İskenderun depicting early shoreline, swamps and marshes, and built areas [obtained from the National Library of Turkey by Nalça (2018)].

The İskenderun shoreline was built out during the city's development. The 1916 shoreline depicted in Fig. 1 approximately aligns with present-day Atatürk Boulevard. It represents the approximate border between reclaimed and naturally formed land. The shoreline was further built out prior to 1969 as indicated by a declassified KH-4 Corona satellite image presented in Taftsoglou et al. (2023). The approximate 1916 and 1969 historic shoreline extents and location of the İbrahim Paşa channel are traced on the post-earthquake observations map in Fig. 2. These provide a basis to delineate potential subsurface constraints on the extent of liquefaction and lateral spreading ground deformations.

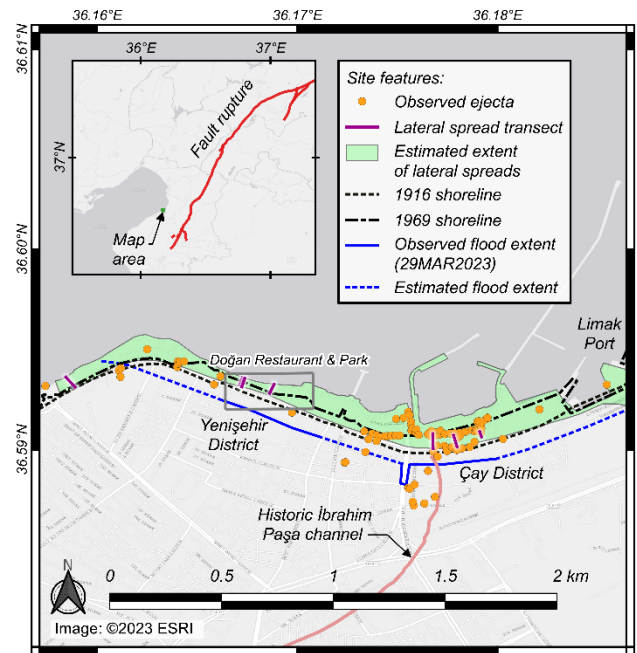
Fig. 2. Map of early shoreline extents and post-earthquake observations in İskenderun (background image: ESRI 2011).

Field observations of extensional ground cracks indicative of lateral spreading extended from the western shoreline of İskenderun to the Limak Port, as mapped in Fig. 2. Several lateral spreading transects are indicated in Fig. 2 where detailed measurements of accumulated displacements were obtained by Moug et al. (2023). Observations at the Doğan restaurant and Emekliler park area are detailed and discussed herein.
