# 1 Full-Scale Shake Table Test Damage Data Collection Using Terrestrial Laser 2 Scanning Techniques

3 Mohammad Aghababaei<sup>1</sup>, Christian Okamoto<sup>2</sup>, Maria Koliou<sup>3\*</sup>, Takuya Nagae<sup>4</sup>, Chris P.  
4 Pantelides<sup>5</sup>, Keri L. Ryan<sup>6</sup>, Andre R. Barbosa<sup>7</sup>, Shiling Pei<sup>8</sup>, John W. van de Lindt<sup>9</sup>, Shideh  
5 Dashti<sup>10</sup>

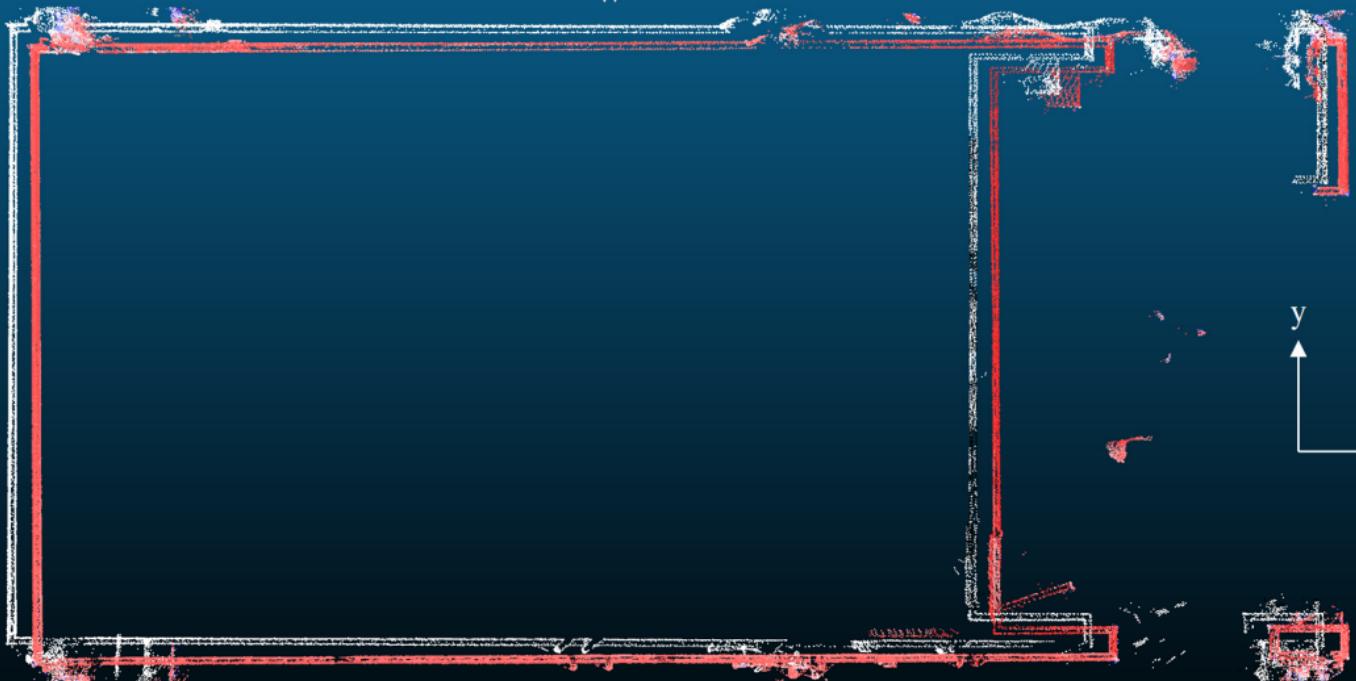
421 before and after the JMA 100% shake table test. The measurements in all four corners were  
422 obtained by computing the distance between the corners of the two point clouds, which indicates  
423 the movement of each corner after shaking compared to before shaking. In Figure 20, displacement  
424 values from traditional laser meters are reported in green and those from LiDAR point clouds are  
425 reported in yellow. As shown in Figure 20, permanent displacements derived from traditional and  
426 LiDAR scanners are very consistent except for the x direction of the southwest corner.  
427 Examination of the time history of the x-direction movement of this corner (Figure 19c) suggests  
428 a malfunction in the performance of the laser meter, which caused it to report the exact same  
429 number (507.588 mm) after a jump in its measurement at 17.69 seconds while other laser meters  
430 still reflected small oscillations in their time histories. This malfunction could be attributed to an

652 Figure 20: Screenshot of point clouds of Building B before (red point clouds) and after (white  
653 point clouds) JMA 100% shaking on test day 2 and measurements (in mm) using LiDAR scans  
654 (shown in green) and traditional instruments (shown in yellow).
