THE 2019 TOKYO METROPOLITAN RESILIENCE PROJECT E-DEFENSE TEST OF A 3-STORY DISASTER MANAGEMENT CENTER

To address this need, an E-Defense test of a 3-story reinforced concrete disaster management center fitted with non-structural components and structural health monitoring instruments was performed under the Tokyo Metropolitan Resilience Project (subproject C). The specimen had hanging/standing/wing walls casted to be monolithic with frame elements. Gaps were present at the end of walls attached to the beams on the 2nd and 3rd floors, while gaps at the end of walls on the roof and at the 1F column bases were filled with concrete. These details allowed plastic hinges to form at intended locations and avoided bar buckling failure, while filling the gap with concrete allowed the wall to act only in compression. Non-structural elements attached to the building were ceilings, windows, exterior tiles and piping on the roof. Instrumentations and equipment installed in the building or used to evaluate damage included accelerometers, potentiometers, laser transducers, cameras, laser scanners, strain gauges and optical fibers; among others. In addition to the testing, a blind prediction comp

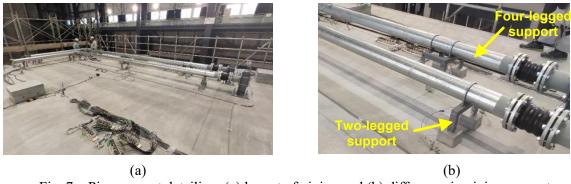
Fig. 7 – Pipe support detailing; (a) layout of piping and (b) difference in piping support

Two pipe systems in L-shape configurations were attached to the roof as shown in Fig. 7a. The pipes were weighed down using concrete supports instead of being bolted down as is common practice in Japan to avoid damaging roof weather proofing material. These supports had two or four-legs as shown in Fig. 7b, the latter of which was expected to be more stable and hence have lesser displacement.
