A Comprehensive Study on Detection of Hidden Delamination Damage in a Composite Plate Using Curvatures of Operating Deflection Shapes

Da-Ming Chen¹ · Y. F. Xu² · W. D. Zhu¹

Abstract

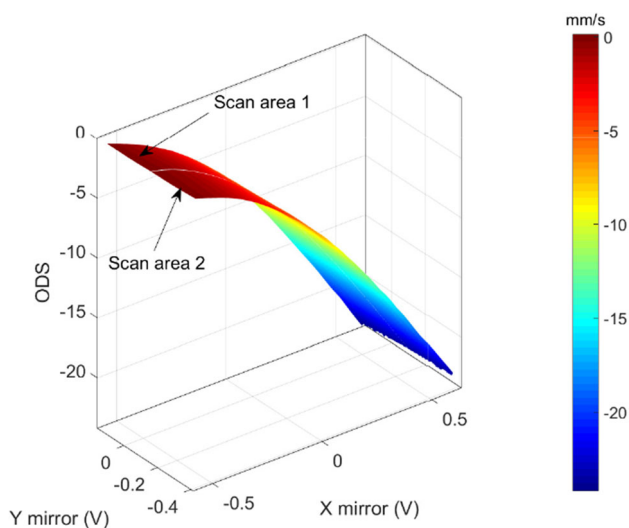
Fig. 11 Full ODS of the damaged composite plate at the excitation frequency of 82.03 Hz

The full ODS of the damaged composite plate at the excitation frequency of 82.03 Hz is shown in Fig. 11, which is formed by two partial ODSs corresponding to scan areas 1 and 2. One can see that the full ODS of the plate corresponding to its second mode is also a pure bending mode along

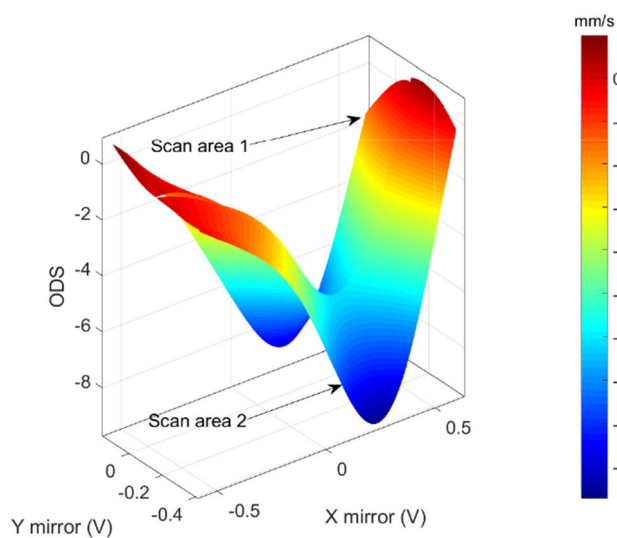
Fig. 24 Full ODS of the damaged composite plate at the excitation frequency of 1040.23 Hz

The full ODS of the damaged composite plate at the excitation frequency of 1040.23 Hz is shown in Fig. 24, which is formed by two partial ODSs corresponding to scan areas 1 and 2. One can see that the full ODS of the plate corresponding to its sixth mode is also a coupled bending-bending mode along both long and short edge directions of the plate. Corresponding partial CODSs of scan areas 1 and 2 are shown
