# Observing progressive damage in carbon fiber epoxy laminate composites via 3D in-situ X-ray tomography

Alejandra M. Ortiz-Morales<sup>1</sup>, Imad Hanhan<sup>1</sup>, Jose Javier Solano<sup>2</sup>, Michael D. Sangid \*

School of Aeronautics and Astronautics, Purdue University, West Lafayette, IN, 47907, USA

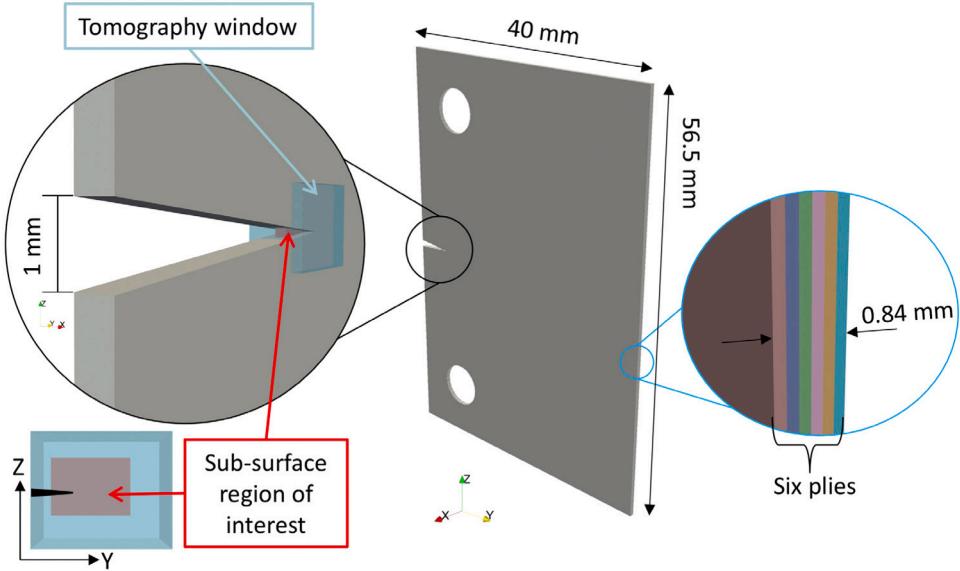
Fig. 1. The geometry of the compact tension specimens, where the left insert shows both the location of the tomography window at the sharp notch tip, as well as the sub-surface region of interest directly ahead of the sharp notch tip, and the right insert shows the thickness of the specimen which contained six plies.

the specimens could not follow the compact tension ASTM geometric standards [31]. The specimen geometry can be seen in Fig. 1, where each specimen had a thickness of 0.84 mm, a width of 40 mm, and a height of 56.5 mm.

Each tomography scan consisted of 1500 X-ray projections which were reconstructed using TomoPy [32]. The missing projections, which were caused by the load frame's columns, did not inhibit the quality of the reconstruction due to TomoPy's ability to handle missing projections [33]. The result was an image volume with dimensions 2048 by 2048 by 2046 voxels, with a voxel size of 0.69 by 0.69  $\mu\text{m}$ . A schematic of the 3D grayscale image volume which is acquired via *in-situ*  $\mu$ -CT (tomography window) is shown in the left insert of Fig. 1.

The tomography image stacks underwent several image processing techniques in order to detect the 3D matrix damage profile (intralaminar cracking or delamination) prior to the failure mode being assessed. First, the microstructure at each load increment, including the damage sustained, was visually inspected using the contrast enhancement tools in ImageJ [34]. A region of interest (ROI) was determined for each specimen based on two considerations. Firstly, the ROI was tailored to crop away locations behind the crack tip that were not of interest because they did not contain notable damage (which helped reduce the image processing computational costs). Secondly, based on observations of the 3D image volume captured just before fracture, the ROI was chosen to focus on areas with high concentrations of matrix cracking. The final ROI represented a critical location with complex damage interactions directly ahead of the crack tip, and it was tracked using 2D cross correlation throughout the loading history of each specimen. A schematic of the ROI within the full tomography window is also shown in the left insert of Fig. 1, where it can be seen that the ROI contains the very tip of the crack front.

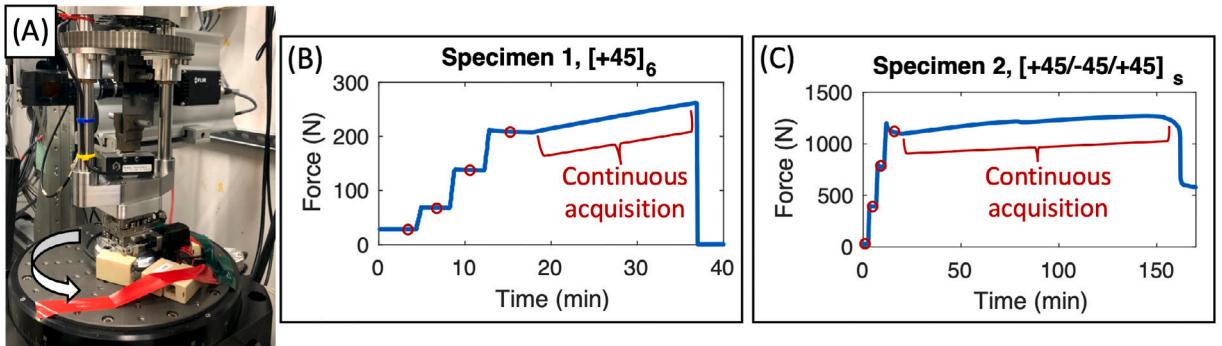
Fig. 2. An overview of the experiment, where (A) shows the *in-situ* tomography setup, custom miniature load frame, custom clevis grips, specimen held in compact tension, and rotational stage used to rotate the assembly during the acquisition of X-ray projections, (B) shows the load vs. time profile for Specimen 1 with layup  $[+45]_6$ , and (C) shows the load vs. time profile for Specimen 2 with layup  $[+45/-45/+45]_s$ . The incremental tomography acquisitions have been shown by red circles, and the continuous tomography acquisitions have been shown by red brackets.

The *in-situ* experiments were carried out at the Advanced Photon Source (beamline 2-BM) at Argonne National Laboratory using the tomography set-up shown in Fig. 2A. Shown on top of the rotational stage is the miniature load frame that used custom clevis grips to apply load on the compact tension specimens. The X-ray projections were captured with a pixel size of 0.69  $\mu\text{m}$ . The beam energy was 25 keV and the sample to detector distance was 400 mm, with an exposure time per projection of 50 ms. The rotational stage, which held the load frame assembly, was rotated with a speed of approximately 2.5°/s over a total span of 180°, where an X-ray projection was acquired every 0.12°. Due to the load frame columns, 188 projections (of the total 1500) that were captured between 78° and 100.56° were not used for tomographic reconstruction.

The force vs. time curves for Specimen 1 ( $[+45]_6$ ) and Specimen 2 ( $[+45/-45/+45]_8$ ) are shown in Fig. 2B and C, respectively. In the plots of Fig. 2, the incremental scans are circled in red and the continuous scanning is marked by a red bracket. Static displacement holds and  $\mu$ -CT scans were conducted for Specimen 1 at the unloaded state, 68 N, 138 N, 210 N. The cross-head displacements corresponding to each of the static loading states for Specimen 1 were 0 mm, 0.034 mm, 0.087 mm, and 0.137 mm. After which continuous loading was conducted until fracture at a cross-head displacement of approximately 0.173 mm. Specimen 2 underwent a similar testing procedure, where static displacement holds and  $\mu$ -CT scans were conducted at the unloaded state, 400 N, 800 N, and 1200 N. The cross-head displacements corresponding to each of the static loading states for Specimen 2 were 0 mm, 0.205 mm, 0.407 mm, and 0.647 mm. After which continuous loading was conducted until fracture at a cross-head displacement of approximately 0.851 mm. During the static cross-head displacement holds, both specimens were held for approximately 3.58 min, which resulted in an average force relaxation of 15.9 N.

Specimen 1, with layup [+45]<sub>6</sub>, failed at approximately 259 N as can be seen in Fig. 2B, where brittle fracture was observed to occur at the notch tip. Specimen 2, with layup [+45/-45/+45]<sub>s</sub>, experienced a ductile fracture as can be seen in Fig. 2C. For Specimen 2, eventual fracture was not catastrophic, and the specimen did not completely fail. Instead, after the load significantly dropped, the damage at the crack tip grew outside the boundary of the tomography window (1689 by 1689 by 1411 μm), and there was significant damage at the pin attachment of the top clevis grip. For the purpose of comparing the results, the point at which the load significantly dropped for Specimen 2 will be considered the fracture point, which occurred at approximately 1263 N.

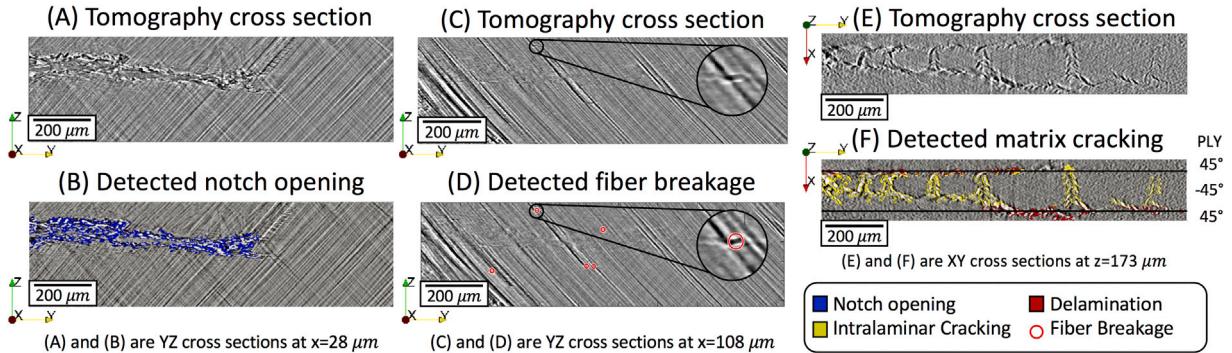
**Fig. 3.** Example of the validation of damage segmentation shown here for Specimen 2, with layup  $[+45/-45/+45]_s$ . The first row depicts tomography images, whereas the second row illustrates feature identification after image processing. Specifically, comparing tomography cross sections containing (A) the specimen notch with (B) the detected notch, (C) fiber breakage events with (D) the detected breakage and the sphere of influence, and (E) the matrix damage with (F) the classified matrix damage including intralaminar matrix cracking and delamination.

After each image processing step, ModLayer (a Matlab image processing graphical user interface) was used to validate the efficacy of matrix damage segmentation, and parameters were varied to ensure the highest accuracy in segmentation for each tomography scan [35]. This verification step was conducted for all load increments of both specimens, and a sample of this validation is shown in Fig. 3.

In order to determine if there was an interaction between the matrix damage profile and the fiber breakage events, a sphere of influence criteria was established centered at each fiber breakage location where the sphere had a radius of  $6.8 \mu\text{m}$ , approximately equivalent to one fiber diameter. A cross section of this sphere overlaid on a fiber breakage event is shown in Fig. 3D. Considering that there is some blur in the tomography images, a sphere of this size enabled the isolation and enclosure of the full breakage event as shown in the insert of Fig. 3D.

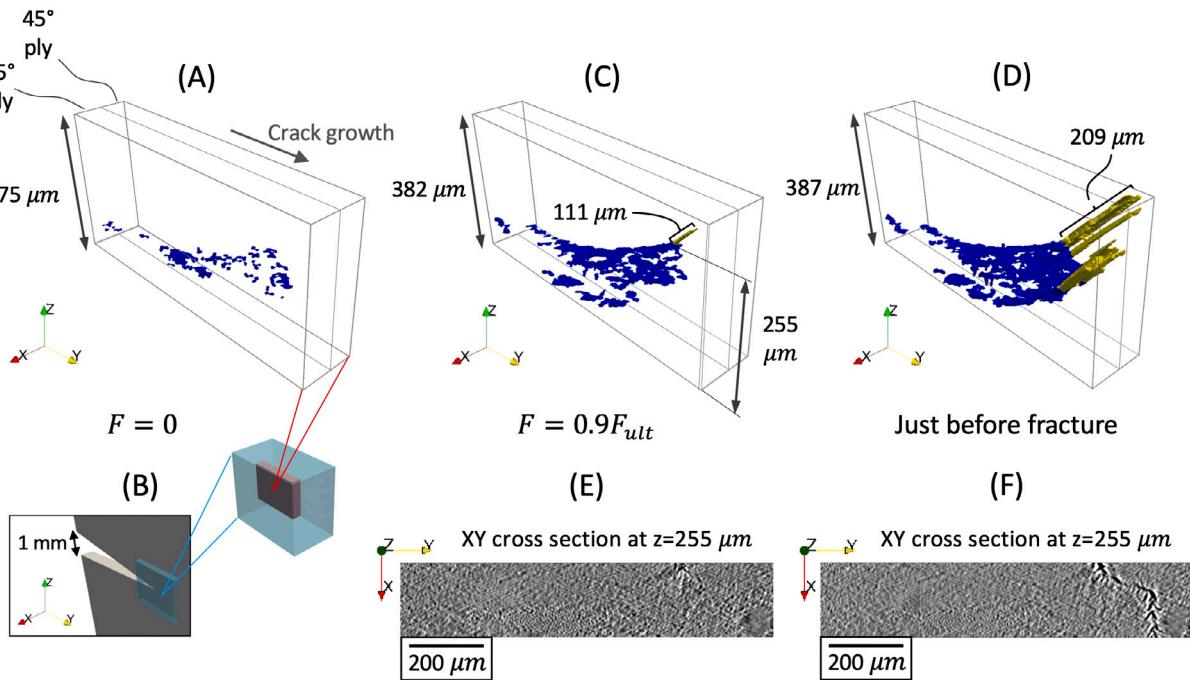
**Fig. 4.** Matrix cracking (which progresses from left to right) in Specimen 1, with layup  $[+45]_6$ , (A) at 0 N, where a schematic of the notch highlighting the ROI is shown in (B), (C) at 234 N ( $0.9F_{ult}$ ), and (D) at 259 N ( $0.99F_{ult}$ ), where only intralaminar cracking was observed emanating from the notch tip. In the 3D visualizations of damage, blue represents the notch tip and yellow represents intralaminar cracking. Tomography XY cross sections, with plane normal (along the Z direction) parallel to the loading direction, at  $z = 255 \mu\text{m}$  are shown (E) at 234 N, and (F) at 259 N where the evolution of damage is observed as load increases.

The notch tip within the ROI for Specimen 1 is shown in Fig. 4A and B. In the first three static load increments of Specimen 1 captured at 68 N, 138 N, and 210 N, no damage was detected. Damage initiation was detected during continuous monotonic loading, at the scan captured at approximately 234 N (0.9F<sub>ult</sub>). Specifically, matrix damage in the form of intralaminar matrix cracking was observed with a length of 111 μm, as shown in Fig. 4C. At the very end of continuous loading and tomography scanning (just before fracture at approximately 259 N), it was observed that the intralaminar matrix crack grew to a length of 209 μm, as shown in Fig. 4D. None of the captured tomography scans for this specimen showed any signs of delamination. After the last captured scan, damage progressed almost instantaneously and brittle fracture occurred. Fiber breakage events only occurred just before fracture in 19 locations, shown in Fig. 5. Among these locations, only one fiber breakage event interacted with intralaminar cracking, shown as a yellow sphere in Fig. 5.

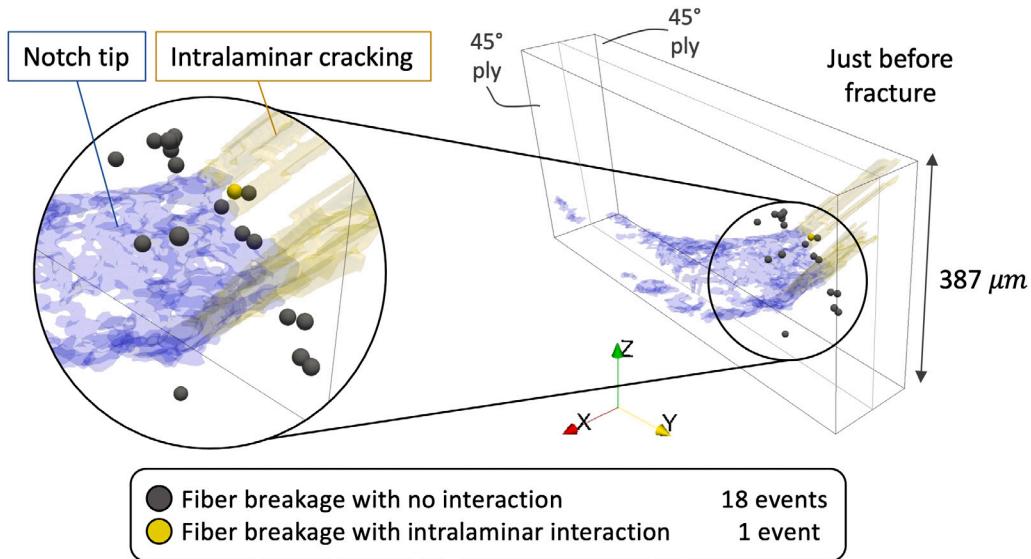
**Fig. 5.** Fiber breakage in Specimen 1, with layup  $[+45]_6$ , at the tomography image captured just before fracture (the only tomography scan which contained fiber breakage).

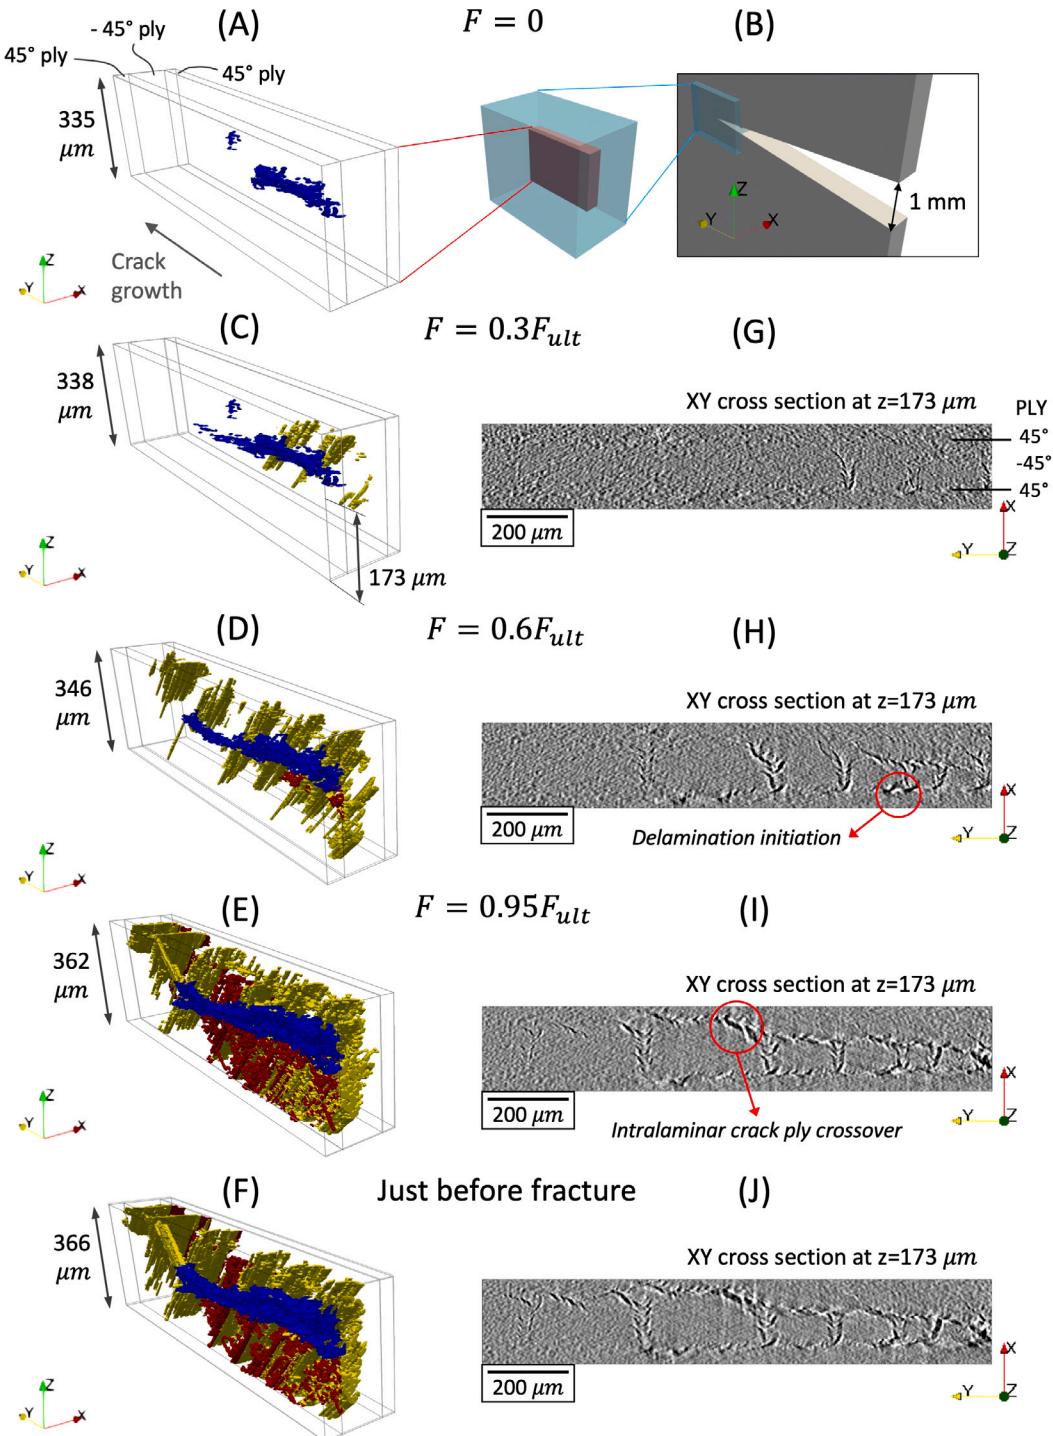
**Fig. 6.** Matrix cracking (which progresses from right to left) in Specimen 2, with layup  $[+45/-45/+45]_s$  (and with black outlines showing the plies in the ROI), (A) at 0 N, where a schematic of the notch is shown in (B), (C) at 400 N ( $0.3F_{ult}$ ), (D) at 800 N ( $0.6F_{ult}$ ), (E) at 1200 N ( $0.95F_{ult}$ ), and (F) just before fracture, where the volume fraction of each matrix cracking mechanism has been quantified at each load step. In the 3D visualizations of damage, blue represents the notch tip, yellow represents intralaminar cracking, and red represents delamination. Tomography XY cross sections, with plane normal (along the Z direction) parallel to the loading direction, at  $z = 173 \mu\text{m}$  are shown (G) at 400 N, (H) at 800 N, (I) at 1200 N, and (J) just before fracture, where the evolution of damage is observed with increasing load. In particular, sites of (H) delamination initiation are observed, as well as (J) sites where intralaminar cracks cross into neighboring plies.

The notch tip within the ROI for Specimen 2 is shown in Fig. 6A and B. Damage initiation was observed in the first static load increment of Specimen 2, which was captured at 400 N (0.3F<sub>ult</sub>). Specifically, matrix damage in the form of intralaminar cracking was observed, shown in Fig. 6C. In the second static load increment captured at 800 N (0.6F<sub>ult</sub>), new locations of intralaminar cracking were detected, and the first signs of delamination appeared, but were minimal (Fig. 6D and H).

grown steadily, where intralaminar cracking remained the dominant matrix damage mechanism near the notch tip, as can be seen in [Fig. 6F](#).

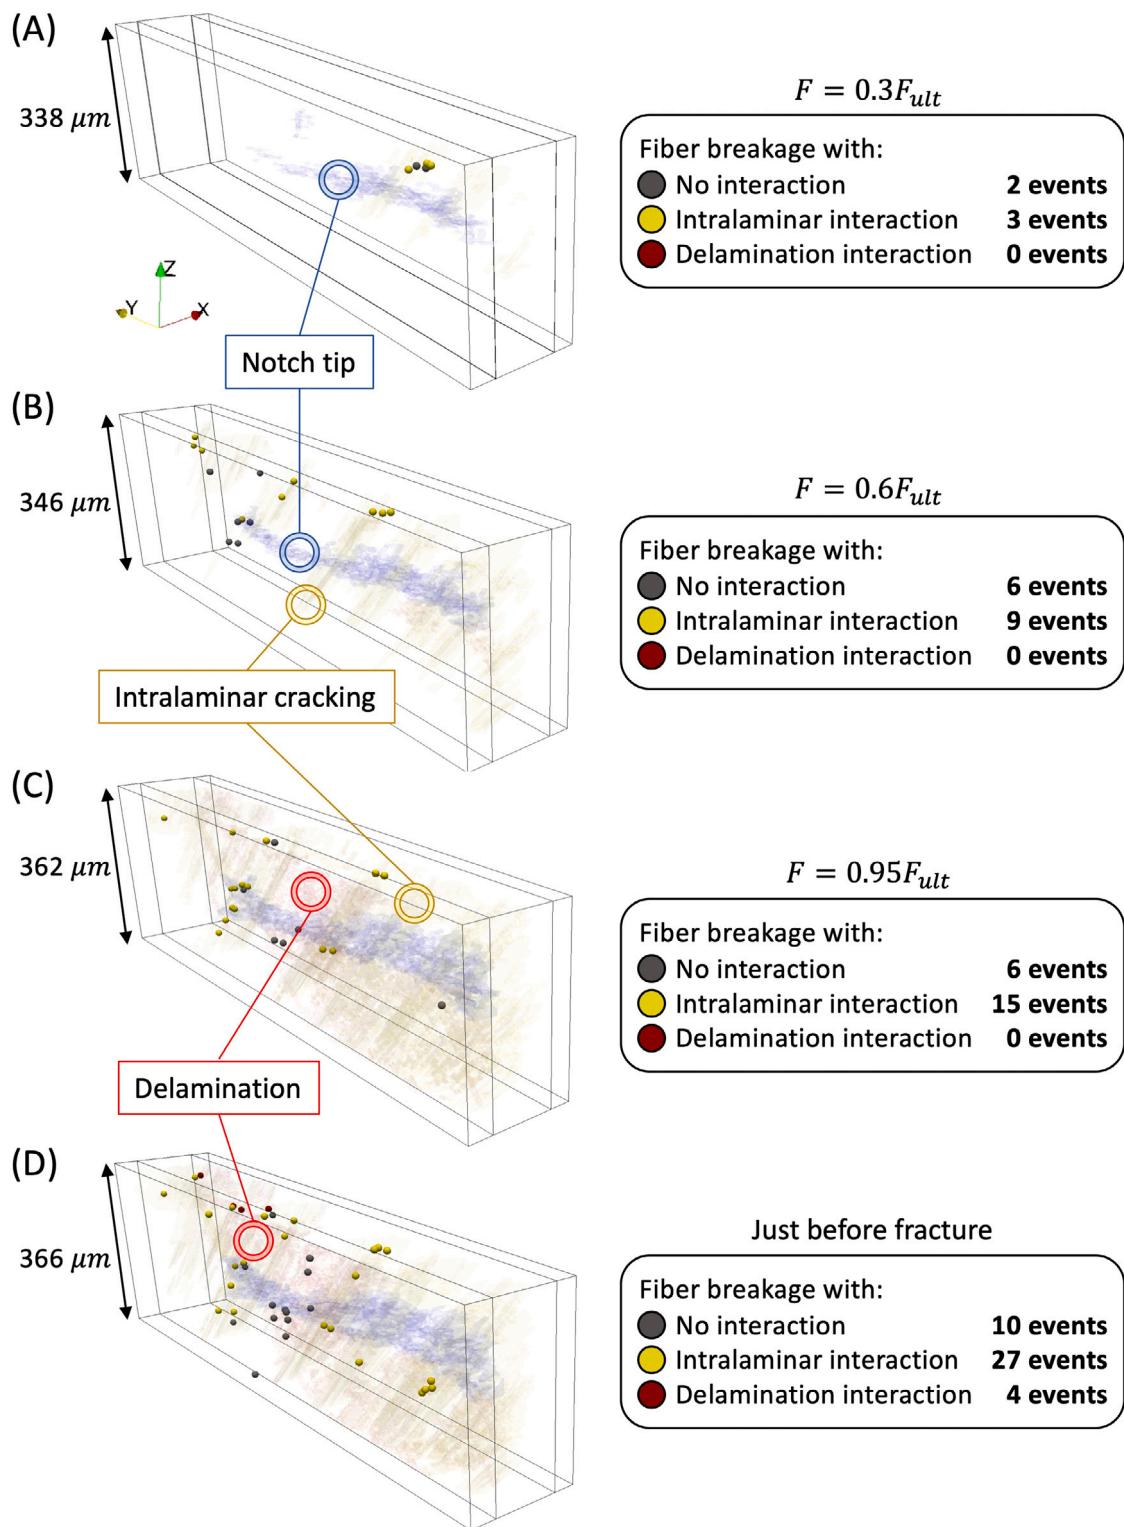
**Fig. 7.** Fiber breakage in Specimen 2, with layup  $[+45/-45/+45]_s$ , (with black outlines showing the plies in the ROI), at (A) 400 N ( $0.3F_{ult}$ ), (B) 800 N ( $0.6F_{ult}$ ), (C) 1200 N ( $0.95F_{ult}$ ), and (D) just before fracture, where it can be seen that fiber breakage has a more prevalent interaction with matrix cracking, including delamination. The fiber breakage events shown here are new fiber breaks at each load state (not cumulative).

Fiber breakage was detected at the first load increment captured at 400 N ( $0.3F_{ult}$ ), with a total of 5 fiber breakage events. Three of these events interacted with locations of intralaminar cracking, shown by the yellow spheres in [Fig. 7A](#). Then, at 800 N, there were 15 new locations of fiber breakage, where 6 of these interacted with intralaminar cracking ([Fig. 7B](#)). Further, at 1200 N, 21 new locations of fiber breakage were detected, where 15 interacted with intralaminar cracking ([Fig. 7C](#)). Finally, just before fracture, there were 41 new events of fiber breakage, and the first interaction between fiber breakage and delamination was documented. Here, 27 fiber breakage events interacted with intralaminar cracking, and 4 breakage events were observed to interact with delamination at the ply interfaces (red spheres in [Fig. 7D](#)). Cumulatively, by the end of the loading sequence and just before fracture, Specimen 2 contained 82 total locations of fiber breakage events in the ROI: 24 were isolated from matrix damage and exhibited no interaction, 54 interacted with intralaminar cracking, and 4 interacted with delamination.

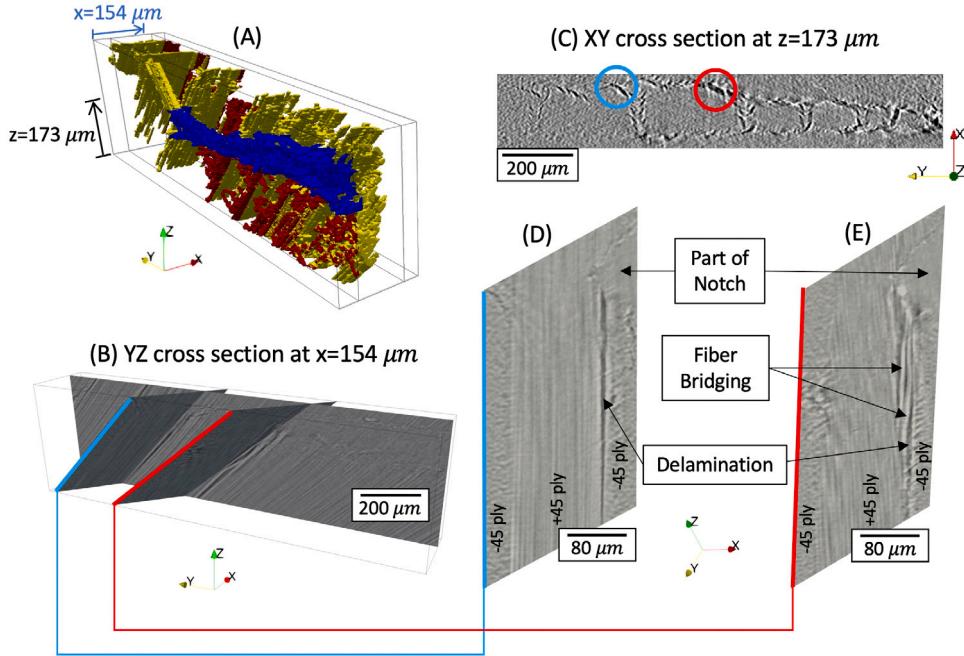
**Fig. 8.** The 3D matrix cracking detection is shown in (A) for reference, where a YZ cross section at  $x = 154 \mu\text{m}$  is shown in (B) that intersects two locations of delamination which have also been circled in (C) at an XY cross section at  $z = 173 \mu\text{m}$ . The first example of delamination is a typical delamination event and is shown in (D), and the second example contains fiber bridging and is shown in (E). Note that the two oblique cross sections in (D) and (E) were not parallel in order to clearly show the bridging fibers in (E).

Additionally in Specimen 2, a location of fiber bridging was directly observed, and has been visualized in [Fig. 8](#). A simple location of delamination is shown in [Fig. 8D](#), and can be compared to the location of fiber bridging in [Fig. 8E](#). This observation shows that fiber bridging is a phenomenon which occurs in configurations other than a DCB test (such as the compact tension configuration in this work). Specifically, fiber bridging can be an active mechanism that increases fracture toughness and resists slow crack growth in composites [38] even when the plane of delamination (YZ plane) is aligned with the loading direction (Z direction). It was unexpected that the fibers which bridge the delamination gap were still intact and did not break, considering that bridging fibers produce high closure over a small displacement while experiencing high stress, sometimes leading to fiber breakage [39,40]. This implies that the relationship between delamination, fiber bridging, and fiber breakage is more complex than previously hypothesized, and may be heavily dependent on microstructural defects near the ply interface [38].

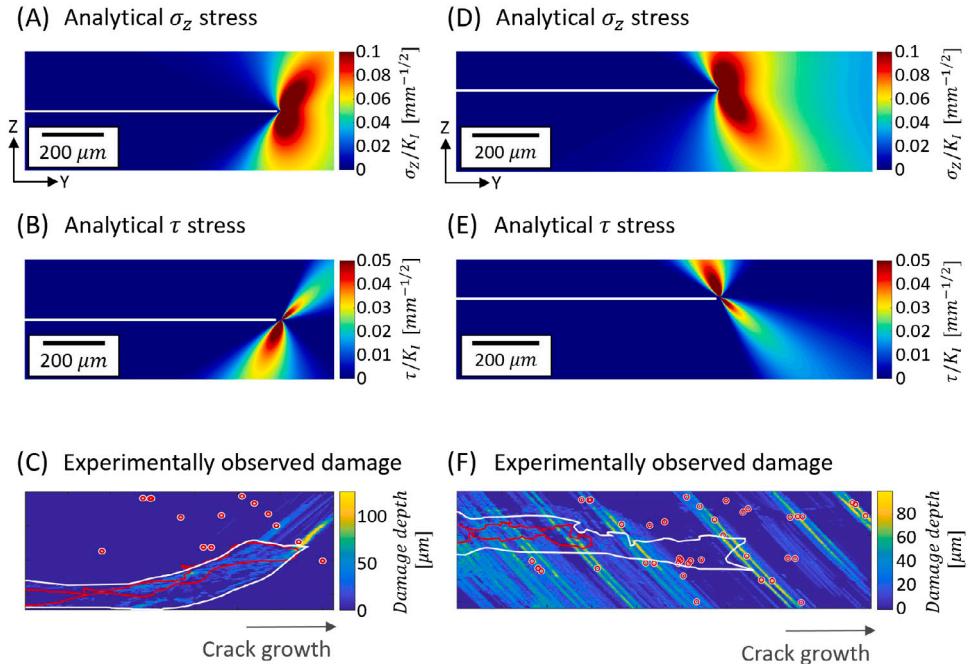
**Fig. 9.** Crack tip stress fields for Specimen 1, with layup  $[+45]_6$ , and Specimen 2, with layup  $[+45/-45/+45]_s$ . The  $\sigma_z$  stress shown was determined (A) for Specimen 1 and (D) for Specimen 2, as well as the  $\tau$  stress components calculated (B) for Specimen 1 and (E) for Specimen 2. The experimentally observed damage shown (C) for Specimen 1 and (F) for Specimen 2 was captured just before fracture (where damage depth represents a 2D projection of 3D damage into the page), with white outlines containing the crack tip at the specific loading state, and red outlines containing the initial crack tip prior to damage initiation (the crack progressed from left to right). The red circles in (C) and (F) represent fiber breakage points.

To examine the nature of matrix cracking and fiber breakage events, the analytical stress solution, shown in [Fig. 9A, B, D, and E](#), which was computed in the vicinity of the crack tip within each specimen's ROI, sheds some light on the micromechanical behavior for each specimen. The experimental behavior can be compared in [Fig. 9C and F](#), where the crack tip before damage initiation is outlined in red, the crack just before fracture is outlined in white, and red circles show the 2D projected locations of fiber breakage. As can be seen in [Fig. 9A and B](#), the stress field in the homogenized ROI for Specimen 1 follows the direction of the fibers, where the highest shear stress occurs directly below and to the left of the notch tip ([Fig. 9B](#)) at the smaller angle between the fiber direction

and the idealized crack. While the direction of the stress field helps to show why intralaminar cracking was dominant during damage initiation, the intralaminar crack did not grow towards the bottom left, but grew up towards the top right of the notch tip (Fig. 9A, B, C). This is likely due to the fact that the real crack tip, shown in Fig. 9C, is much more tortuous and curves upward, compared to that which is assumed in the homogenized solution. This behavior shows that the exact geometry of the crack plays a crucial role in the directionality of damage initiation, and must be accounted for in the development of accurate damage predictions. As for fiber breakage, it can be seen in Fig. 9C that many of the fiber breakage events occurred at the crack flanks (behind the crack tip) in an apparently stochastic manner, since they did not align with the high stress regions. This apparent stochastic fiber breakage behavior, which was also seen in Figs. 5 and 7 as fiber breakage events with no matrix cracking interaction, likely occurred due to defects induced during fabrication, such as small scratches on the fiber surfaces during tape production or lay-up, as suggested by Garcea et al. in the analysis of a  $[90/0]_s$  layup [41].
