# Assessment of hurricane wind performance and potential design modifications for informally-constructed housing in Puerto Rico

This study assesses the wind performance of various housing typologies representing informal construction practices in Puerto Rico to suggest modifications to enhance housing resilience in hurricanes. Based on fieldwork and interviews, the study defined four base housing typologies and possible variations in design and construction details. Each house was assessed using performance-based static wind analysis of potentially critical components. The results show that the initial governing failure mode in all base house typologies considered is roof panel loss due to tear-through at the fasteners, with subsequent governing failures being panel loss due to failures at the purlin-to-truss connections and failures of the truss-to-wall connections. In-plane wall failures and masonry uplift failures were both found to occur at much higher wind speeds than roof failures. To improve the hurricane performance, several feasible modifications are suggested, including installing hurricane straps at both the truss-to-wall and the purlin-to-truss connections, as well as

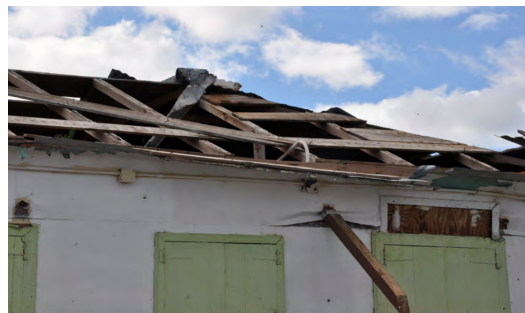
Figure 1. Illustration of roof panel loss in Puerto Rico due to Hurricane Maria (Source: FEMA, 2018a)

In Puerto Rico, after Hurricanes Irma and Maria, FEMA's reconnaissance team observed that wood-frame buildings that were damaged by wind typically had failures within the roof system due to insufficient connections between structural members (FEMA 2018a), as exemplified in Figure 1. Weak connections caused failures to occur at the connection holding the metal roof panels to the roof structure, the connection between structural members in the roof structure, or at the connections holding the roof to the walls. These types of issues arise almost exclusively in informally-constructed houses (FEMA 2018a). Of these, the most common failure mode in Puerto Rico was the loss of roof covering in structures with wooden roof systems. This roof covering loss was due to the use of improper fasteners, metal panels with an insufficient gauge, a lack of redundancy, and excessively wide truss and purlin spacing (FEMA 2018a). In some cases, metal roof panels were nailed to wooden roof members with no consideration of increased wind pressures at the ends, ridges, or corners of the roof, which also contributed to failures (FEMA 2018a). Additionally, these panels were often heavily corroded due to improper coatings, inadequate material selection, or age, which likely weakened connections. These connection failures resulted in the roof covering partially missing on many houses, leading to further destabilization and water intrusion. Although less prevalent, metal roof panels have also been found to be pried from a house with wooden purlins still attached (Ginger et al. 2010). FEMA's reconnaissance team observed that houses with structural decking beneath the metal panels outperformed those without it in Puerto Rico and that adjustments such as using thicker (superior gauge) metal panels or reduced fastener spacing improved roof performance (FEMA 2018a).

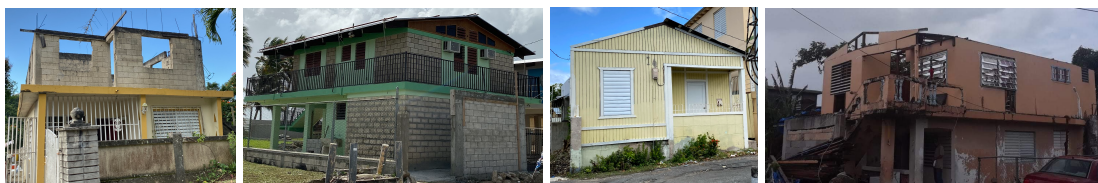
Figure 2. Photos of Puerto Rican informally-constructed houses [Photos: Polly B. Murray and the authors]

Due to the wide variation in housing design details in Puerto Rico, we first sought to characterize informal housing construction across the island based on a literature review of housing characteristics across the Caribbean and fieldwork/exploratory interviews. During fieldwork in July 2019 and February 2020, we measured structural dimensions and took photos of the exterior of typical houses built with reinforced concrete and wood (Goldwyn et al. 2021). During these interviews, households were asked to show and describe any damage to their houses due to Hurricane Maria and the 2019-20 earthquakes (only in the 2020 interviews). Engineers, architects, and reconstruction program staff and volunteers also shared photos and videos of typical damage to different, common housing types. We also examined inventory at hardware stores across Puerto Rico during this fieldwork to determine material availability and prices. In interviews, many informal builders also explained the structural vulnerabilities that are commonly produced by unsafe construction practices or design choices of other informal builders that they viewed as unacceptable yet commonplace. Figure 2 includes photos of several typical houses taken across these fieldwork trips. We used this information to establish four main housing typologies and variations therein to reflect the most common construction practices and materials observed in Puerto Rico's informally-constructed housing.

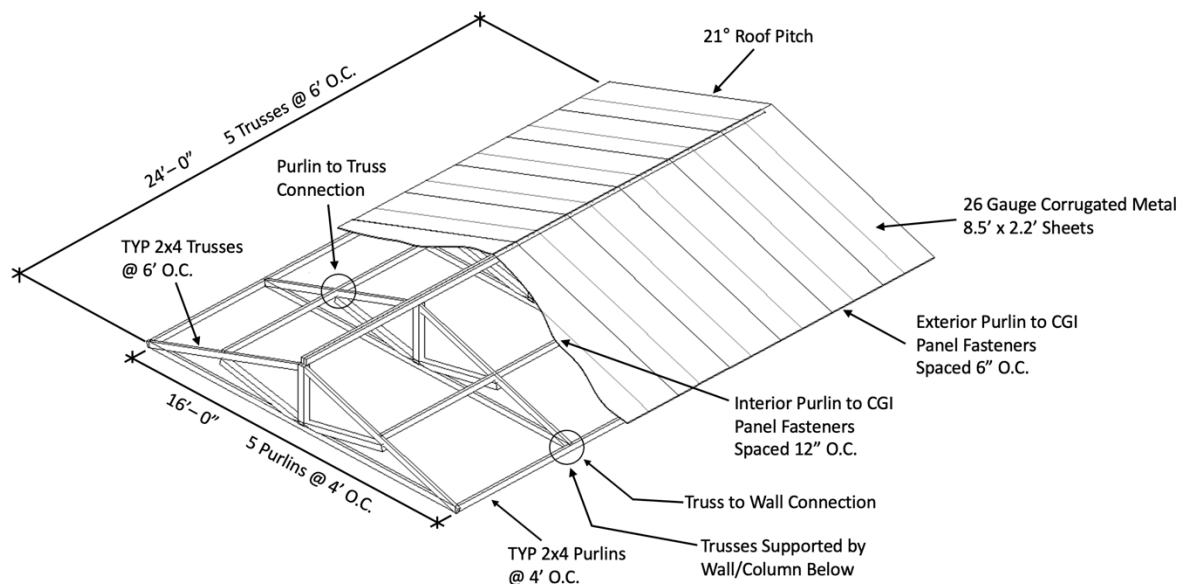
Figure 3. Base house typology, *Gable 1*, showing roof system plan view and 3D schematic. (1 in = 25.4 mm; 1 ft = 0.305 m)

The initial base case, denoted *Gable 1* (detailed in Figure 3), represents a one-story wood-frame house with a corrugated metal roof. Three additional base typologies were defined to reflect common variations in the number of stories, primary housing material, and roof shape. These four base typologies are defined in Table 1.

Much of Puerto Rico's informal construction consisted of light, wood-frame houses (FEMA 2018a, Wells 2020). We assumed that one-story houses in this study had wood framing with plywood sheathing, or reinforced concrete (RC) columns with unreinforced concrete masonry unit (CMU) infill walls. We assumed two-story houses had concrete or masonry walls on the first floor, with plywood walls on the second floor. This is common among two-story, informally-constructed houses because the stories are often not constructed simultaneously (FEMA 2018a, Goldwyn 2021). The most common roof type was a wood-frame roof with corrugated metal panels, which we assume for all the typologies. While some houses did have tile or concrete roofs, these materials are more expensive and thus less common (FEMA 2018a). We assumed the purlin length to be 10 feet (3.1 meters) with two purlins per line (parallel to the roof gable) based on local material availability and the size of the houses being considered (Figure 3).

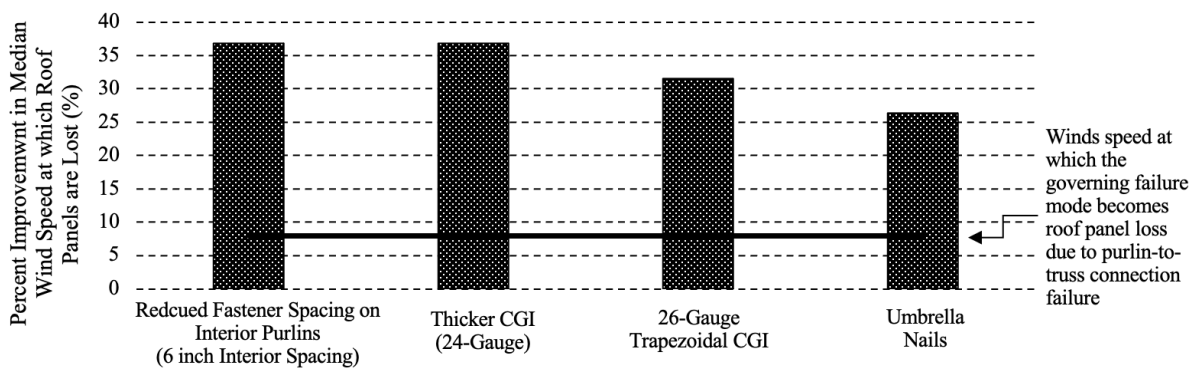
Figure 4. Changes to median wind speed at which roof covering is lost due to modifications at the panel-fastener interface on roofs\*

\*Percent improvement from base case failure for *Gable 1* at 85 mph. Base structure: 12 in interior/6 in exterior spacing of fasteners, 26-Gauge CGI, corrugated metal, standard nails

Given the characteristics of the gable roof on three of the four base house typologies, the governing failure was loss of roof panels due to fastener tear-out, which occurred at a median wind speed of 85 mph (137 kph). Considering this governing failure mode, several design/construction decisions can potentially improve the performance at this interface, including reducing fastener spacing, changing fastener type, choosing a thicker-gauge roof (CGI) panel, and choosing a different panel shape. Figure 4 shows the component changes that can be made to this interface, as well as their impact on the median wind speed at which the panels fail due to faster tear-out, as compared to the base case of the *Gable 1* house typology.

Figure 4 shows only the *sufficient modifications*, which include reducing fastener spacing on interior purlins, using thicker CGI (24-Gauge), using umbrella nails, and using 26-Gauge Trapezoidal CGI. These materials are widely available in most hardware stores and therefore are feasible modifications to this interface. Trapezoidal CGI is commonly recommended by local builders and hardware stores; we hypothesize that it has superior performance in part because of the flat area where fasteners are attached. These all change the failure mode to roof covering loss due to failures at the purlin-truss connections. Thus, the improvement possible in roof performance is only 8% (or up to 92 mph), unless improvements are also made to the purlin-truss connections. In other words, the panels will start failing due to the purlin-to-truss connections before the full level of improvement from these modifications can be observed. However, the overall safety of the roof system can be bettered, given other component improvements.

When the panels or the fasteners undergo any one of the changes shown in Figure 4, panel loss due to the purlin-to-truss connections becomes the governing failure mode. These types of connections were assumed to be nailed in the base typology and can be improved by using a wooden cleat or a hurricane strap at the connection. Cleat performance depends upon the diameter of the nail used in the cleat connections. Figure 5 shows at least a 0.25 inch (6.4 mm) or greater diameter nail in a wooden cleat connection or use of a hurricane strap results in a change in the governing failure mode to the truss-to-wall connection (which occurs at a median wind speed of 101 mph (162 kph).

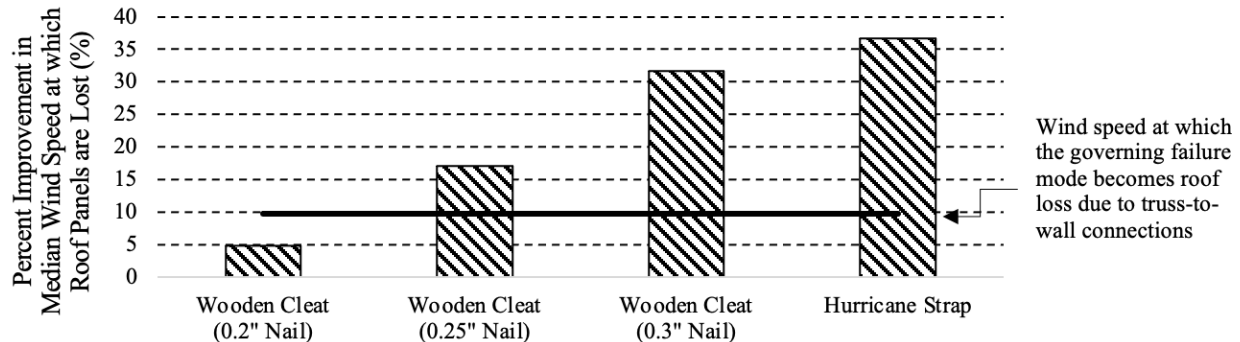
Figure 5. Changes to median wind speed at which roof covering is lost due to modifications at the purlin to truss connection\*

\*Percent improvement from the previous case at 92 mph. Base structure: nailed purlin-to-truss connections

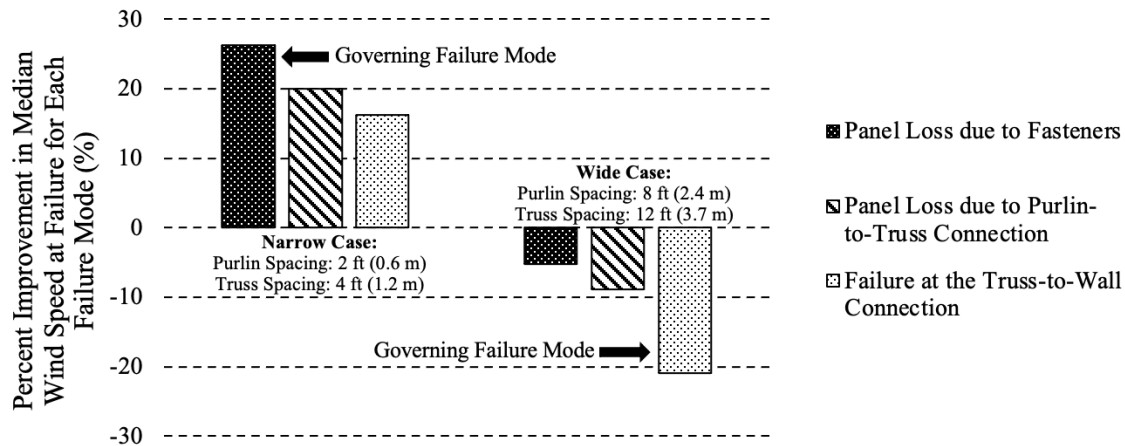
Figure 6. Changes to median wind speed at which various failure modes occur due to modifications in purlin and truss spacing\*

\*Percent improvement from base case at 85 mph. Base structure: 4 ft purlin spacing, 6 ft truss spacing

We considered three variations of purlin and truss spacing to determine the effect of roof member spacing on roof system performance, with results provided in Figure 6. Overall, decreasing the spacing between roof members results in performance improvement at the panel-fastener interface, the purlin-to-truss connection, and the truss-to-wall connection because of greater load distribution. In the base case with all else equal, reducing spacing increased wind speed at governing failure up to 107 mph (173 kph). Conversely, if purlin and truss spacings are larger than that in the base gable roof, premature truss-to-wall connection failures may occur at a median wind speed of only 76 mph (122 kph).

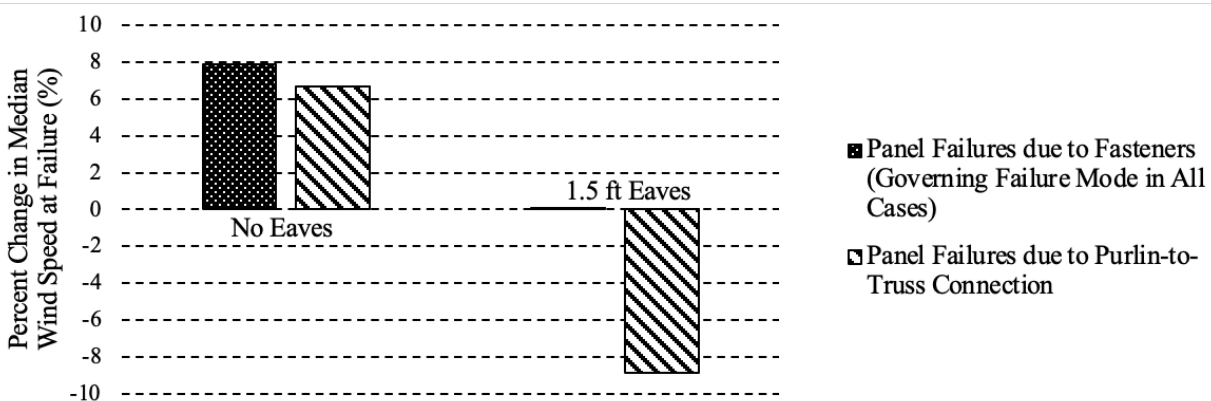
Figure 7. Changes to median wind speed at which various failure modes occur due to modifications in eave size\*

\*Percent improvement from base case: 0.5 ft eaves on all sides

We also considered variations in the size and placement of the eaves, i.e., the roof overhangs. As expected, results in Figure 7 showed that larger eaves caused the median wind speed at roof failure to decrease due to larger pressures, whereas having smaller eaves, or no eaves at all, resulted in improved performance. Changing the eave length increased the uplift on the panels, and affected the wind speed at which panels were lost (due to either the purlin-to-truss connections or fastener tear-through). Eave size did worsen the performance of the truss-to-wall connections, but these changes were minor when compared to the effect on the panel failures, because of the greater tributary area of loads on the truss-to-wall connections.
